SERVICE REQUEST DETAILS FORM Generated by:

07/03759/PESTLO

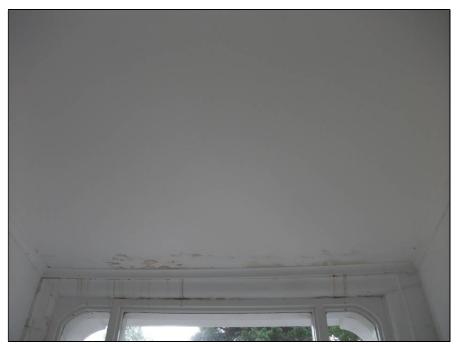
Photo 3 – Ceiling area above the fanlight before ceiling removed. Note the staining of both ceiling and painted stonework.

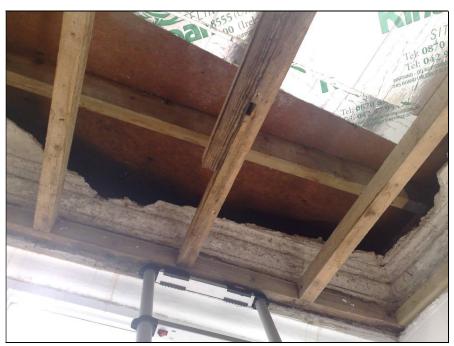
Photo 4 – Same area follwing removal of the ceiling (was plywood). Note the old plasterwork cornice remains in place. Above the new ceiling structure.

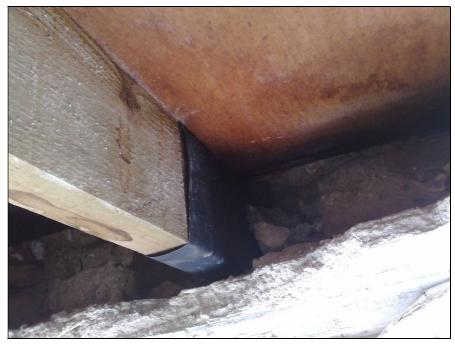
Photo 5 – Shows the replacement roof timbers and roof decking. The dark edge to the decking is very saturated. All the timber showing in this photo had very elevated moisture levels (Protometer used).

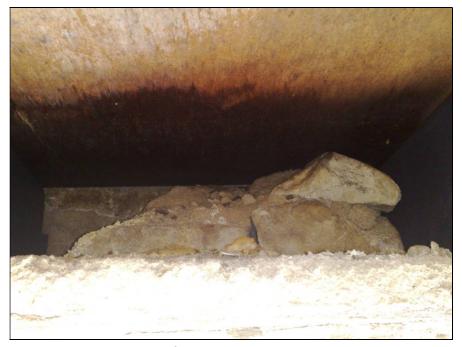
Photo 6 – Another view of the saturated timber decking.

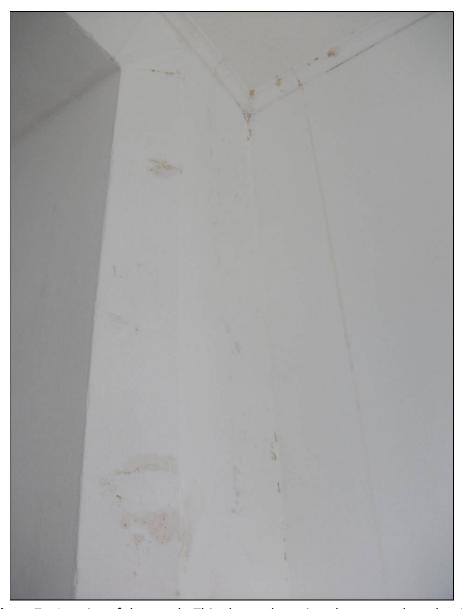
Photo 7 – Interior of the porch. This shows the painted stonework to the right of the inner door(looking from outside), the side wall (plasterboard finish) and part of the ceiling. Note the ceiling and side wall staining and salt damage to the stonework paint finish.

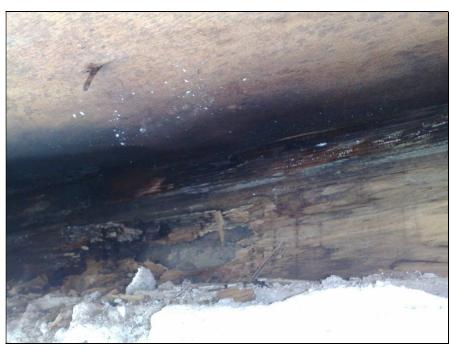
Photo 8 – Roof edge timber element above the front door. Severe timber rot and visibly saturated timber and roof decking. Looks to be an older/original timber left in place when the new roof was fitted.
