Principal Inspection Report

Structure Name: Cloddach Bridge

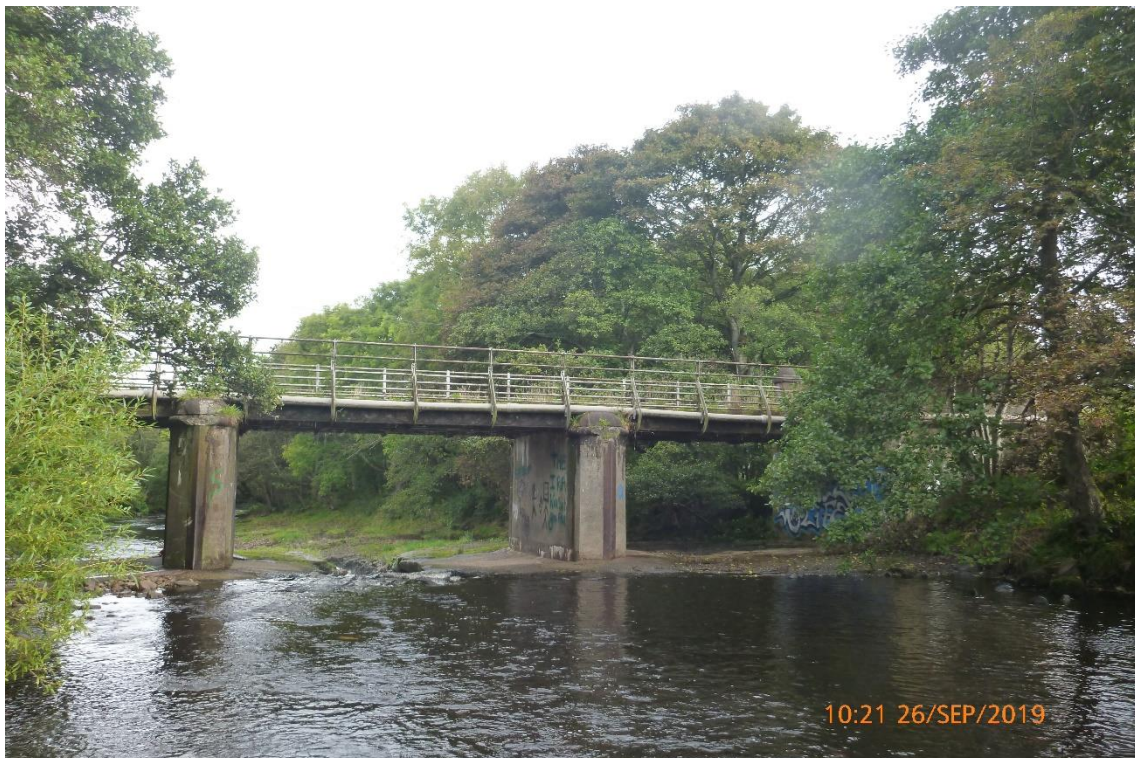
The structure is generally in poor condition with significant corrosion to the steel beams. The invert has been altered and a large gorge formed which is creating scour close to the bridge piers.

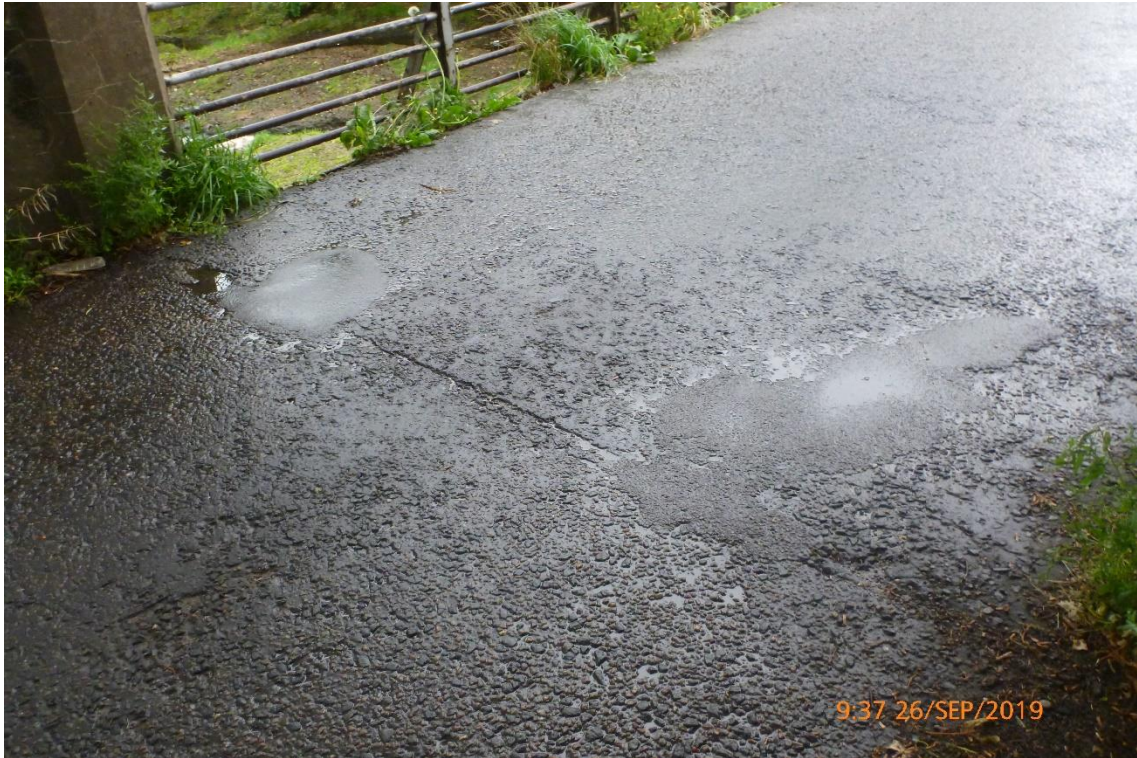
Photograph 7: Carriageway surfacing in good condition with minor patch repairs. No Joint visible.

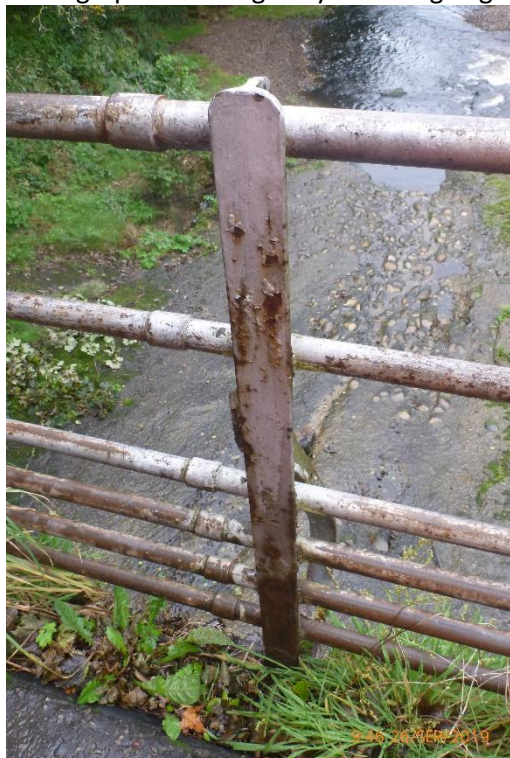
Photograph 8: Typical section of parapet corrosion.

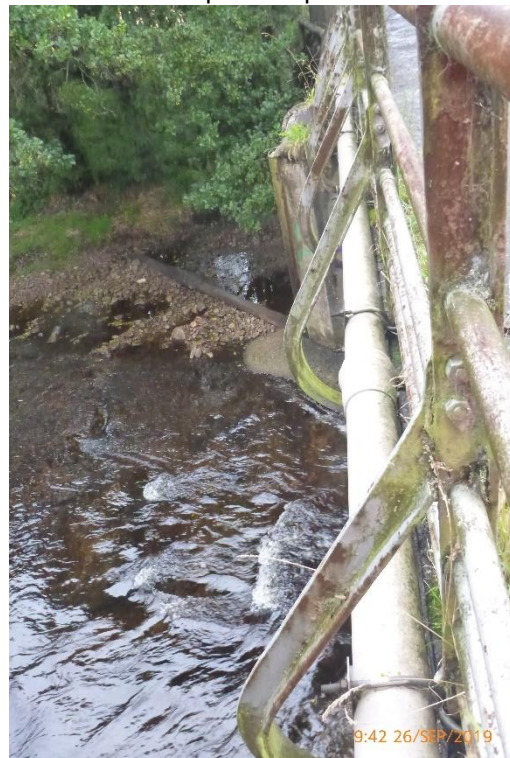
Photograph 9: View of pipeline passing through parapet bracing members on the South side.

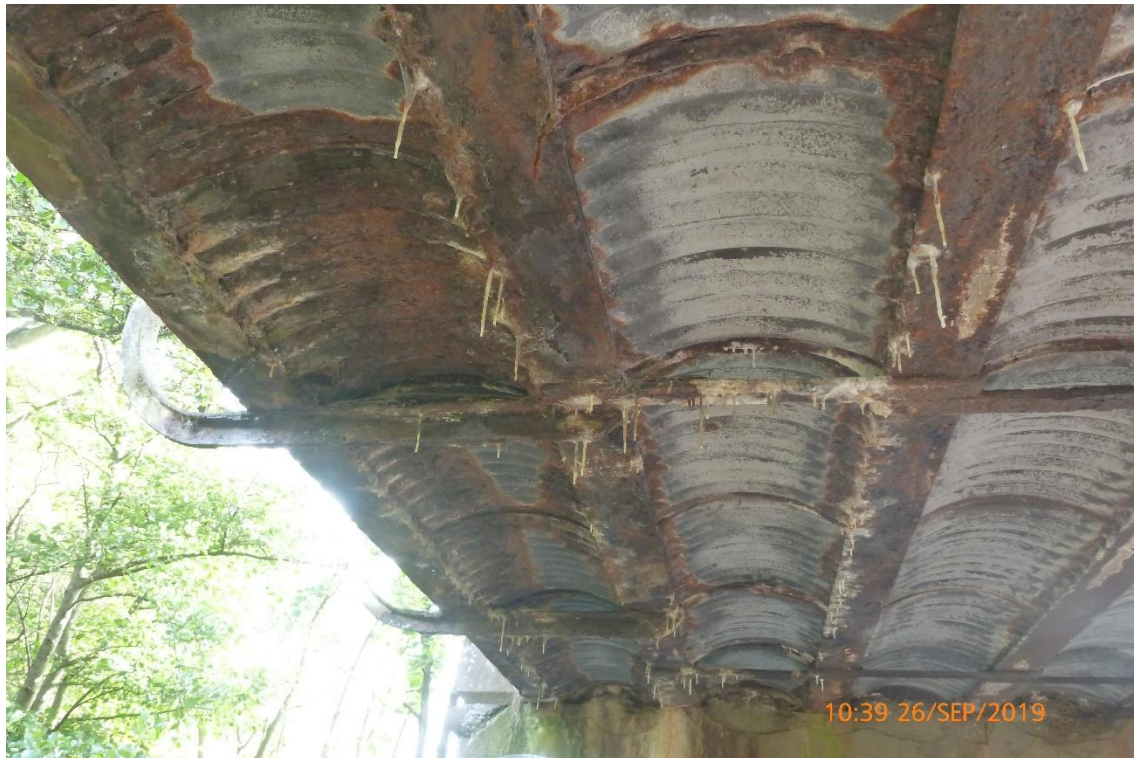
Photograph 10: Typical view of corrosion / rusting and calcite stalactites on bridge invert.

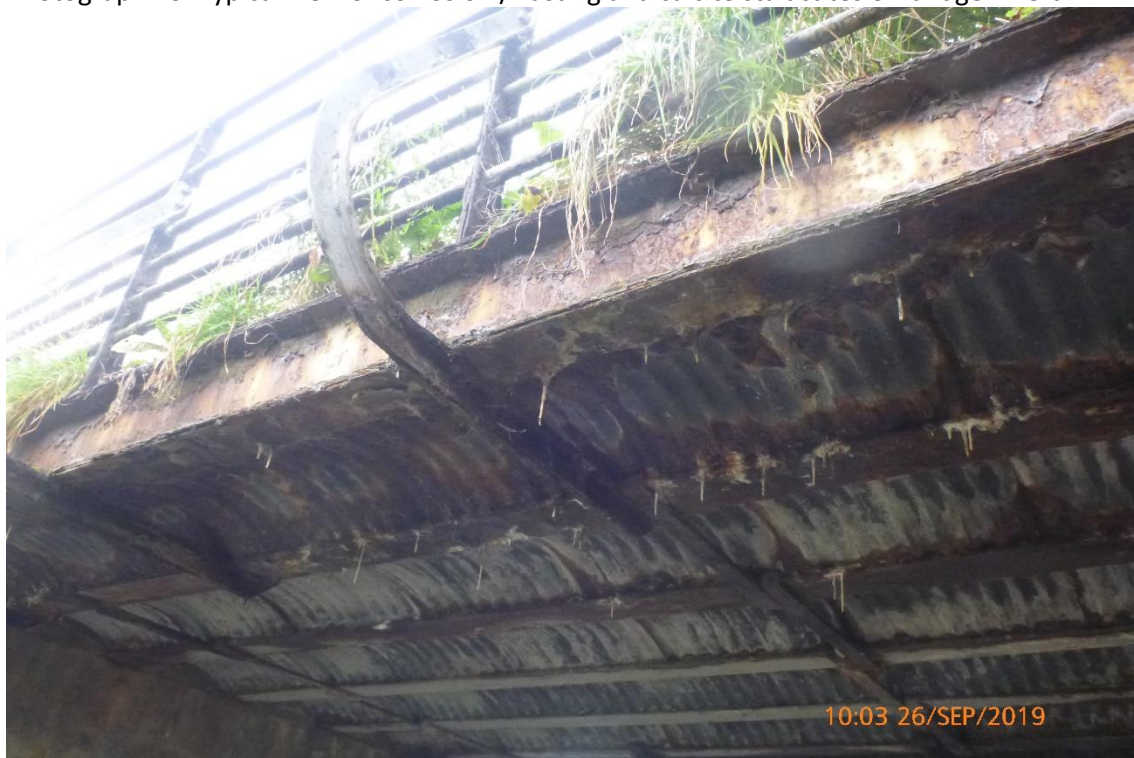
Photograph 11: Typical view of corrosion to outside beams and corrosion to bottom of bracing members.

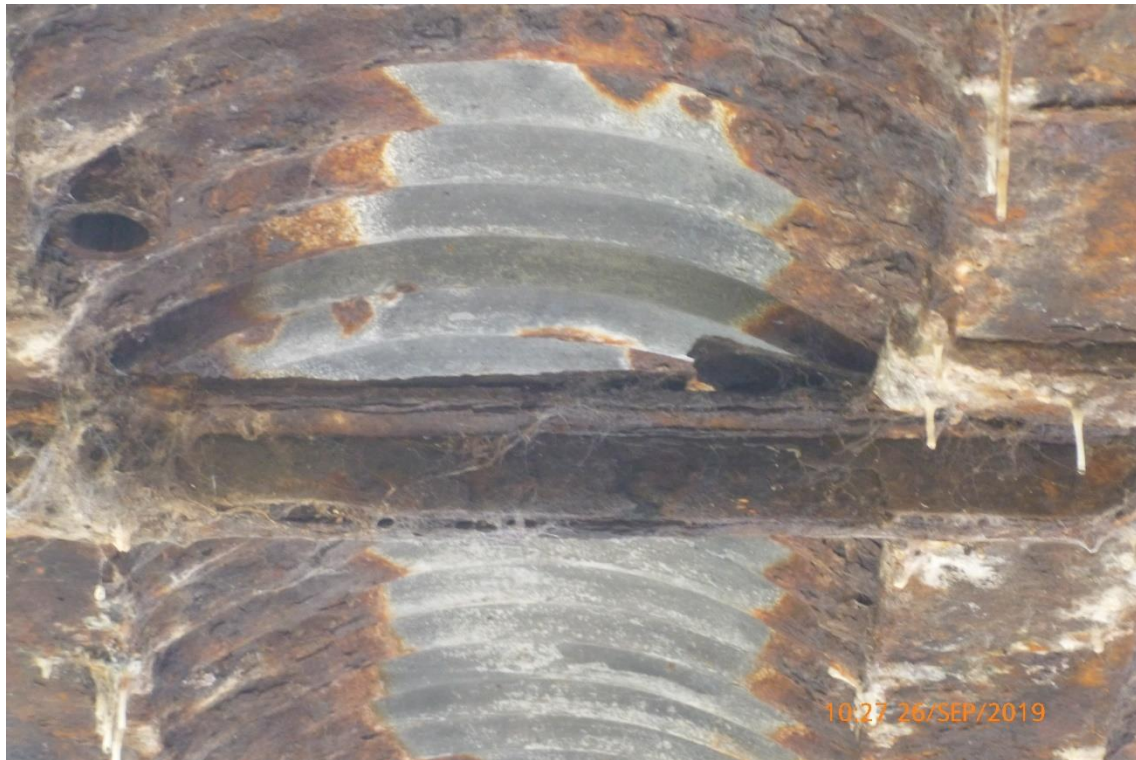
Photograph 16: Significant corrosion to parapet bracing member.

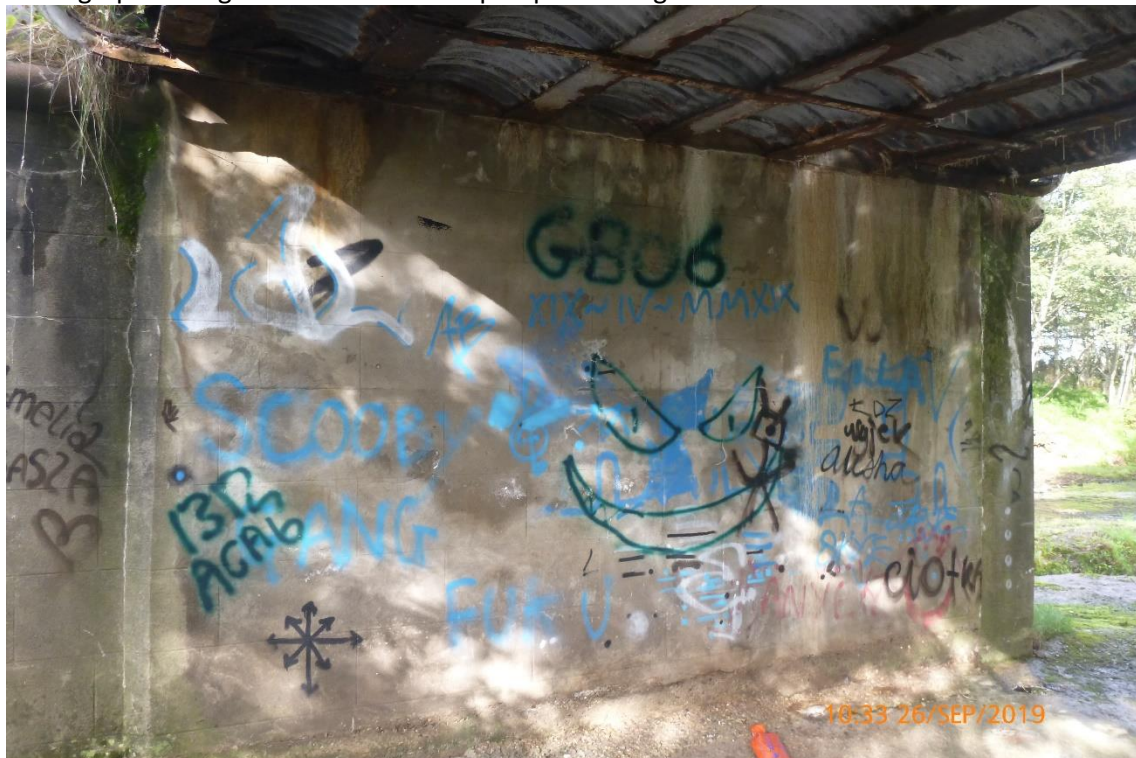
Photograph 17: Example of graffiti present on all abutment and pier faces.

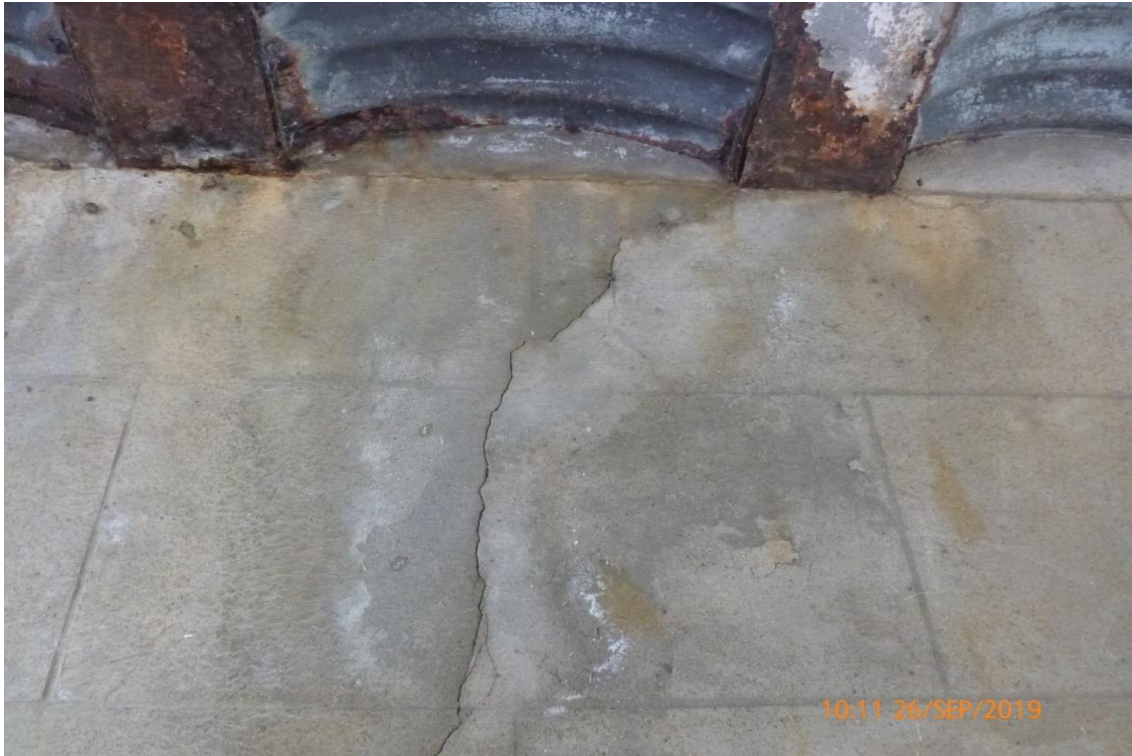
Photograph 18: Vertical Crack on West Abutment starting from beam (0.8mm).

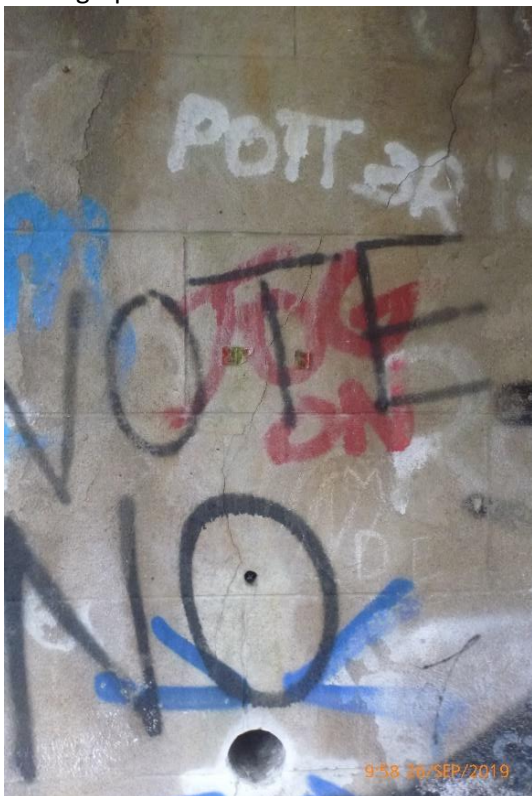
Photograph 19: Vertical crack on West Abutment, with broken crack gauge (0.8mm)

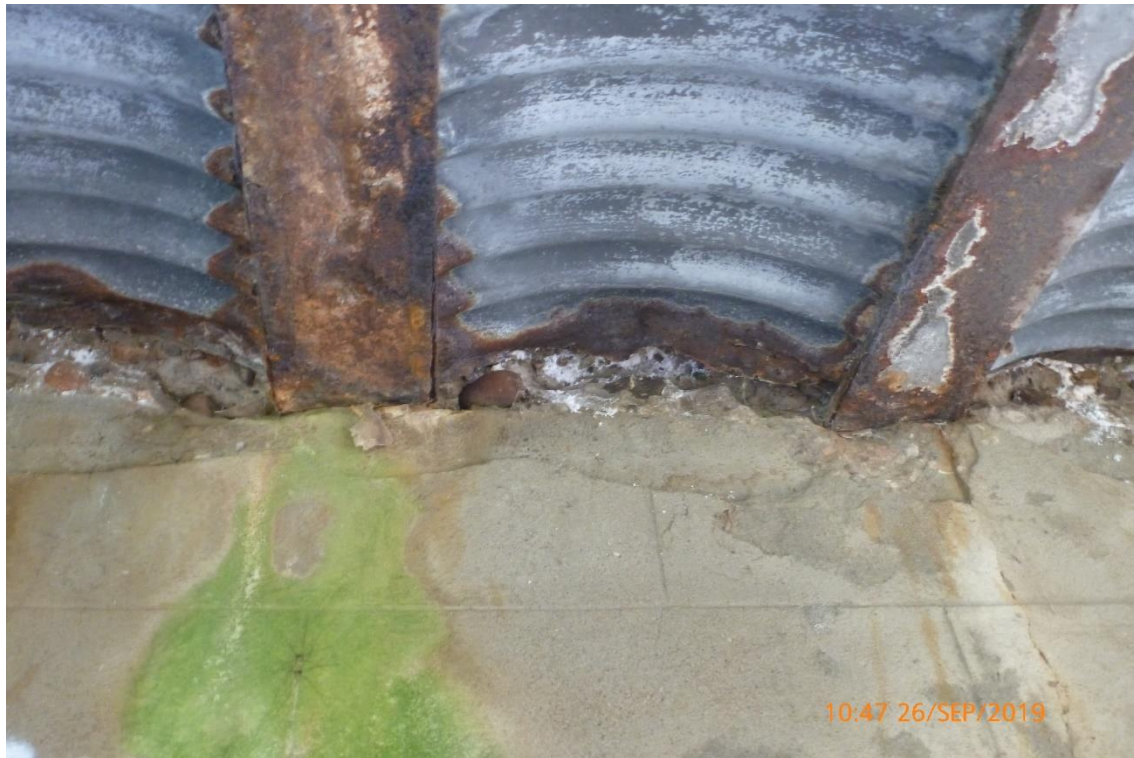
Photograph 20: Spalling of concrete between and under beams. Algae aggregate sizes visible

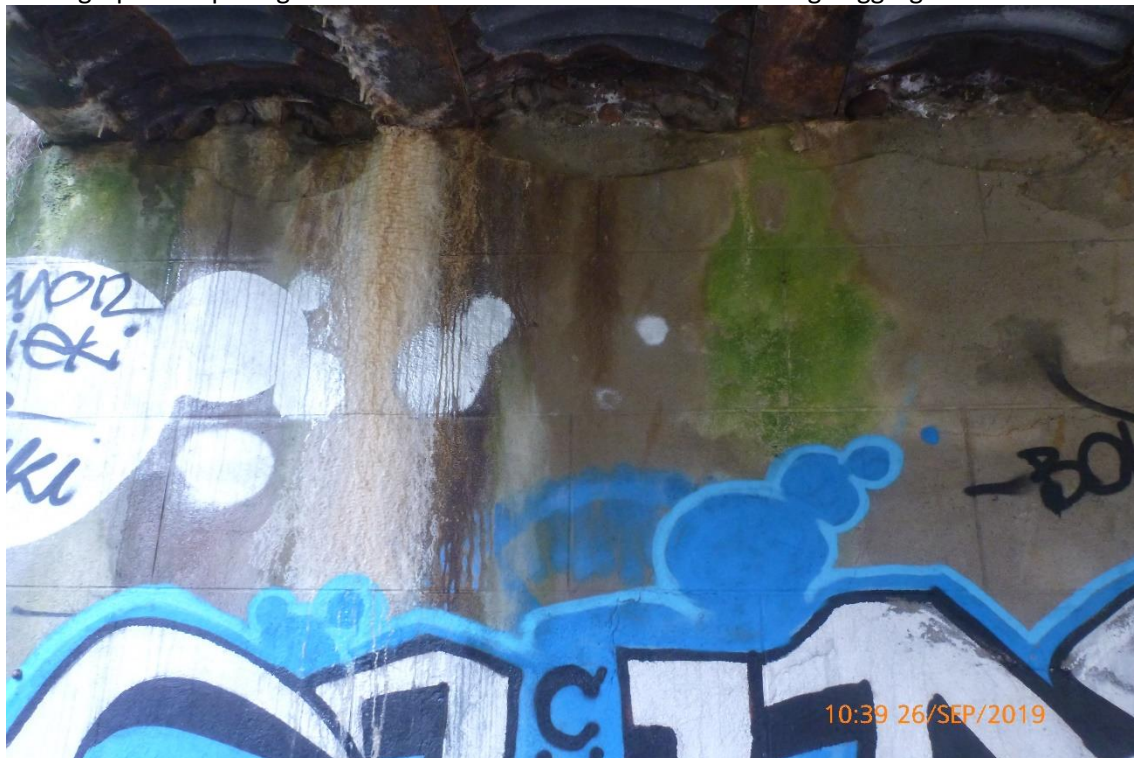
Photograph 21: Typical example of significant calcite build up on Abutment and algae staining.

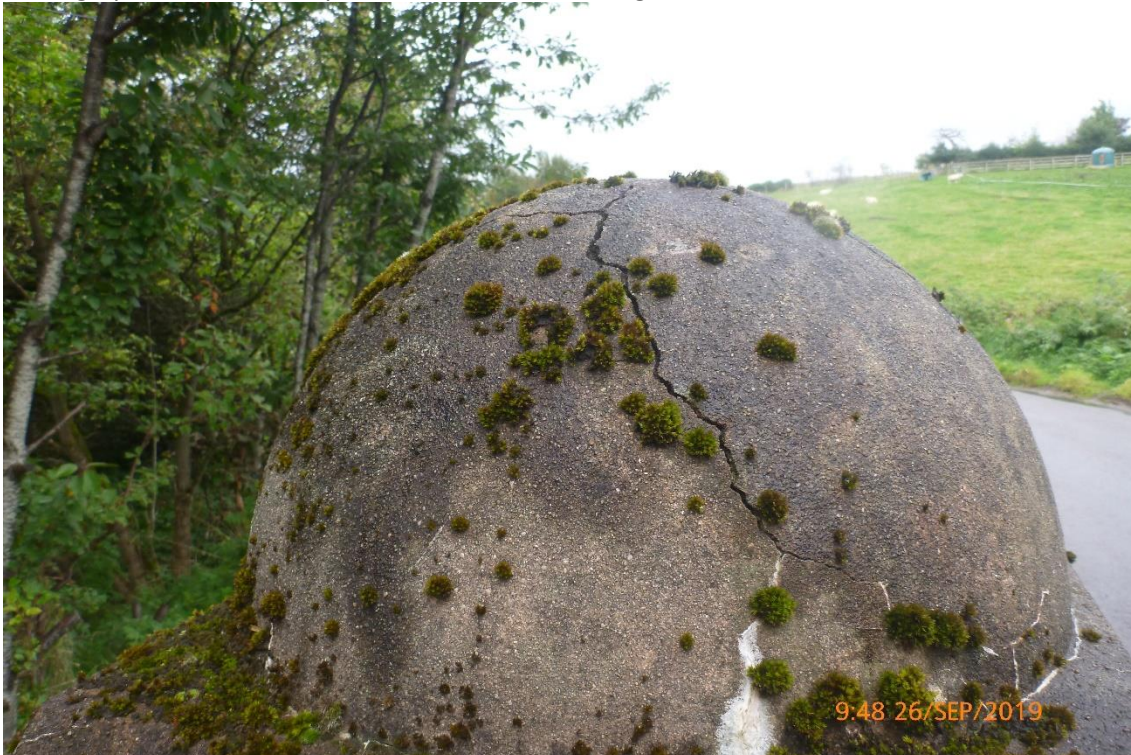
Photograph 34: Cracking of Wingwall parapet topping stone (North-East)

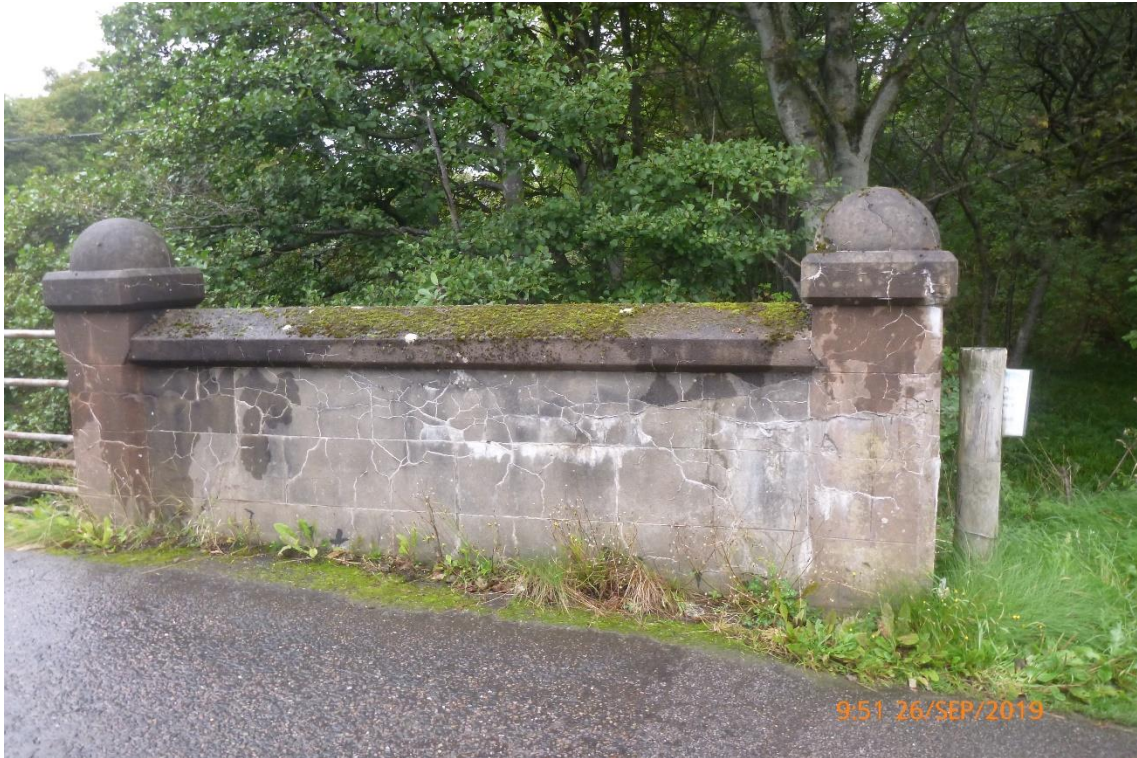
Photograph 35: Typical condition of parapet with cracking and crazing.
