Principal Inspection Report

Structure Name: Cloddach Bridge

Structure No: C2E/20

| Inspection date | 26/09/2019 |

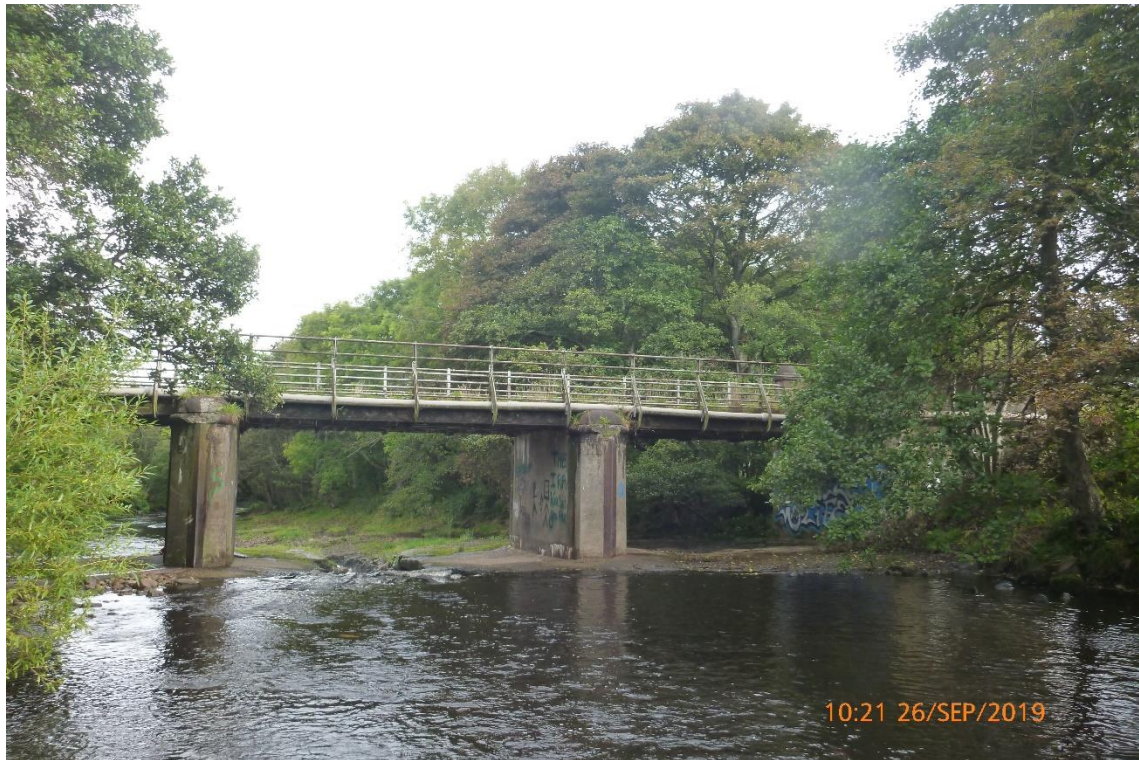
There is a pipe attached to the South side of the structure. The pipe is bolted to the approach walls and attached to the parapet upstands using two bracket connections. The connections are in good condition with no rusting (Photograph 3, 9, 22, 31 & 32).

Photograph 3: General view looking North

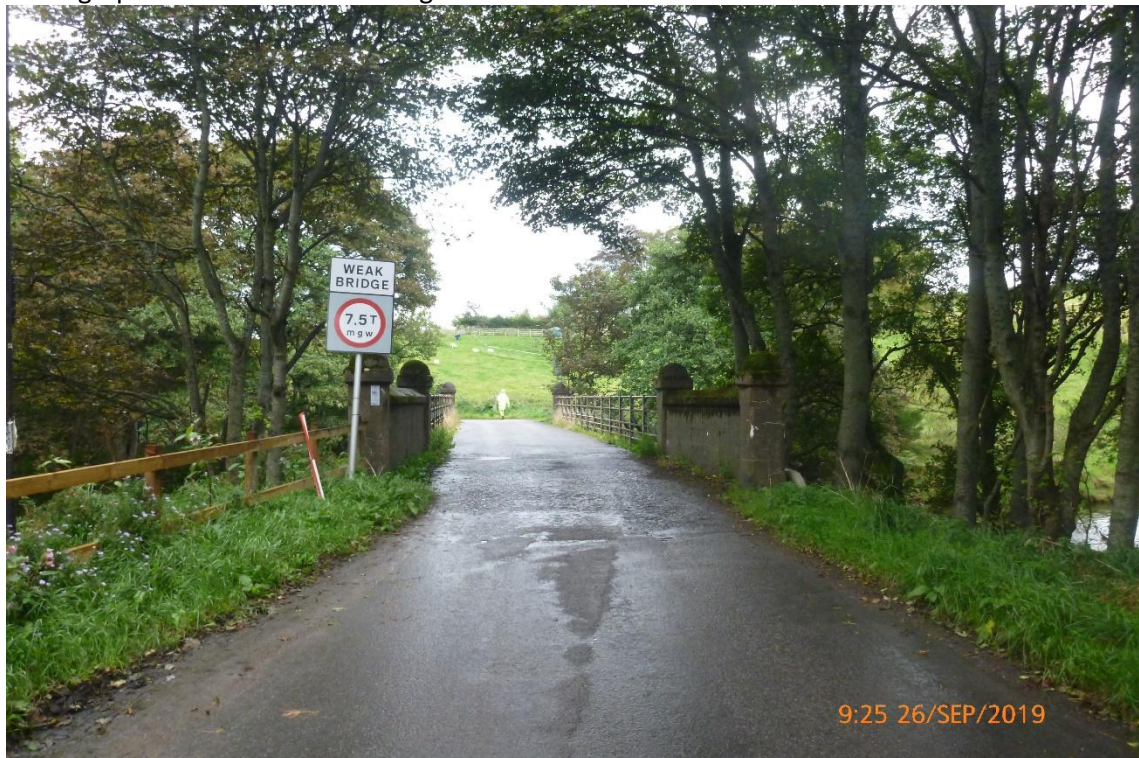
There are no vehicle restraint barriers on the approach to the structure. However there is a new timber port and rail fence on the North-West side that is not attached to the bridge structure (Photograph 4).

Photograph 4: General View Looking East

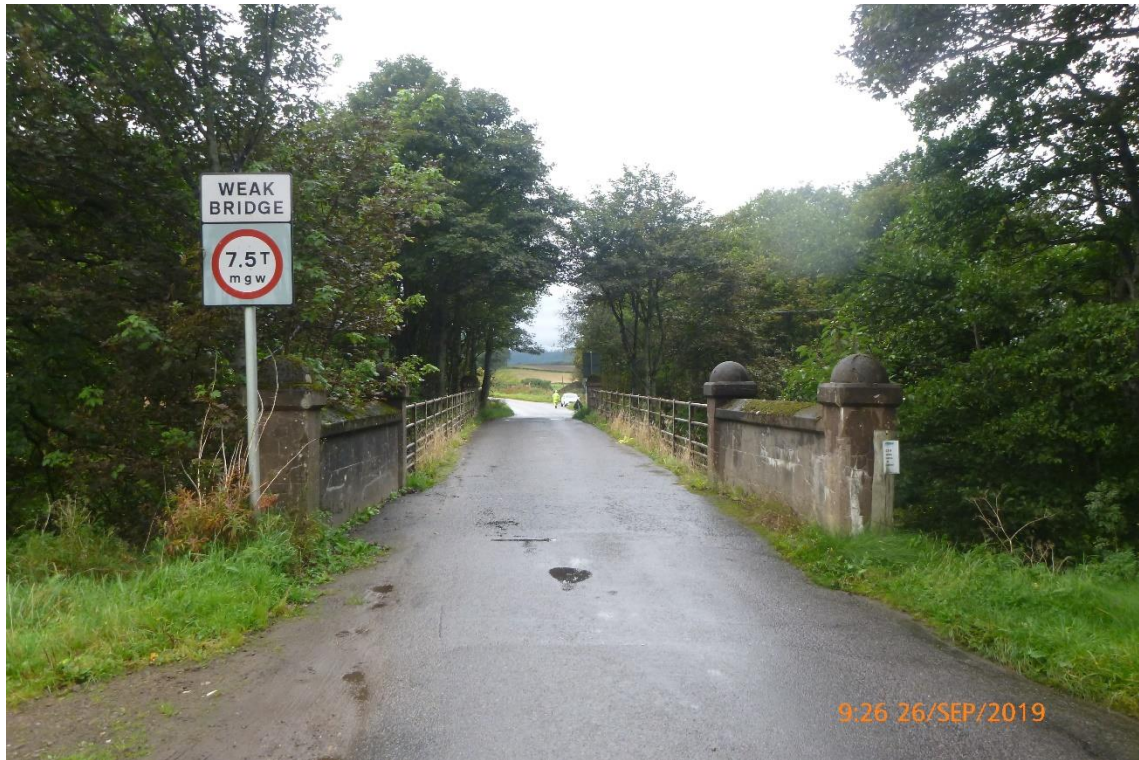
The existing concrete drainage channels that run along the edge of the bridge deck, between the carriageway and the parapets, are blocked and filled with debris and vegetation. Each span has a drainage outlet on either side of the deck at approximately midspan. Although water was seen dripping from these drainage holes on further investigation they were blocked up (Photograph 5,6,7,8 & 16)

Photograph 5: General View Looking West.

It is recommended that the drainage gullies next to the carriageway are cleared out and the vegetation removed to limit future water seepage through the deck and onto the main beams.

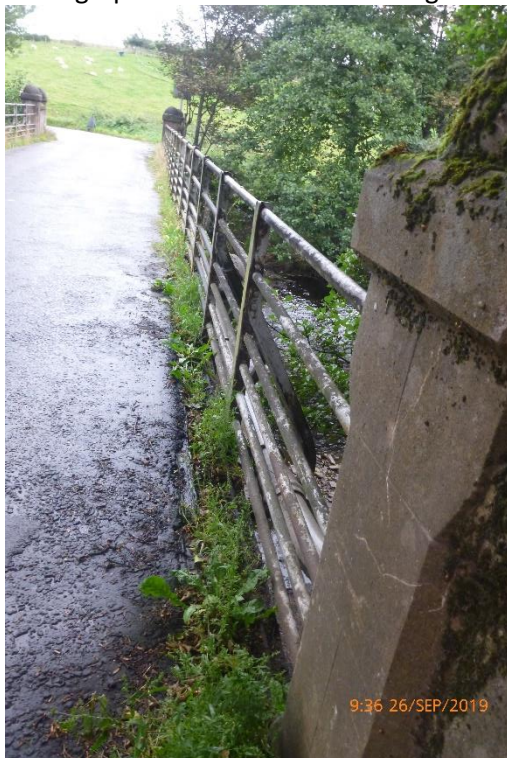
Photograph 6: Vegetation growing at edge of carriageway with no verge.

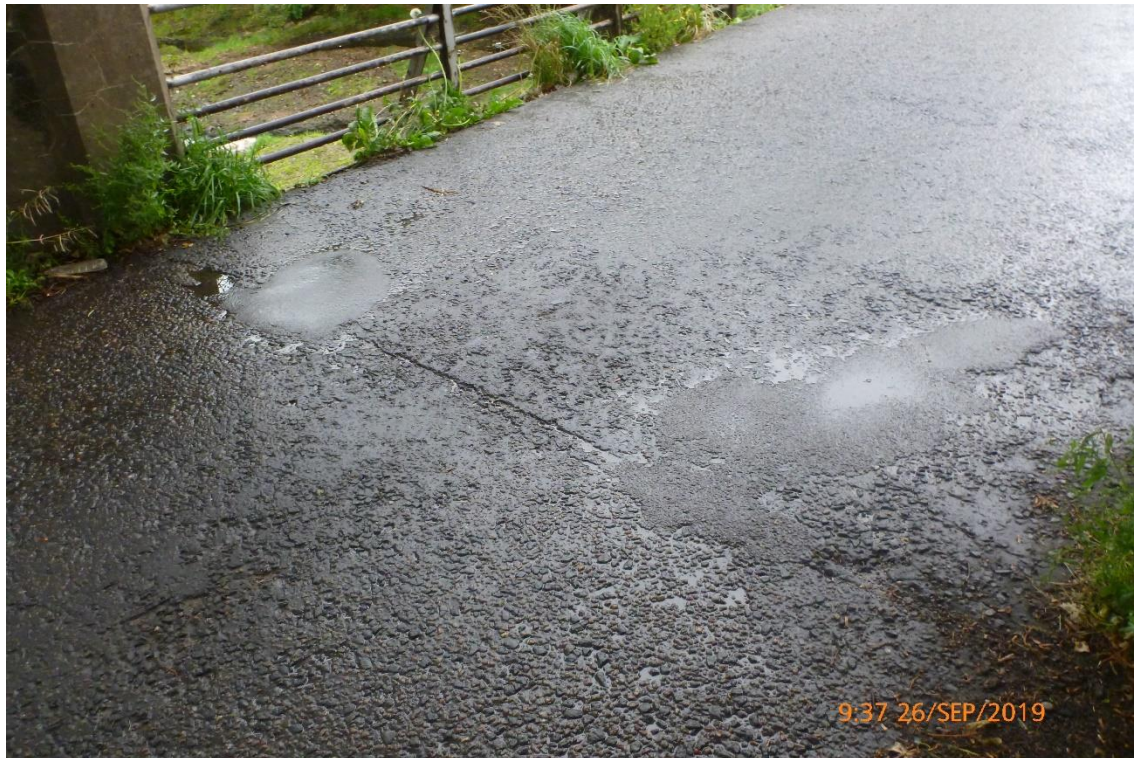
The carriageway surfacing was generally in good condition with a few patch repairs at the edge of the bridge structure. There are no verges on the structure (Photograph 7).

Photograph 7: Carriageway surfacing in good condition with minor patch repairs. No Joint visible.

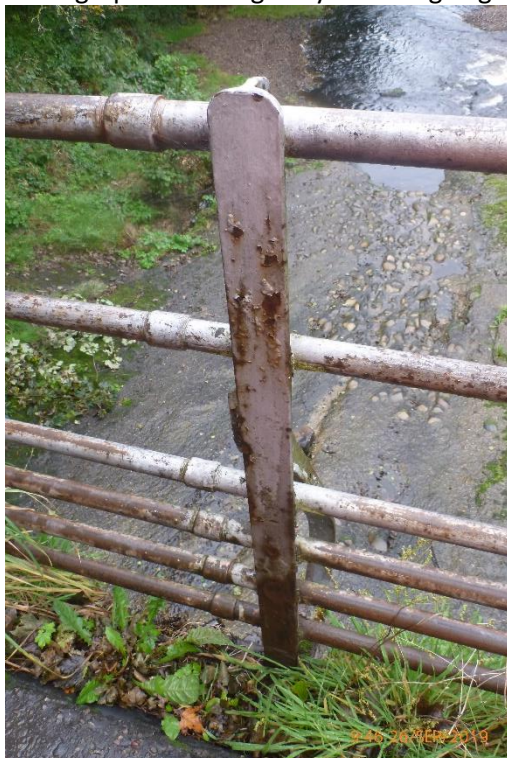
The parapets are formed from painted steel, post and rail, which are substandard for vehicle restraint. Generally the parapets are in fair condition with spots of paint flaking and rusting apparent on the parapet stands. There are no expansion joints along the parapets (Photograph 8, 9, 11 & 32).

Photograph 8: Typical section of parapet corrosion.

It is recommended that the parapets are grit blasted and repainted to protect against corrosion.

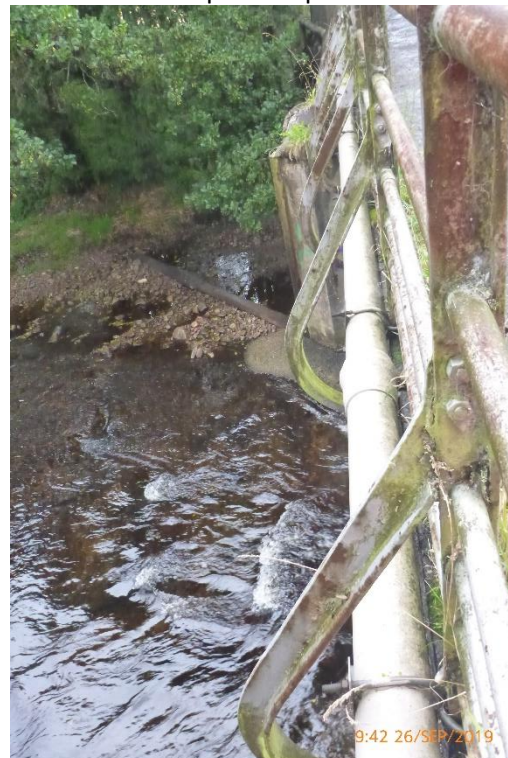
There are four parapet bracing members per span that connect to beams 1 & 2, and 6 & 7 on the north and south side of the structure. The top section of the bracing members are in fair condition with minor rusting and paint flaking in places. The corrosion and rusting is concentrated at the bracing to parapet connection. The bottom sections of the bracing are heavily rusted and corroded, and the paint either ends or has worn away just before the start of these sections. There are multiple layers of patina present on the underside section of the bracing members with calcite stalactites on some members (Photograph 9, 10, 11, 14, 16, 22 & 32)

Photograph 9: View of pipeline passing through parapet bracing members on the South side.

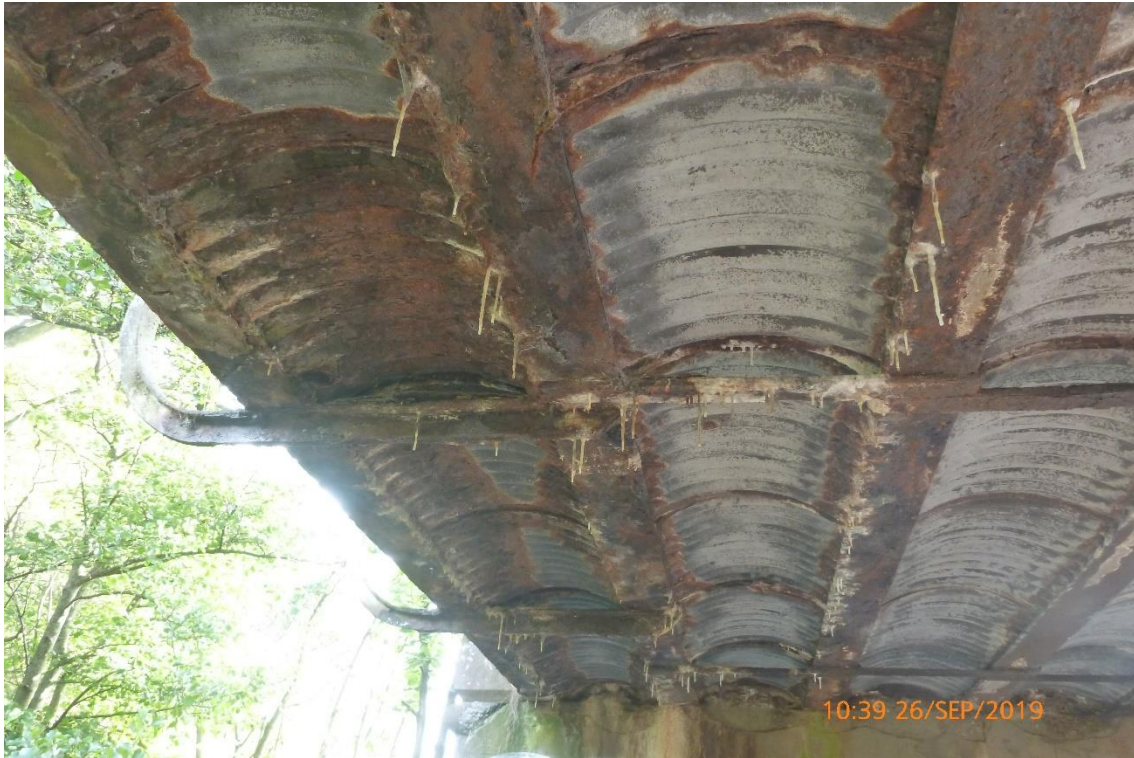
Generally the main steel beams have significant corrosion and rusting especially on the four outmost beams (two on the North side and two on the South side) of the structure over all three spans. There is no sign of paint protection on these outside beams and there are several layers of rust build up. Therefore, the section depth of the bottom flange on the outer beams is unknown. Generally, although there was some flaking to the rusting, it was not easily removed (Photograph 10 – 16).

There are three transverse bracings or ties under each span that connect beams 2 to 6. The transverse members do not continue to the outer beams. In general, all of the bracing members are corroded and rusting however are in a better condition than the main steel beams (Photograph 10, 11 & 15).

The corrugated steel jack arches are rusting and corroding in places especially at the steel beam connection, at the pier and abutments end and at the outmost beams. The steel is flaking in places and the depth of steel is unknown (Photograph 10, 11, 14 & 16).

Photograph 10: Typical view of corrosion / rusting and calcite stalactites on bridge invert.

It is recommended that the beams are grit blasted and cleaned of rusting and corrosion to allow a detailed thickness test to be completed on all structural members. A revised assessment should be completed to determine the current capacity of the structure and the beams painted to protect against future corrosion.

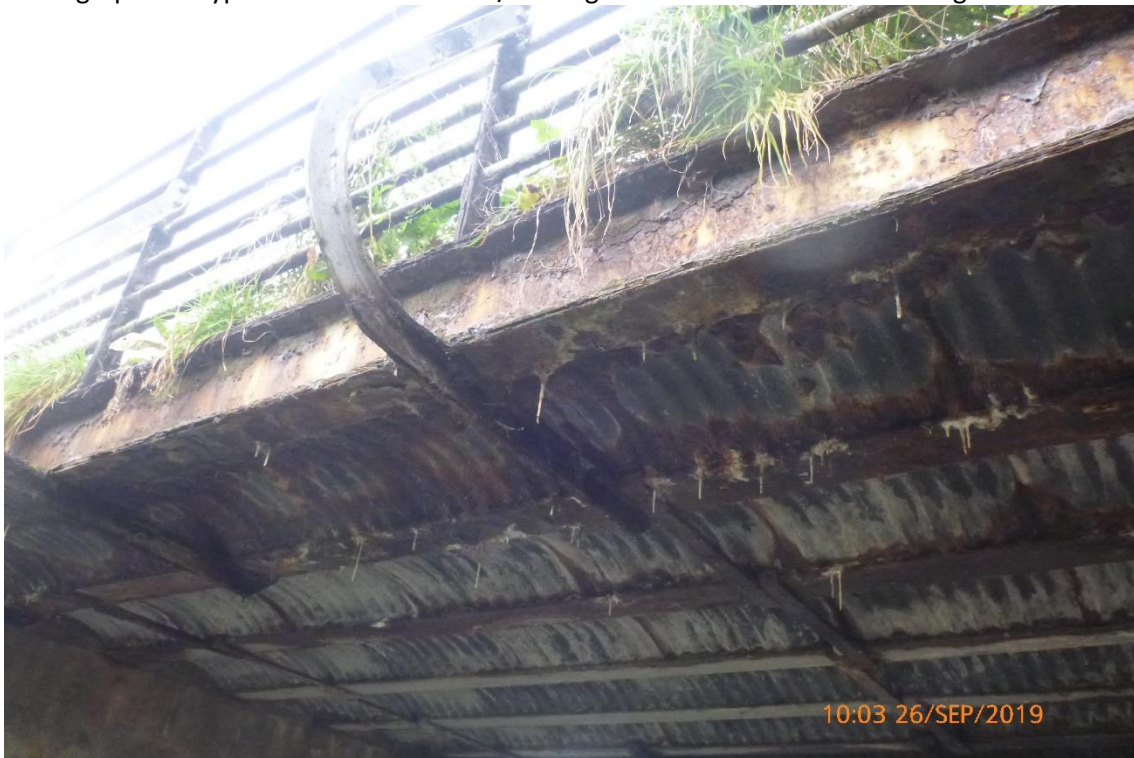
Photograph 11: Typical view of corrosion to outside beams and corrosion to bottom of bracing members.

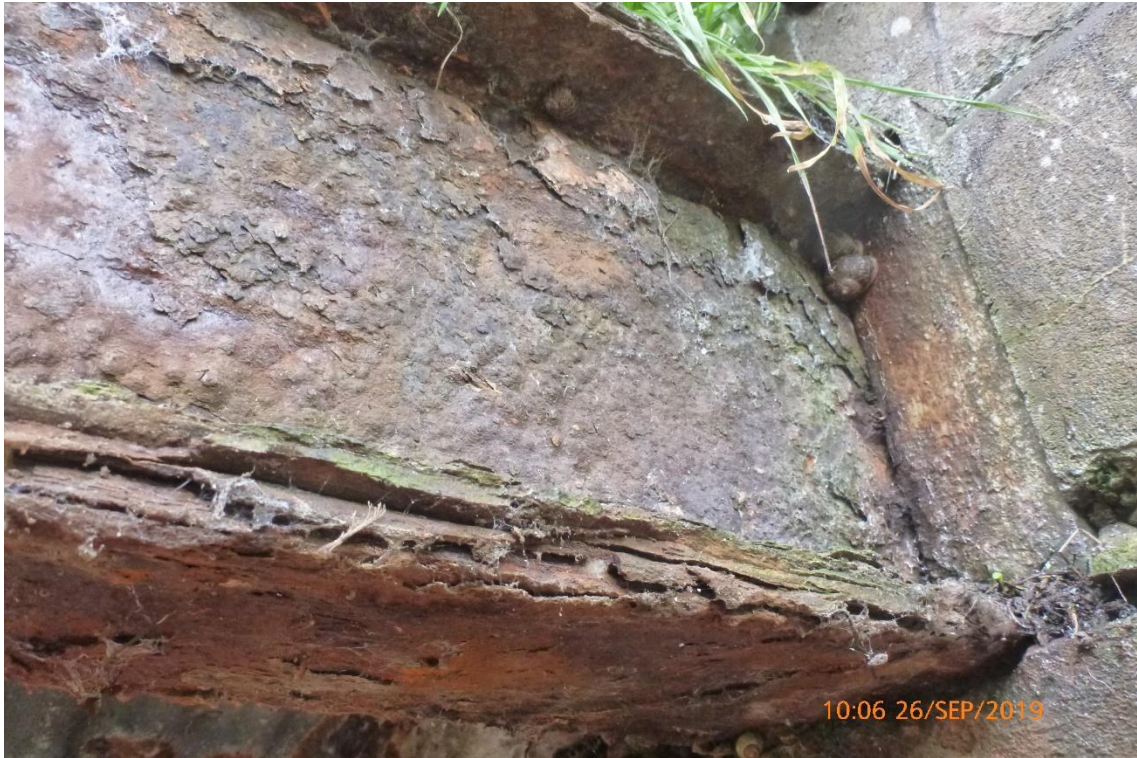
Photograph 12: Typical view of exposed beams faces with significant patina build up.

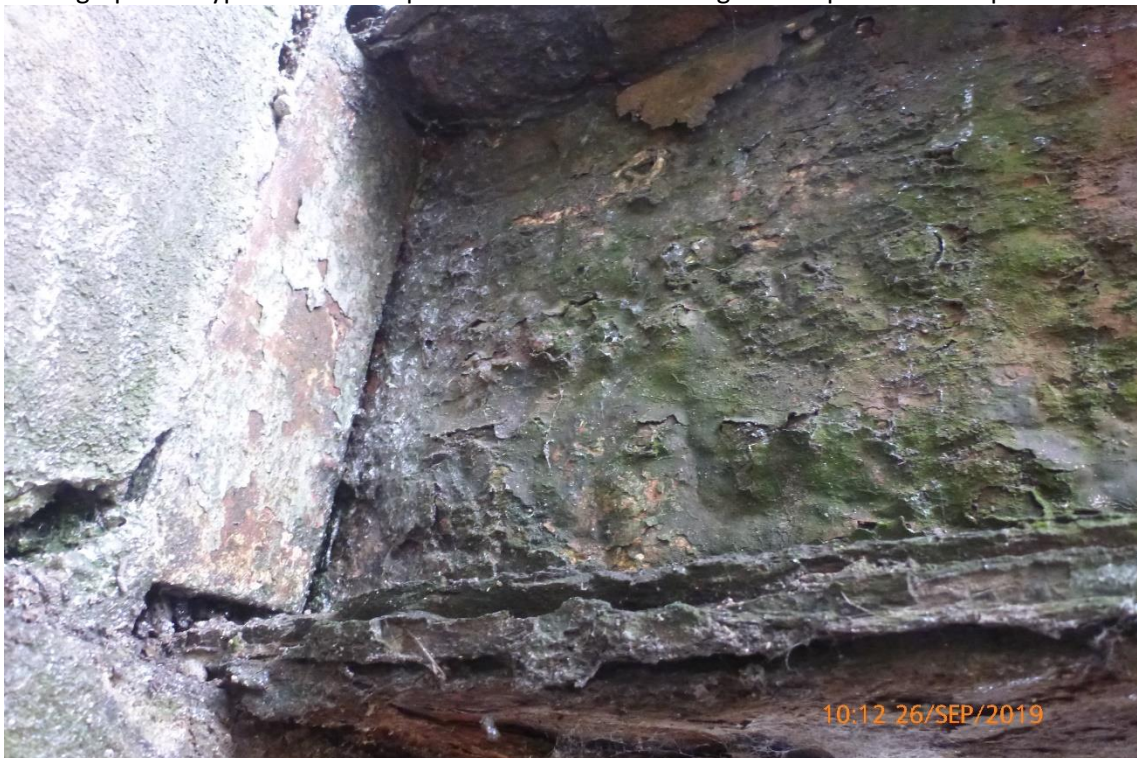
Photograph 13: Typical view of exposed beams faces with significant patina build up.

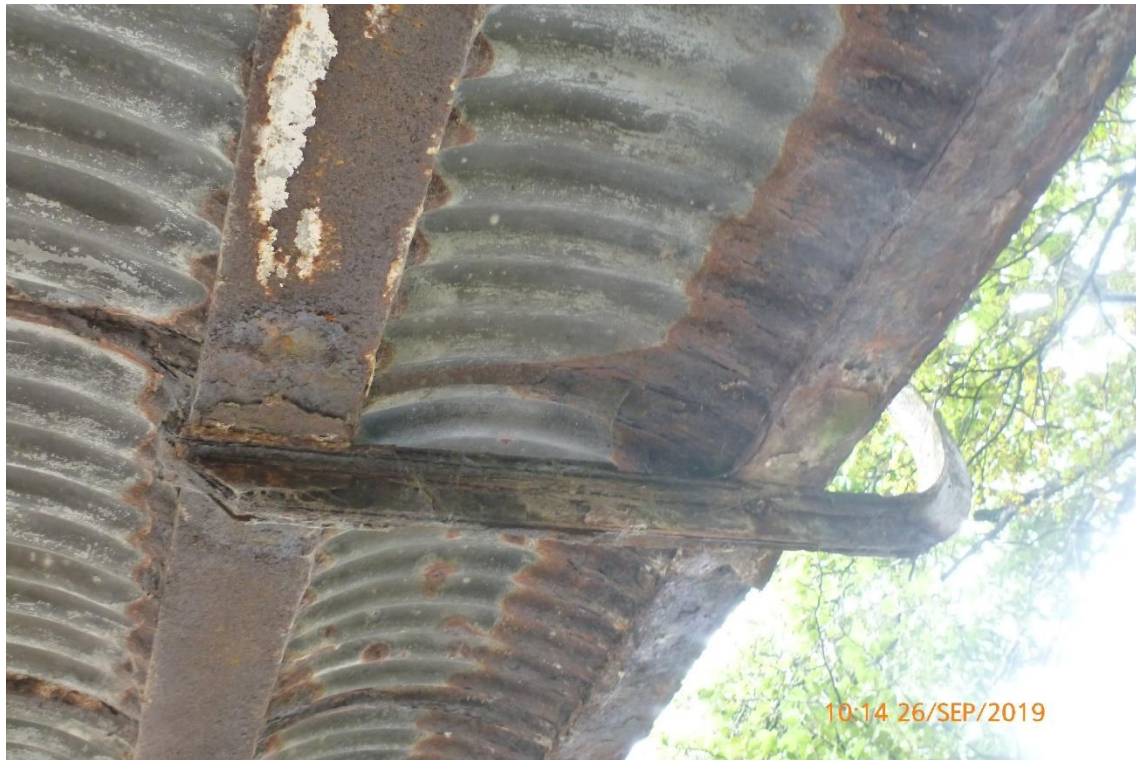
Photograph 14: Typical view of corrosion and patina layers at parapet cross bracing.

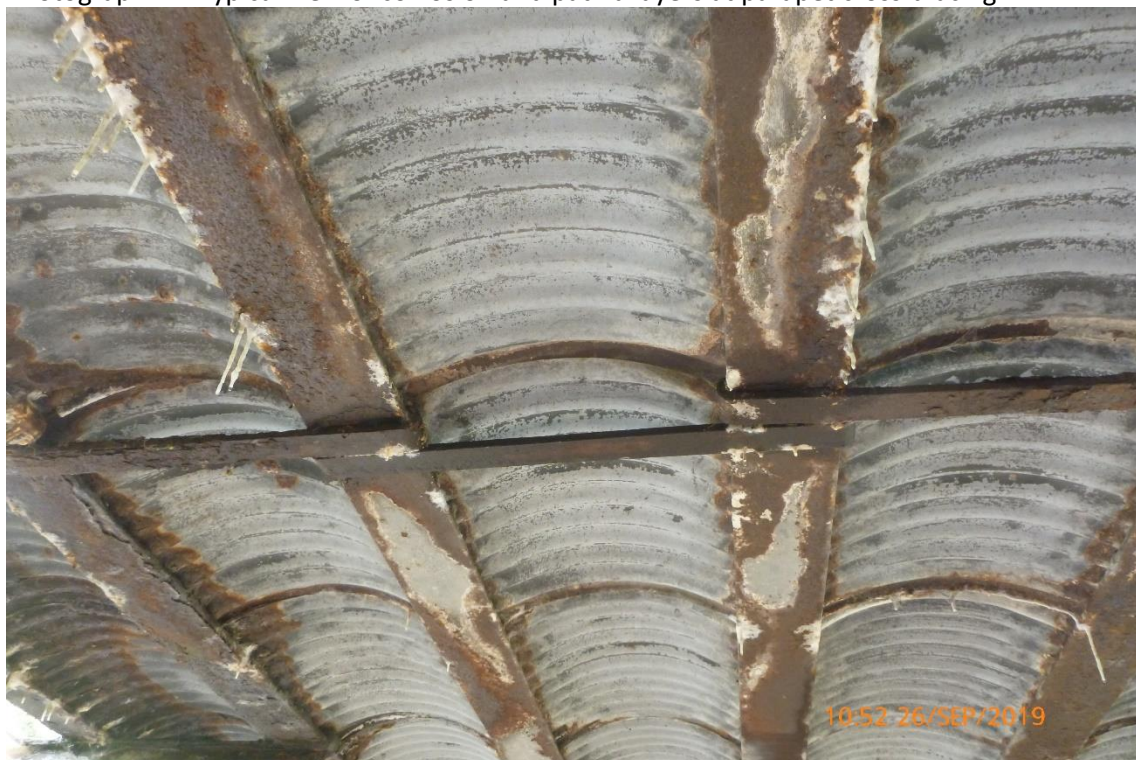
Photograph 15: Typical view of transverse bracing members.

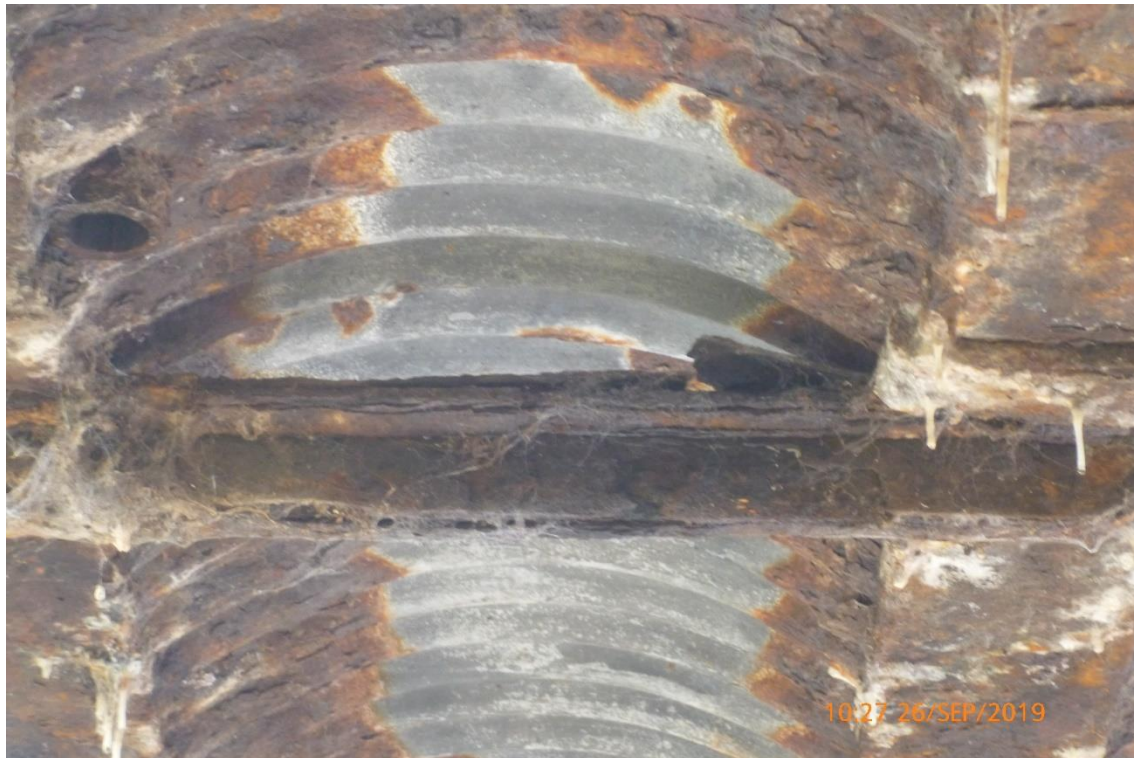
Photograph 16: Significant corrosion to parapet bracing member.

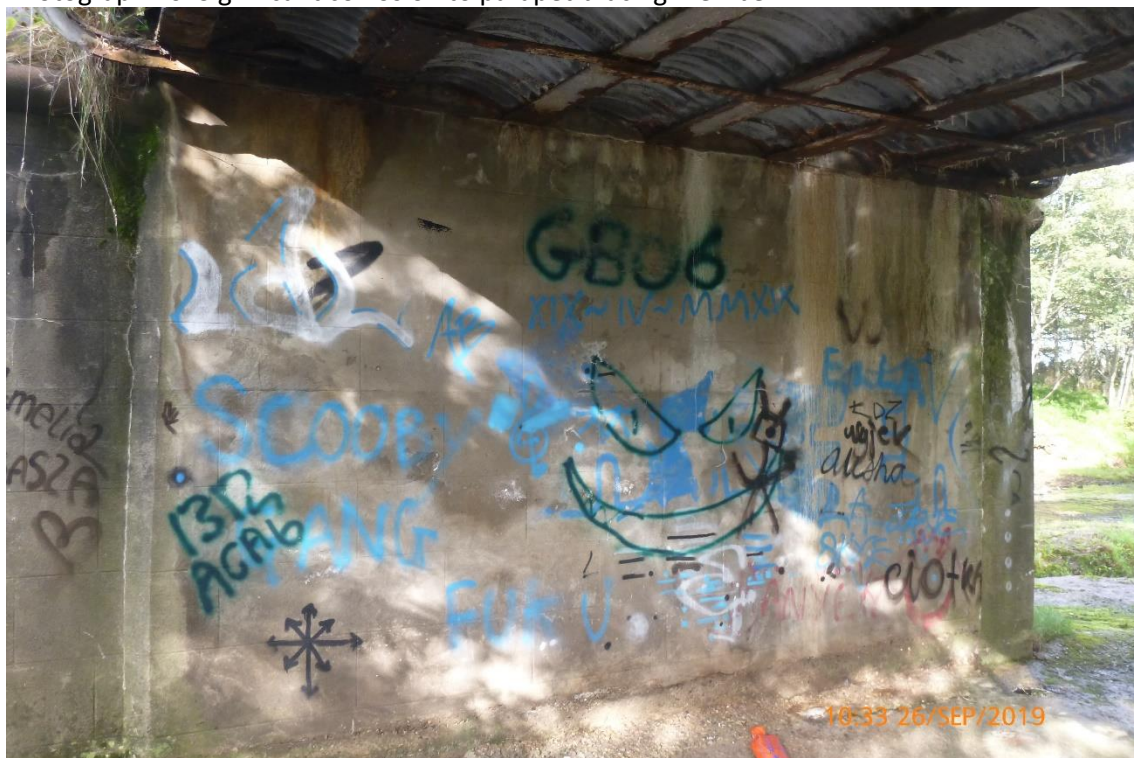
The abutment has non-offensive graffiti along the full abutment face. There is a vertical crack of approximately 0.8mm width running the full height of the abutment starting at the base of the fifth beam. There is a broken crack gauge located over the crack. It is unknown when this crack gauge was placed or what the crack width was at that time of placement (Photograph 17, 18 & 19).

There is calcite staining and rust staining on the Abutment emanating from the bottom of the steel beams with damp staining apparent at the edge beams at the time of the inspection. Although the drainage holes appear clear at the Abutment there is no sign of water egress from these locations (Photograph 17 & 19).

Photograph 17: Example of graffiti present on all abutment and pier faces.

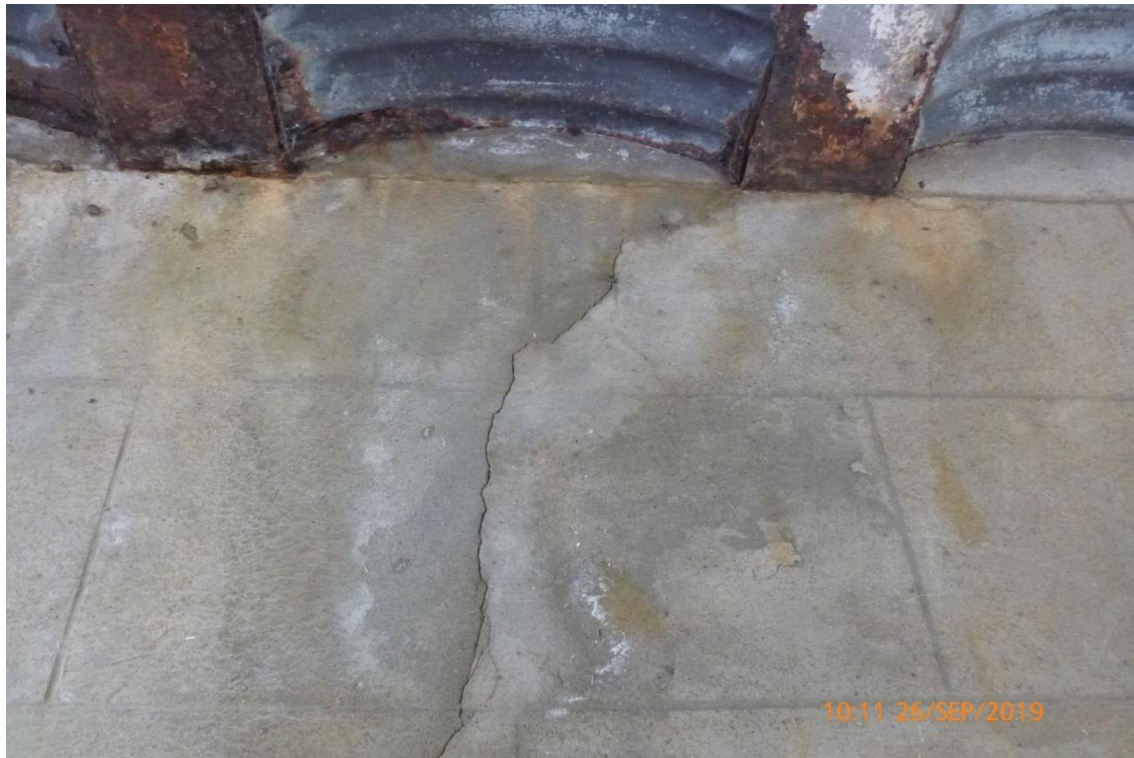
Although cracking was noted on the abutments and piers (0.8mm crack on the West abutment) there was very little delamination and in general they are in fair condition. The crack in the West abutment was recorded in the 1995 PI and it is evident that a crack gauge was placed over the crack in the past. However, the crack gauge had since broken off and there are no crack width's previously recorded therefore it is unknown if the crack has spread or increased in width. If this crack is getting bigger it could be an indication that settlement of the abutment is occurring.

Photograph 18: Vertical Crack on West Abutment starting from beam (0.8mm).

It is recommended that the crack on the East abutment is monitored and the crack width recorded to determine if settlement of the abutment is occurring.

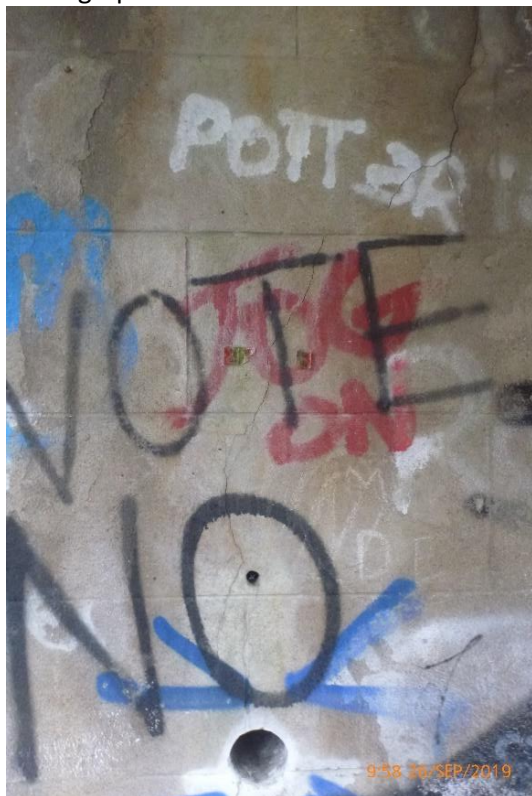
Photograph 19: Vertical crack on West Abutment, with broken crack gauge (0.8mm)

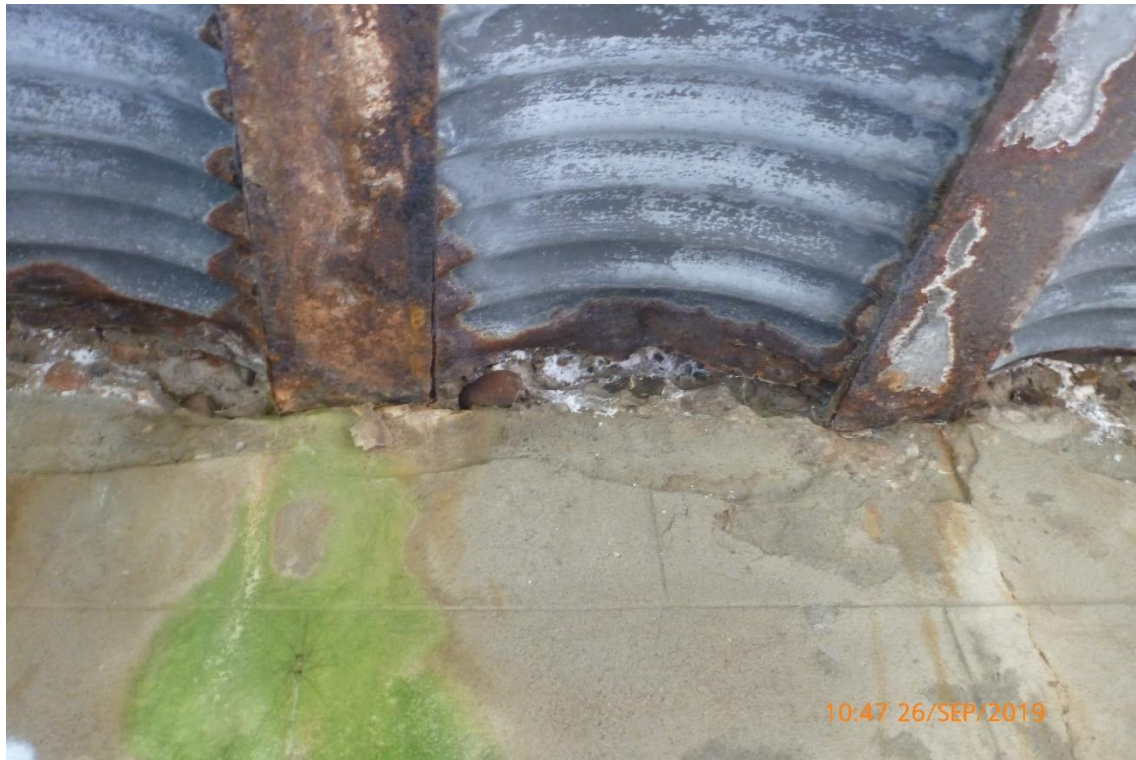
The abutment has non-offensive graffiti along the full abutment face. There is algae staining and significant calcite staining coming from the soffit of the steel beams. Along the top of the Abutment there is spalling/breakout of the concrete between and under the steel beams with large aggregate visible (Photograph 20 & 21).

Photograph 20: Spalling of concrete between and under beams. Algae aggregate sizes visible

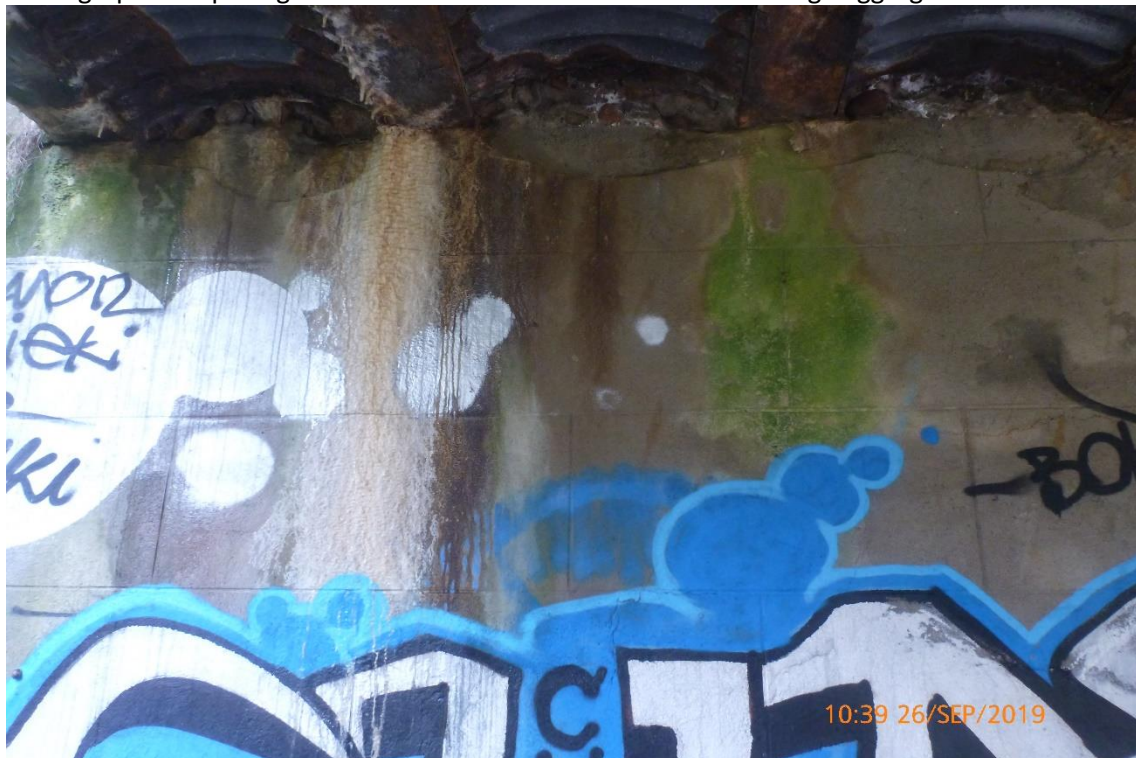
Photograph 21: Typical example of significant calcite build up on Abutment and algae staining.

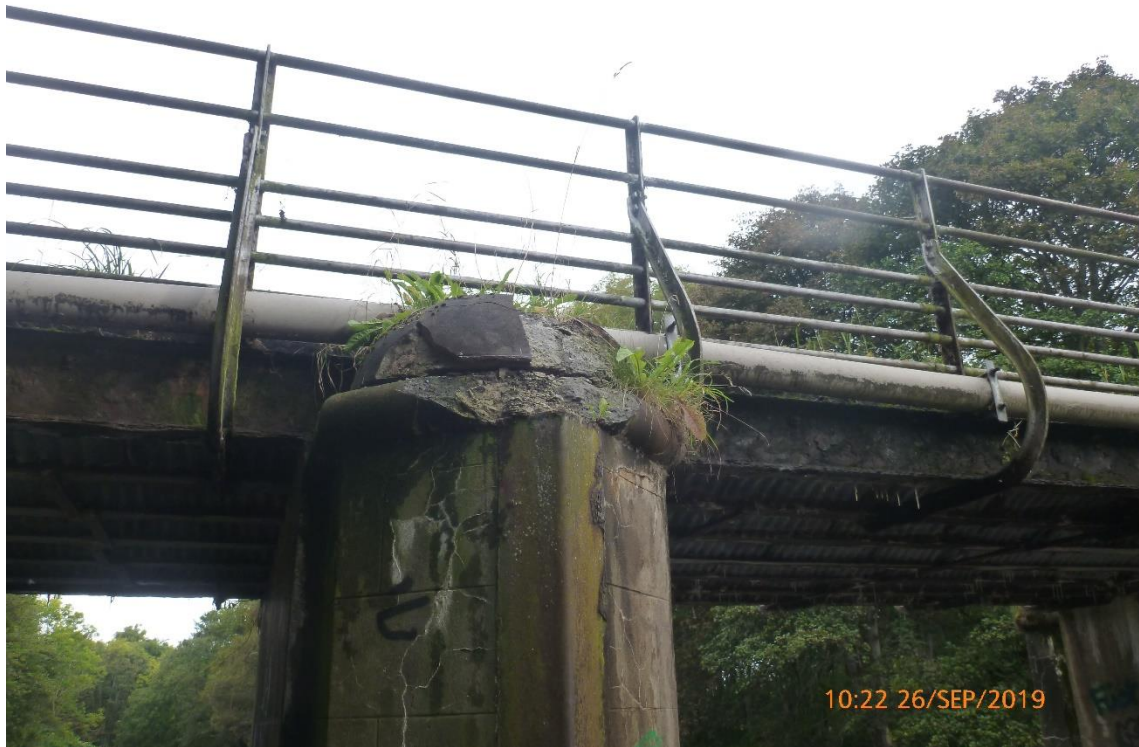
The piers have graffiti along all faces. The semi-circular topping stones at the cutwaters have concrete breakout on the upstream and downstream side of both piers with sections of vegetation growing (Photograph 22)

Photograph 22: Typical example of concrete break out at cutwater.

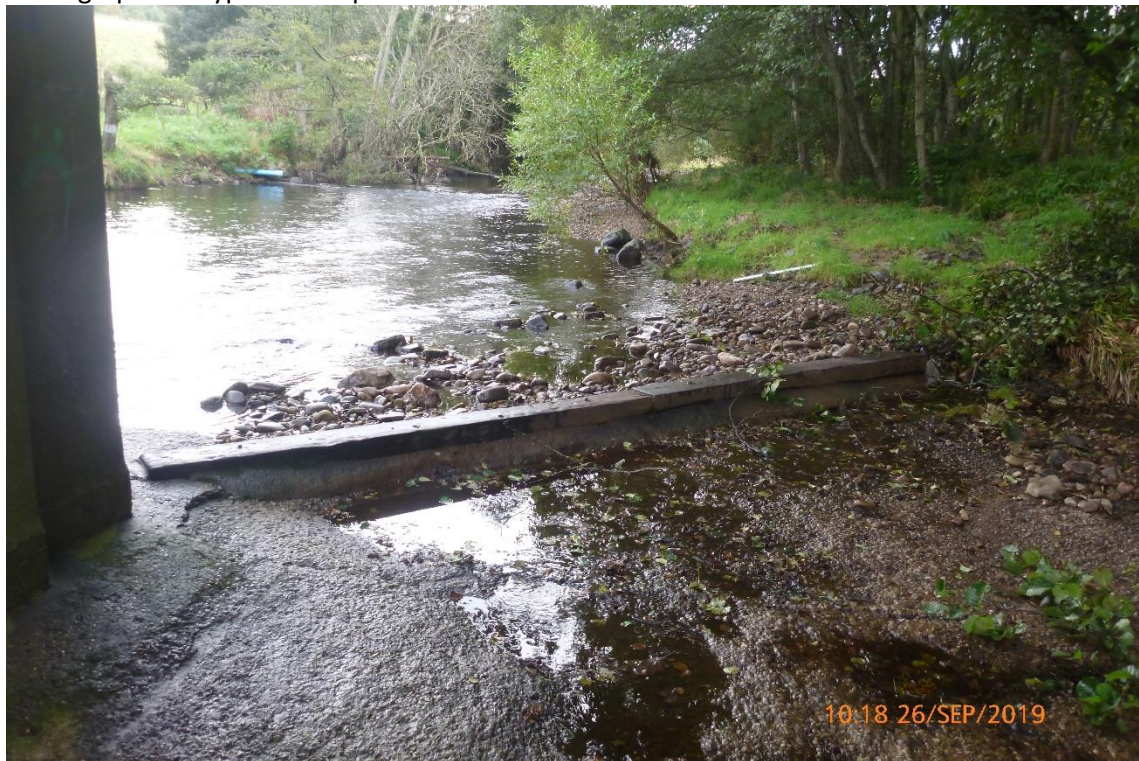
The invert comprises of insitu mass concrete under the bridge. It appears the river layout has been manually altered using a small concrete weir to ensure, at low flows, the water only passes under the centre span (Photograph 23).

Photograph 23: River training works at upstream of Span 1.

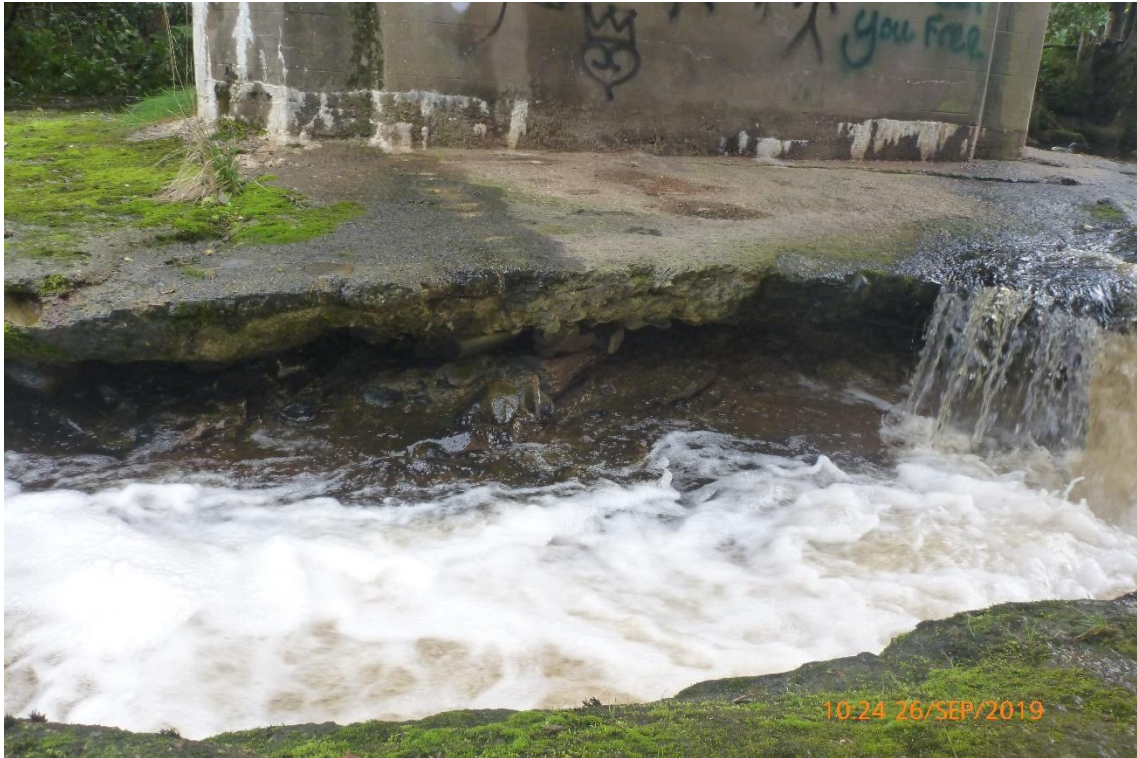
Under the centre span, a deep cut in the concrete invert and rock bed has been created manually or naturally. The water is very fast flowing and turbulent therefore, access could not be gained to the invert at this location. At pier 2, at the midspan side, the pier sits approximately 2m away from the cut however, the river has scoured under the bridge invert by approximately 1-1.5m. This scour was not identified during the previous PI however was reported as a defect in November 2018. It is unknown how fast the scour is progressing (Photograph 24, 25 & 26).

At the middle span of the structure it is apparent that the river is scouring beneath the bridge invert especially towards the East side. Currently the piers are not showing any signs of settlement or distress, however the rock bed appears relatively soft with a bed of sand and pebbles. It is unknown how quickly the rate of scour is occurring.

Photograph 24: Scour of bridge invert at centre span. Visible scour extending beneath invert on East side.

It is recommended that the scour to the bridge invert at the centre span is monitored and the rate of scour determined. If the scour extends closer to the pier it is recommended that works are undertaken to protect the piers from scour.

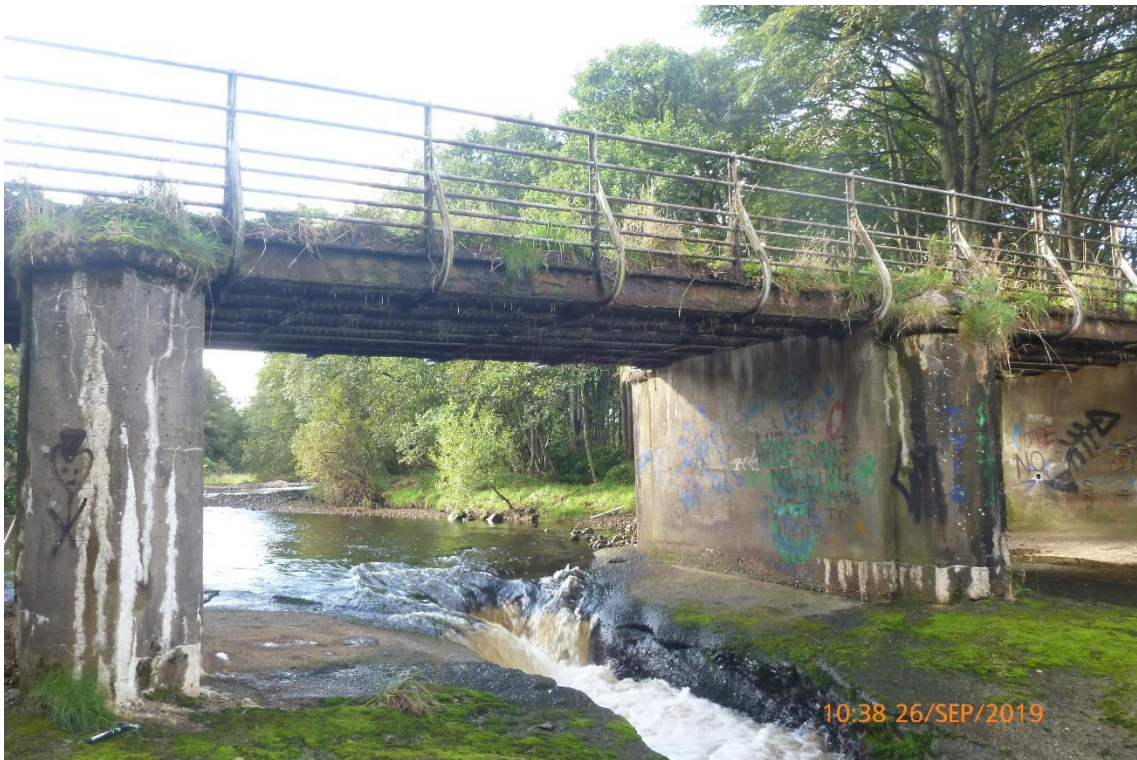
Photograph 25: General view looking South at centre span with invert scour.

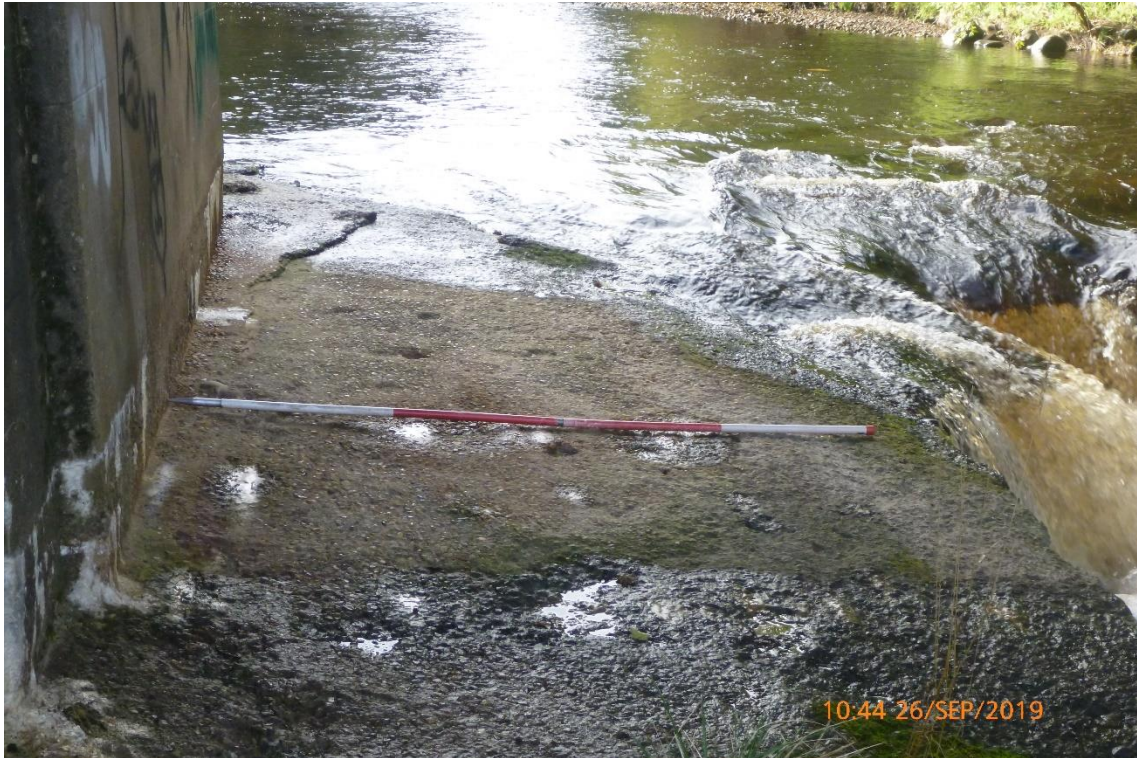
Photograph 26: distance from pier face to scour edge.

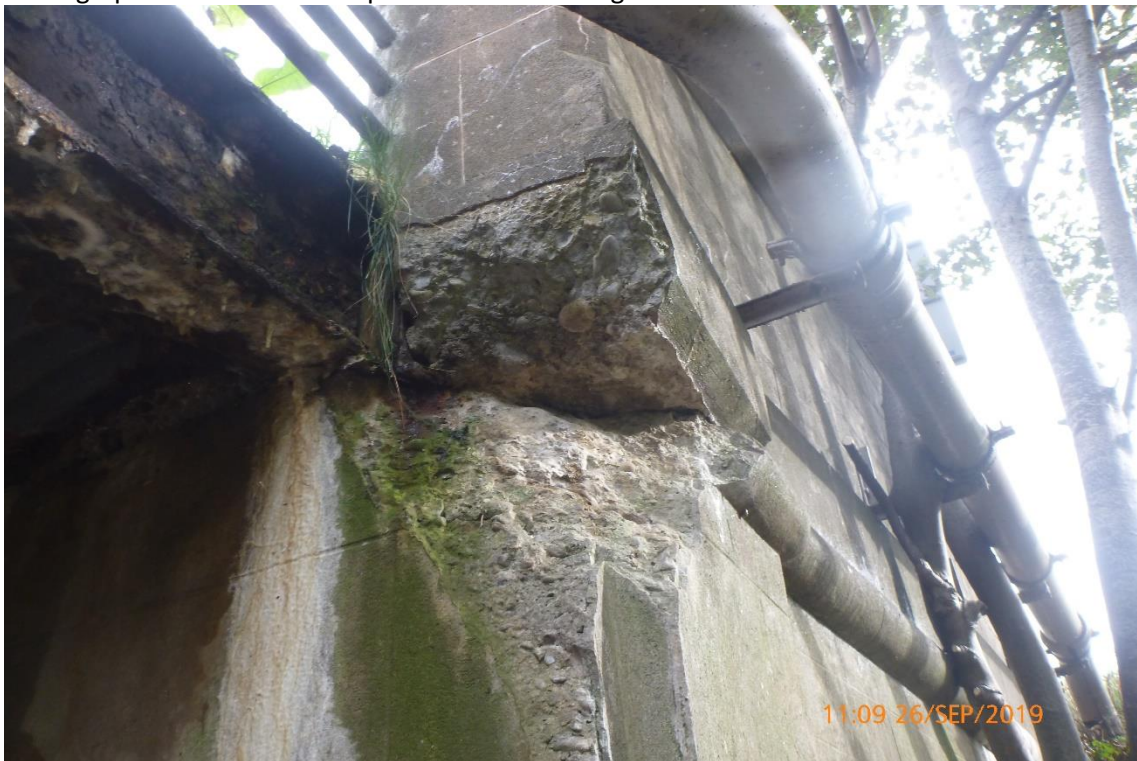
A large corner of the abutment at the upstream end has broken away and is lying beside the structure leaving part of the masonry safety wall partially unsupported. This is at the location where the steel parapet is fixed to the masonry approach wall. The broken off section is sufficiently large that it was unable to be moved (photograph 27 & 28).

The wingwalls are in fair condition with some graffiti present. There is mild delamination of sections of the concrete at the base of the wingwalls at the water's edge, likely due to scour. The wingwalls all have concrete breakout at the corners (Photograph 27 & 29).

The West embankments shows no sign of distress. However, at the East embankment there is some mild erosion at the bottom of the abutment and wingwall (Photograph 27). Areas of Japanese knotweed and giant hogweed were noted on the West and East banks of the river, close to the structure.

At all of the abutments corners, concrete has spalled and or broken away. At the West abutment at the upstream side a large corner of concrete has broken off leaving the masonry parapet wall partially unsupported at the section where it connects to the steel parapet. This poses a safety risk and there is an increased risk of the wall / parapet failing if struck by a vehicle.

Photograph 27: Concrete breakout at East abutment / wingwall.

It is recommended that the broken corner of the East abutment is repaired to provide support to the masonry approach wall and the embankment at the East abutment is monitored to limit scour and / slipping of the embankment.
