Principal Inspection Report

Structure Name: Cloddach Bridge

Structure No: C2E/20

| Inspection date | 26/09/2019 |

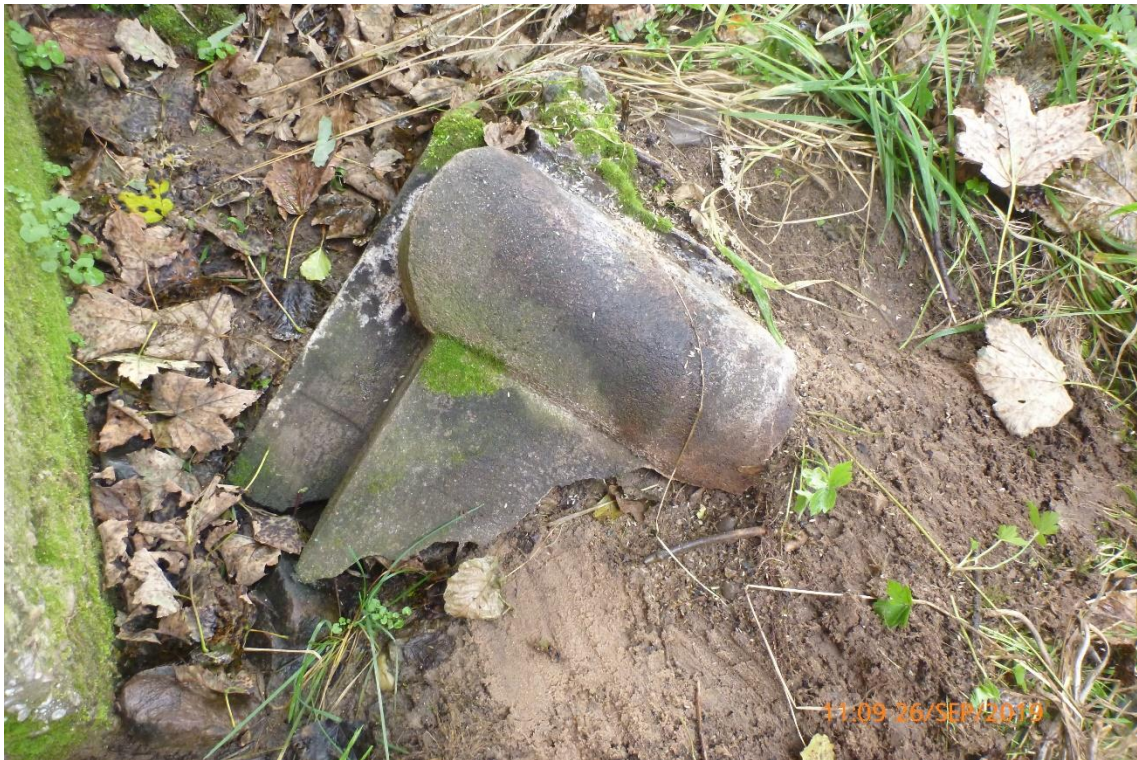
A large corner of the abutment at the upstream end has broken away and is lying beside the structure leaving part of the masonry safety wall partially unsupported. This is at the location where the steel parapet is fixed to the masonry approach wall. The broken off section is sufficiently large that it was unable to be moved (photograph 27 & 28).

At all of the abutments corners, concrete has spalled and or broken away. At the West abutment at the upstream side a large corner of concrete has broken off leaving the masonry parapet wall partially unsupported at the section where it connects to the steel parapet. This poses a safety risk and there is an increased risk of the wall / parapet failing if struck by a vehicle.

Photograph 28: Concrete breakout at East abutment / wingwall

It is recommended that the broken corner of the East abutment is repaired to provide support to the masonry approach wall and the embankment at the East abutment is monitored to limit scour and / slipping of the embankment.

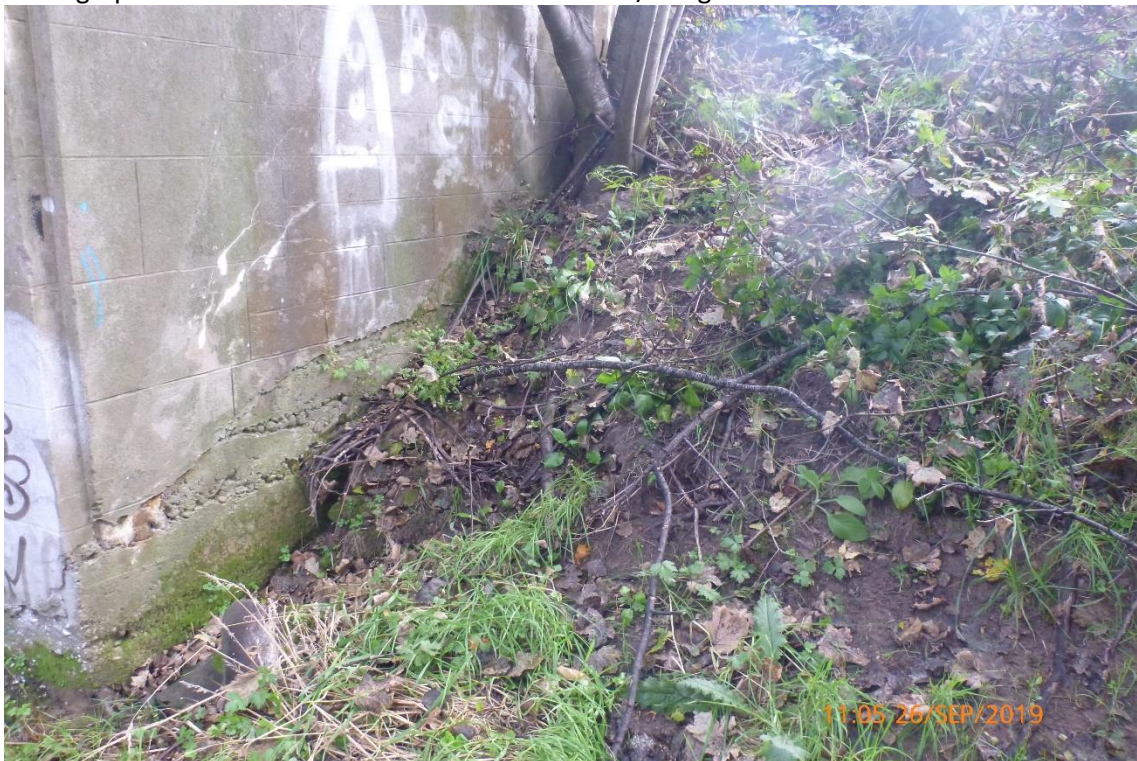
The wingwalls are in fair condition with some graffiti present. There is mild delamination of sections of the concrete at the base of the wingwalls at the water's edge, likely due to scour. The wingwalls all have concrete breakout at the corners (Photograph 27 & 29).

The embankment at the East abutment is showing signs of erosion leaving parts of the wingwall corner exposed.

Photograph 29: Minor scour to embankment and wingwall (South-East).

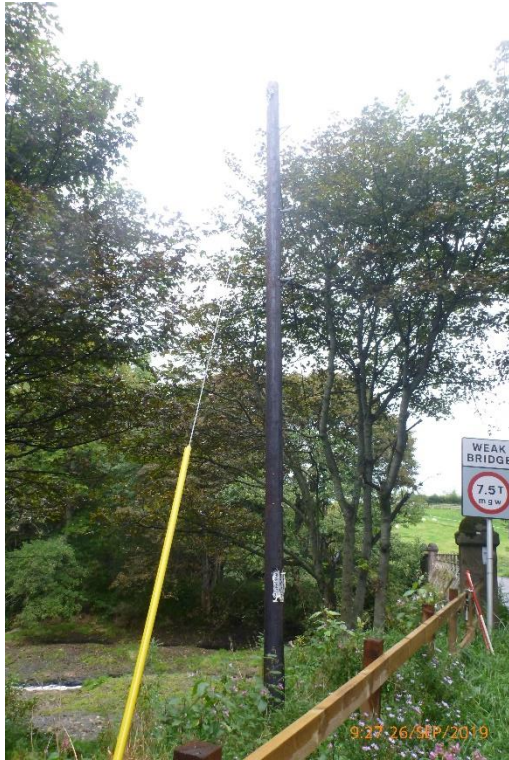
To the North of the structure there is an overhead telecoms cable over the river. This continues underground at the bridge embankments. The cable is well above head height and is not attached to the structure (Photograph 30).

Photograph 30: Overhead telecoms cable to North of bridge.

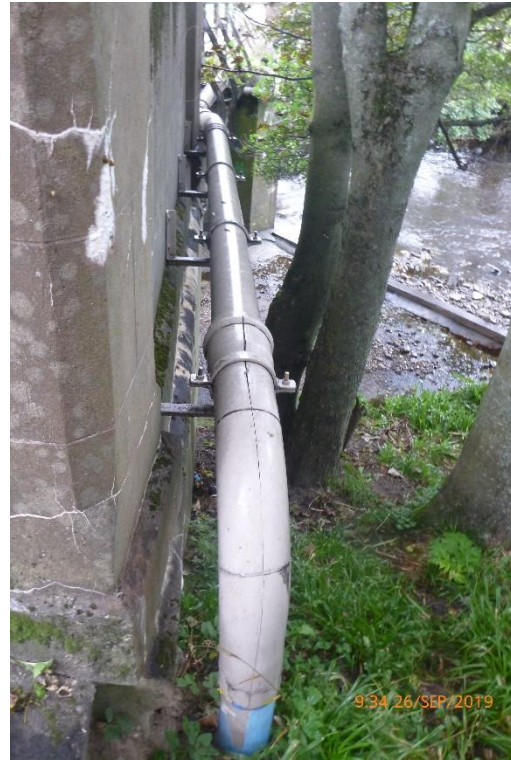
There is a pipe attached to the South side of the structure. The pipe is bolted to the approach walls and attached to the parapet upstands using two bracket connections. The connections are in good condition with no rusting (Photograph 3, 9, 22, 31 & 32).

Photograph 31: Pipeline attached to South of structure.

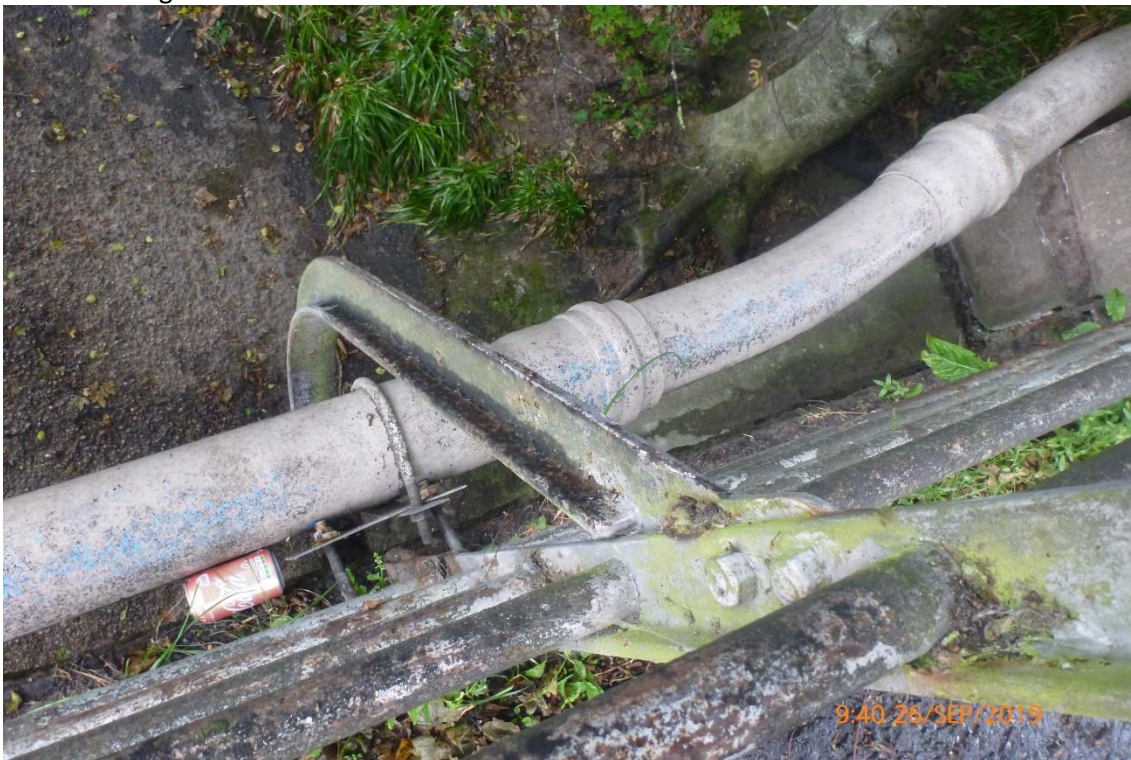
The parapets are formed from painted steel, post and rail, which are substandard for vehicle restraint. Generally the parapets are in fair condition with spots of paint flaking and rusting apparent on the parapet stands. There are no expansion joints along the parapets (Photograph 8, 9, 11 & 32).

Photograph 32: Pipeline connection to bridge parapets.

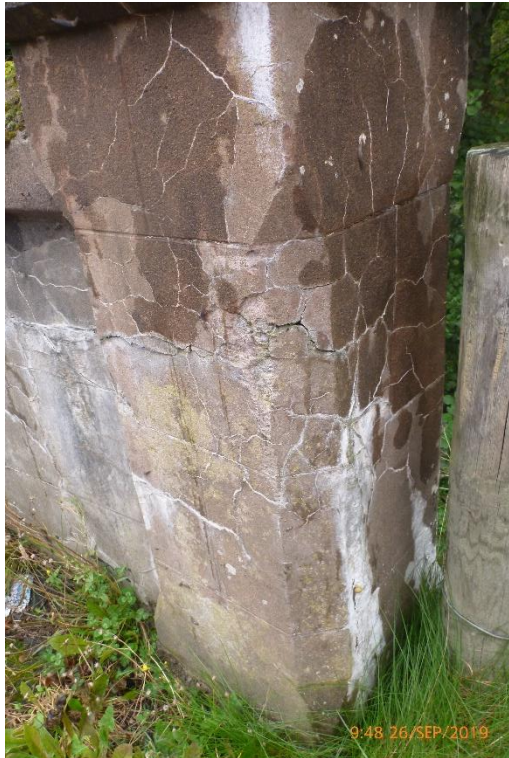
All of the approach walls have experienced cracking with areas of delamination. The North-East approach wall has evidence of a vehicle strike with crushed and cracked concrete at the corner and a large crack on the semi-circular topping stone (Photograph 33, 34 & 35)

Photograph 33: Parapet impact and concrete crushing, North-East.

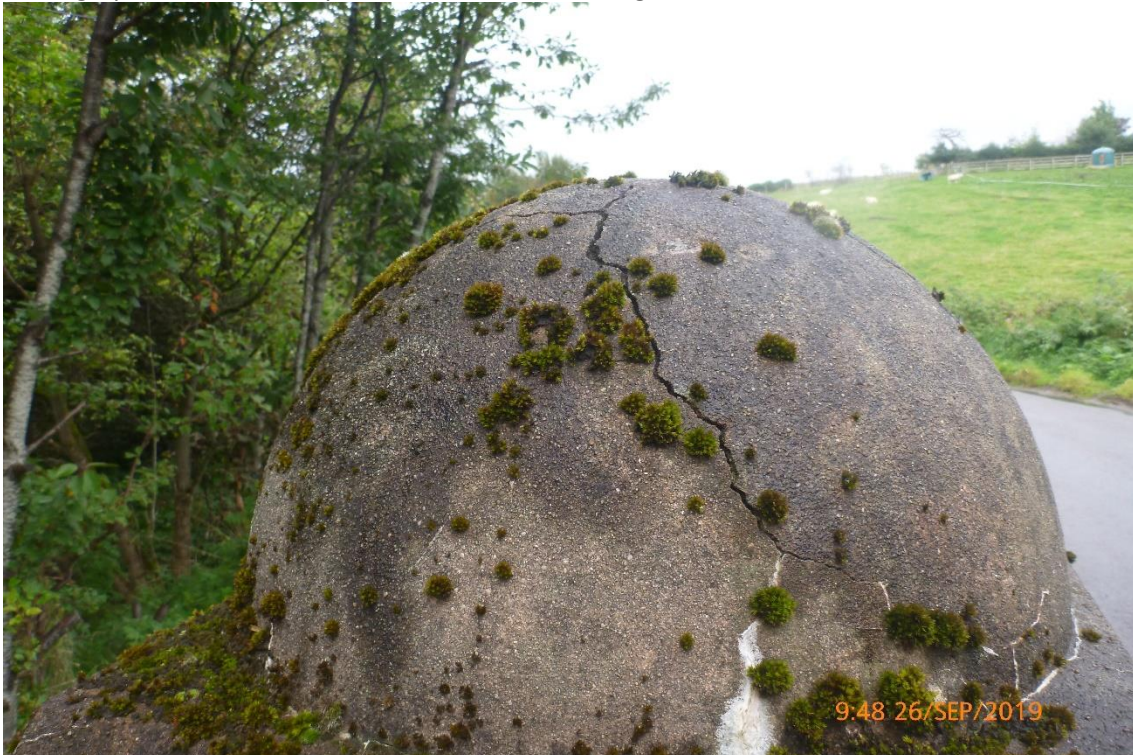
Photograph 34: Cracking of Wingwall parapet topping stone (North-East)

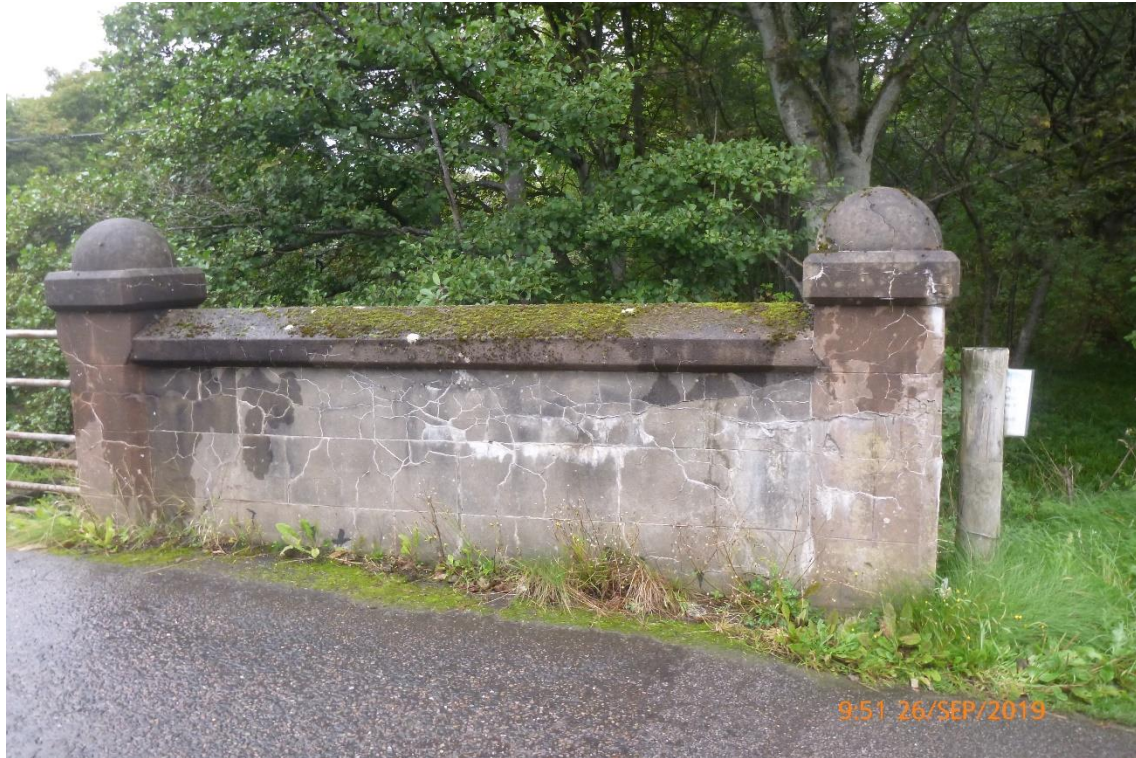
Photograph 35: Typical condition of parapet with cracking and crazing.
