ROAD: C2E

**BRIDGE NAME: CLODDACH SOUTH OF
ELGIN**

1997

BRIDGE INSPECTIONS FORM FOR END SUPPORTS

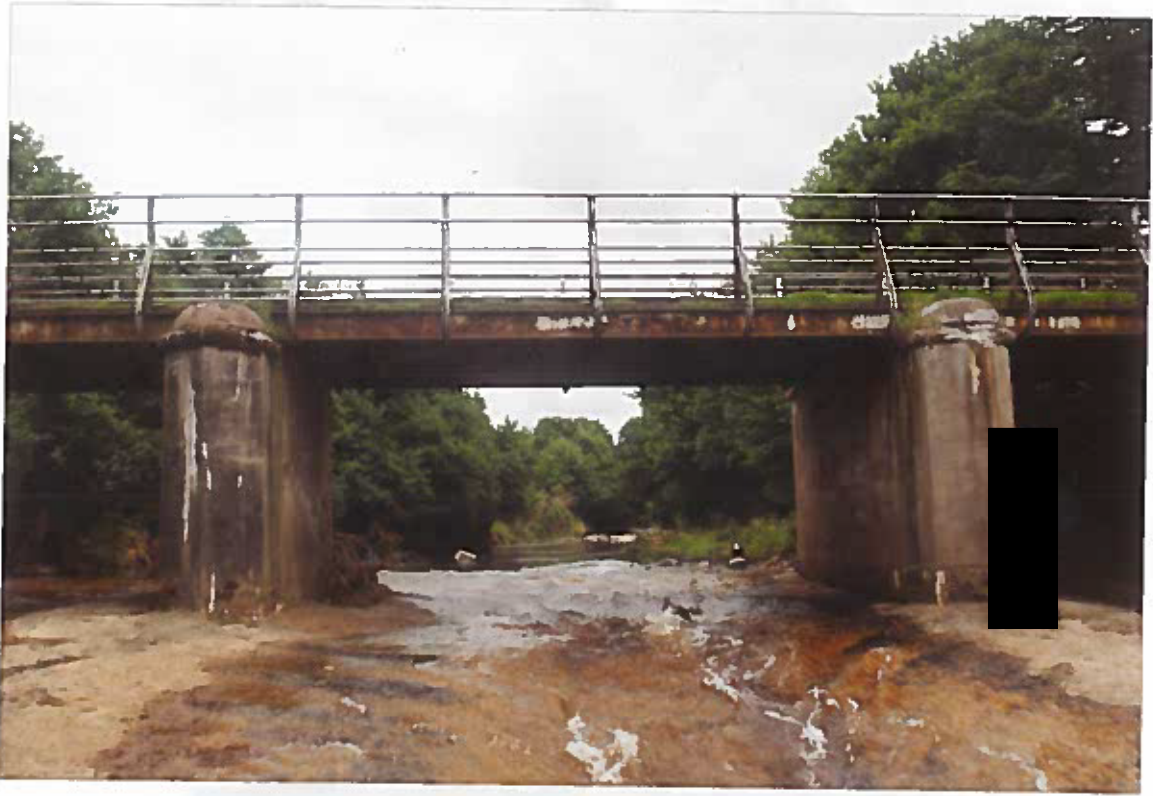
PLATE A

HAIRLINE HORIZONTAL
CRACK (POSSIBLE JOINT).

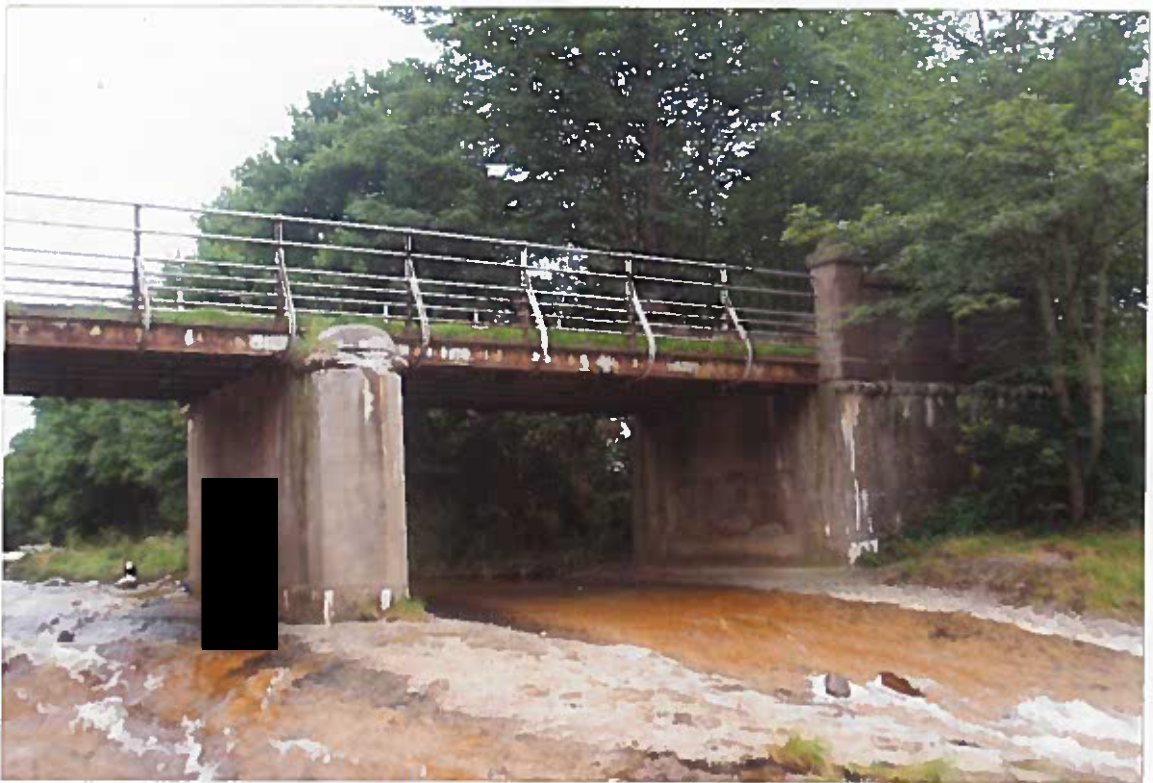
PLATE B

HAIRLINE
CRACKS - GB
CRACK ON
ABUTMENT
FULL HEIGHT

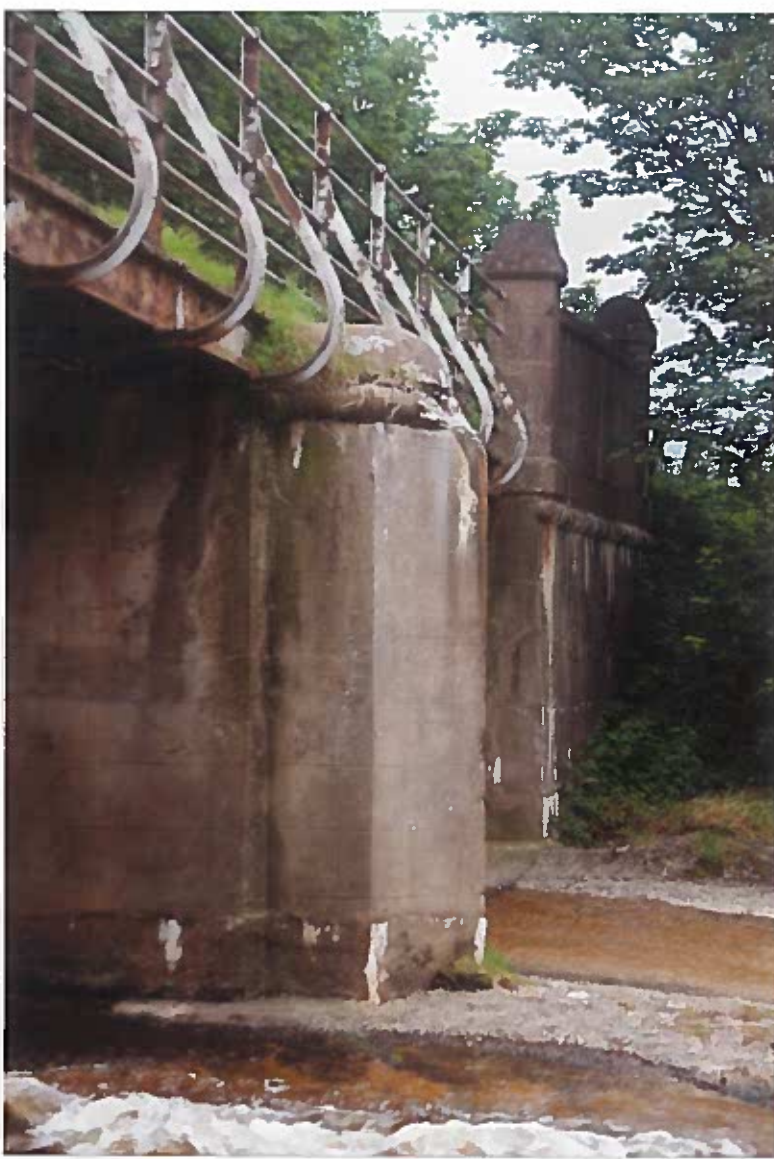
PLATE C

SPLIT AT
TOP OF PIER

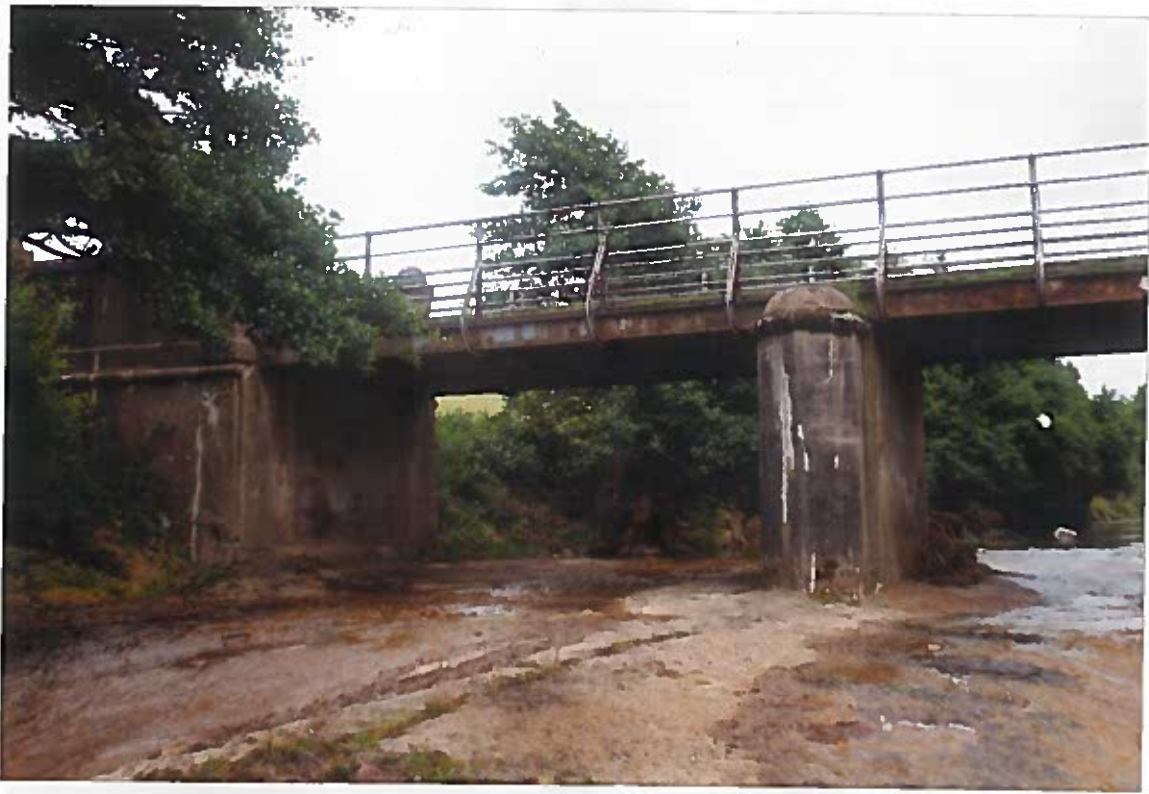
PLATE E

BEAM FLANGES
CORRODED

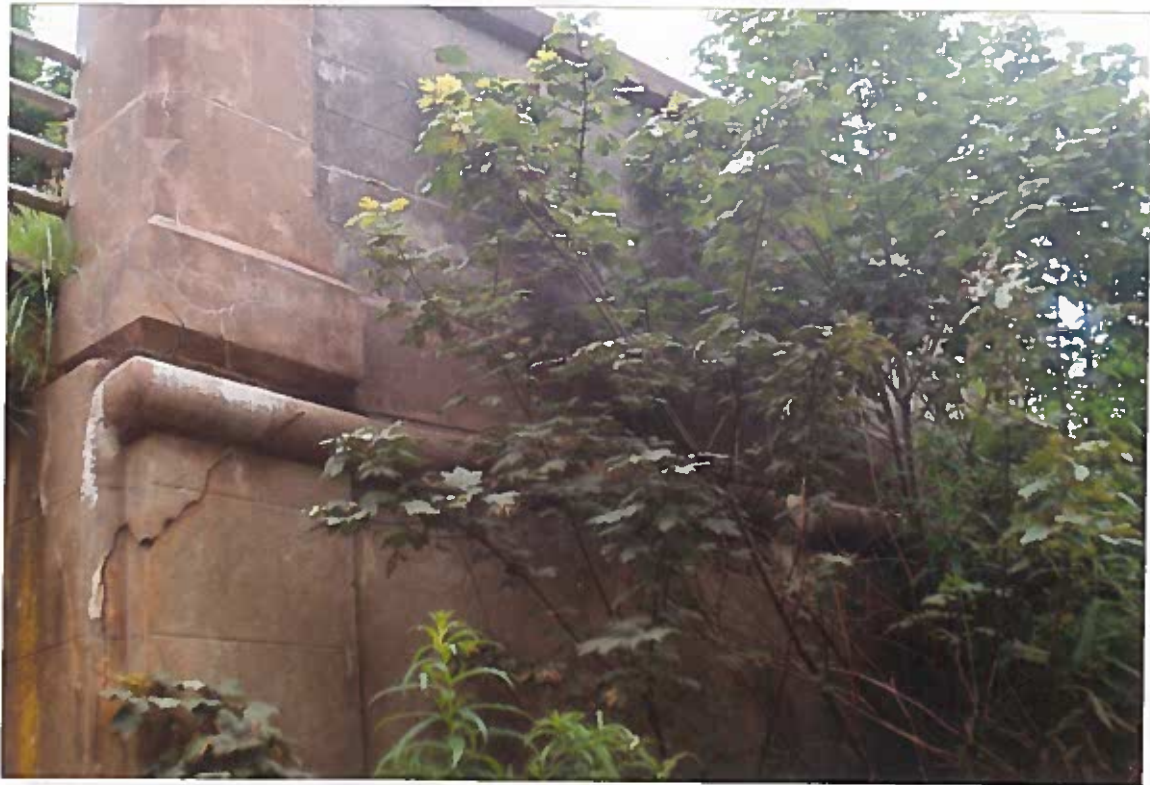
PLATE F

HORIZONTAL CRACK
ALONG BOTTOM OF
PARAPET

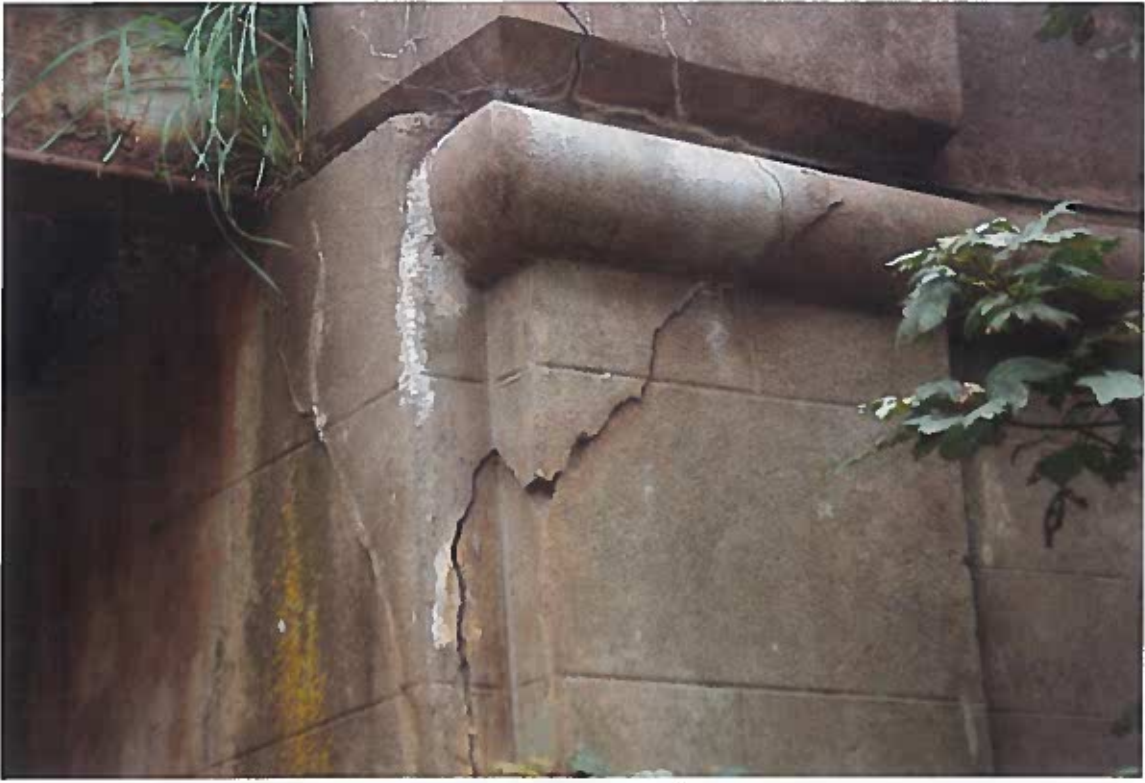
PLATE G

CORNER
SPALL

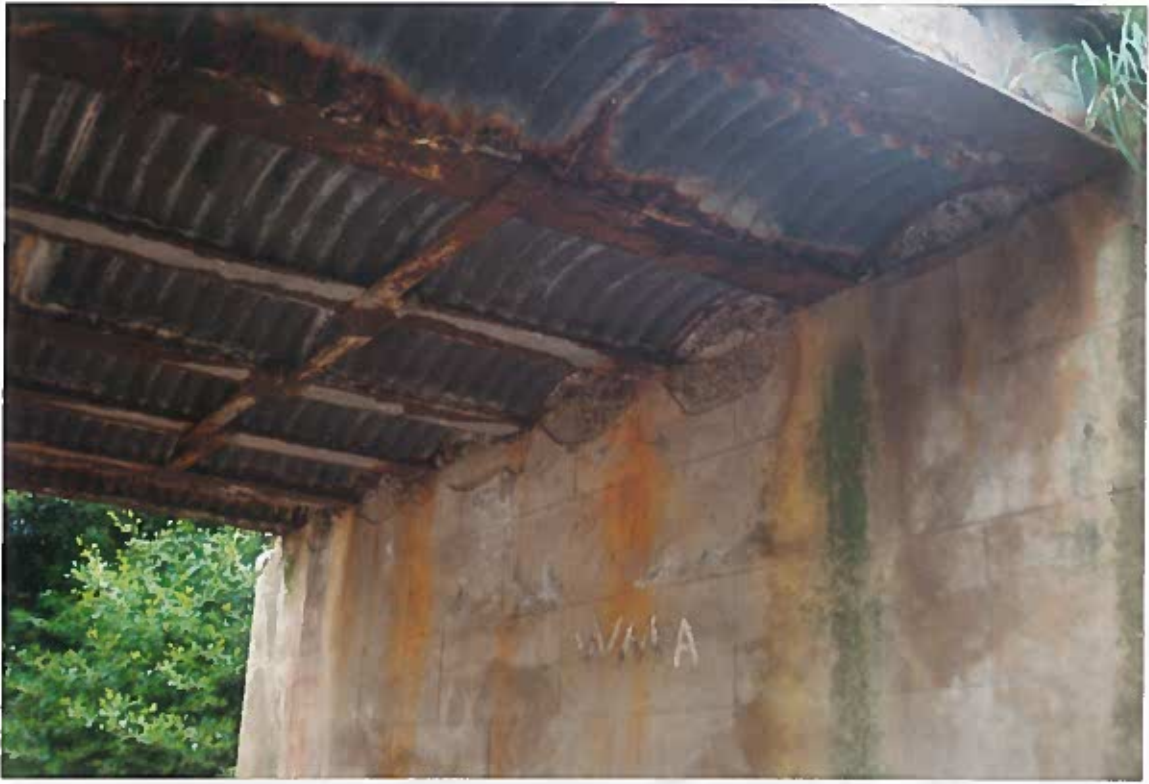
PLATE I

OLD CRACKING
ON FACE
GENERAL

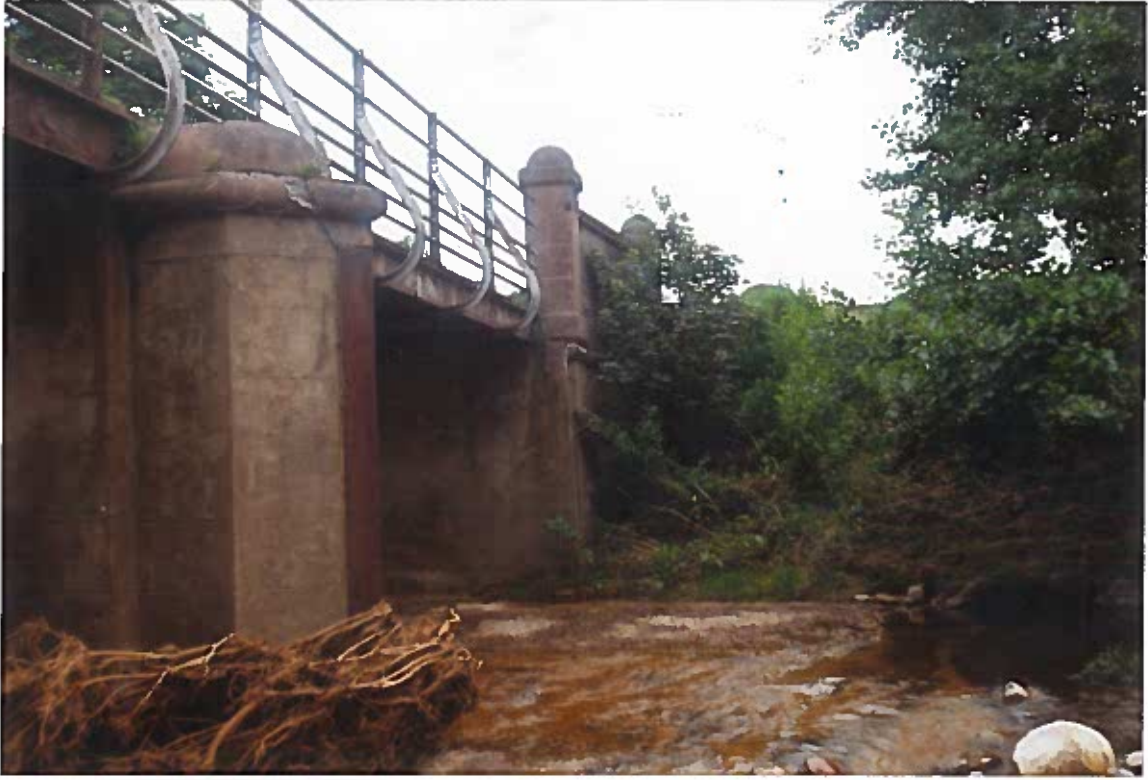
PLATE M

SPLIT AT TOP
OF PIERS
