Forres Conservation Area

Part 2: Conservation Area  
Management Plan

November 2013

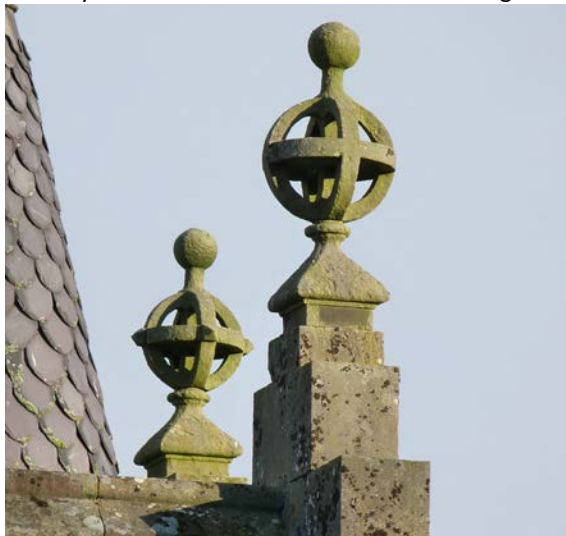
The unimaginably difficult to carve sandstone globes at The Park, Victoria Road show the skill of masons at work in the town (1877)

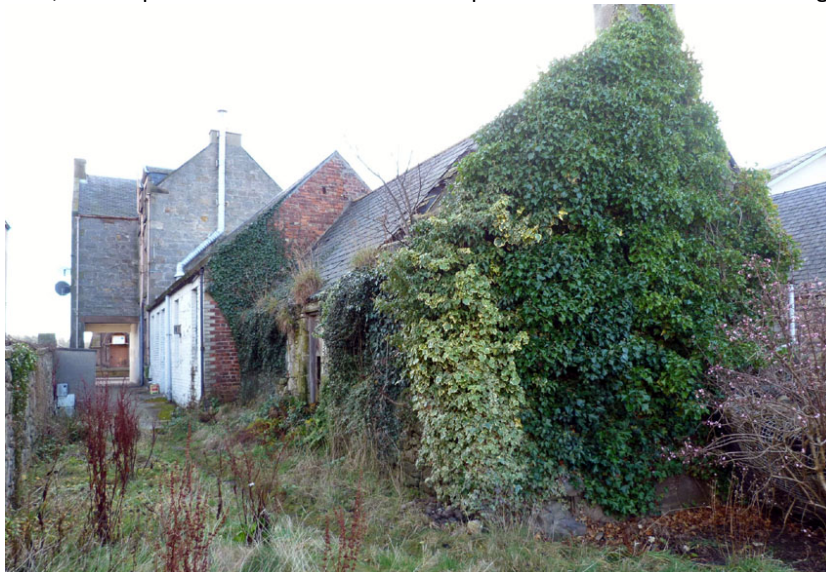
A single storey property in the wynd to the rear of 149 High Street has lain empty for many decades

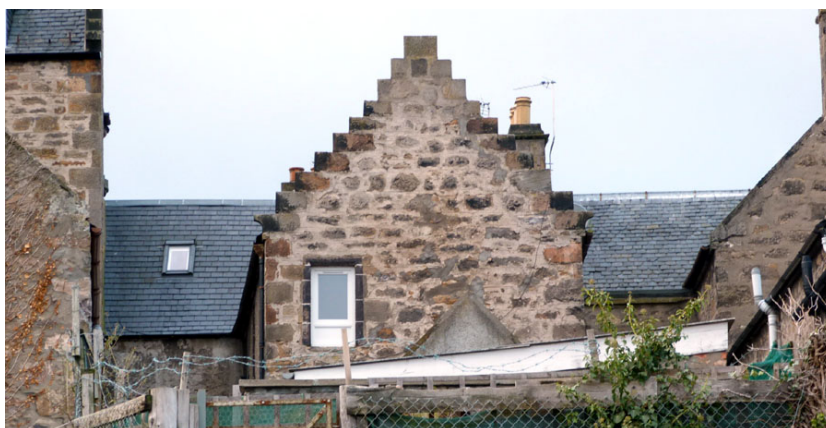
A wing to the rear of a listed building on the High Street displays a steeper roof pitch than would be the norm and crowsteps suggesting that parts of an earlier building could have been retained on the site: a chimneyhead at the gable has been taken down and the fabric modernised with modern windows and a new slate roof with a modern tile ridge

- 3.3.3 Earlier buildings may be distinguished by roofs with a steeper pitch than would be the norm, and a significant number of the more domestic properties had retained their thatched finishes into the twentieth century judging by the evidence of historic photographs. Buildings from the late seventeenth century to the mid-eighteenth century, and possibly later even, were usually harled and retained their distinctive crowstepped gables with elegant curved skewputts. It is not uncommon to find the existence of crowstepped gables to the rear of High Street properties which may have been altered or refaced which may suggest the existence of an earlier property on the site. Gables from this era would be marked by chimneyheads with heavy splayed sandstone copes and plain roll mouldings. Rooms within the attic space of these buildings occasionally have 'cat-slide' dormers of a simple pattern, but while good examples of distinctive heavy stone slates had survived into the mid-twentieth century from the evidence of historic photographs all of these older structures have now vanished from the street scene. Gable widths and floor spans would be governed by standard joist spans and sizes. Crowstepped gables would often be revived in the nationalistic revival styles of the mid-to-late nineteenth century of

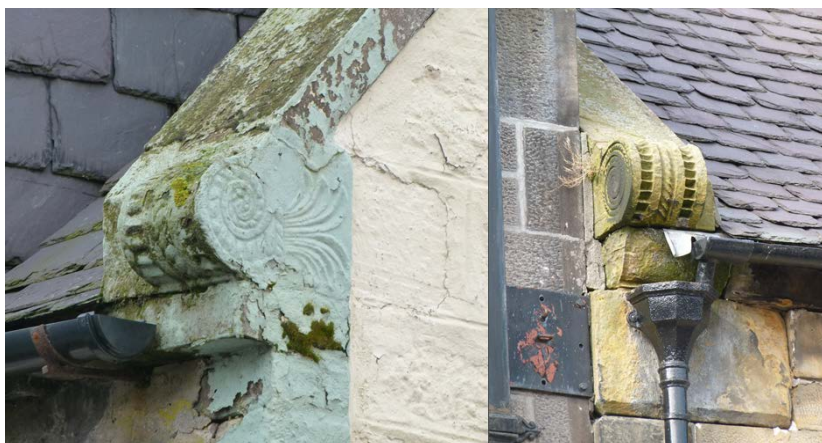
Elaborate carved skewputts of which there are a number of examples to be found in the period c1775-1820

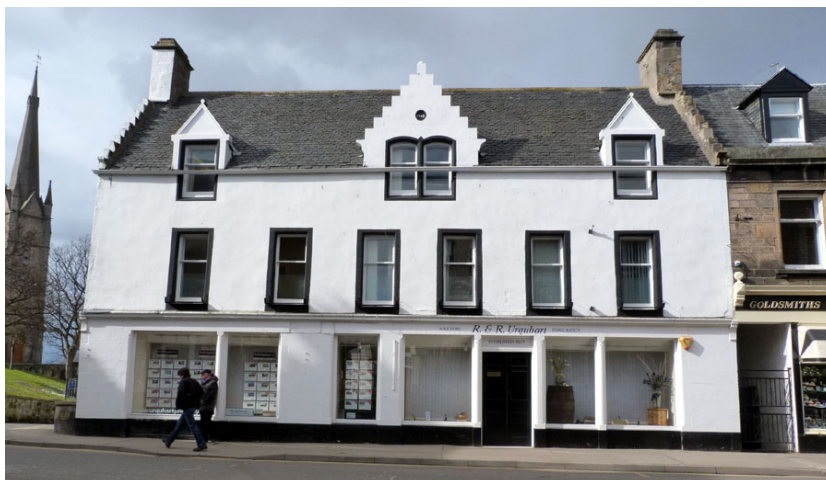
A range of Victorian cast iron shopfronts inserted at the ground floor of the earlier building at 117-121 High Street which carries the date of 1748

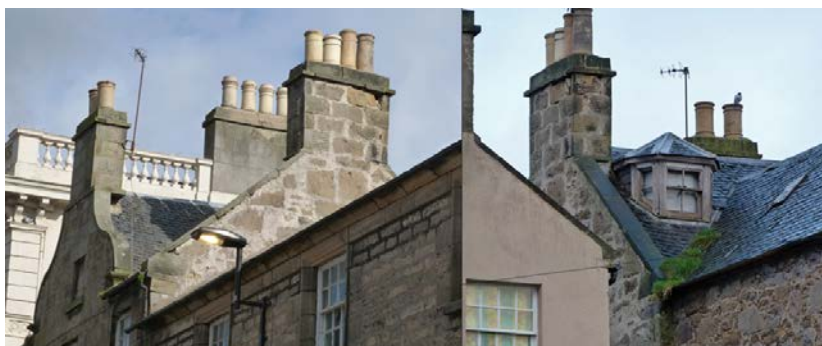
A key listed building on the High Street displays a lack of maintenance with a number of features failing: gutters need to be cleaned, roof slating needs to be overhauled, chimneyheads are leaning and bulging and have open masonry joints with missing stonework, and joinery needs decoration and repairs for which access is heavily constrained

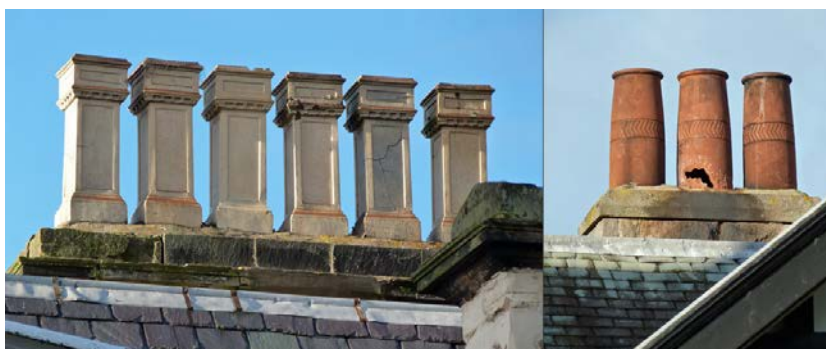
The loss of a single chimneyhead can be damaging to the appearance of the building, and to the wider conservation area. There will be a presumption against the demolition of chimneyheads. Where these elements of the roofscape require to be taken down, but only if their condition merits it due to decay or structural instability, sound material should be retained and incorporated in any rebuilding. The appearance of the original feature should be matched in all respects. Encouragement will be given to restoring missing chimneyheads.

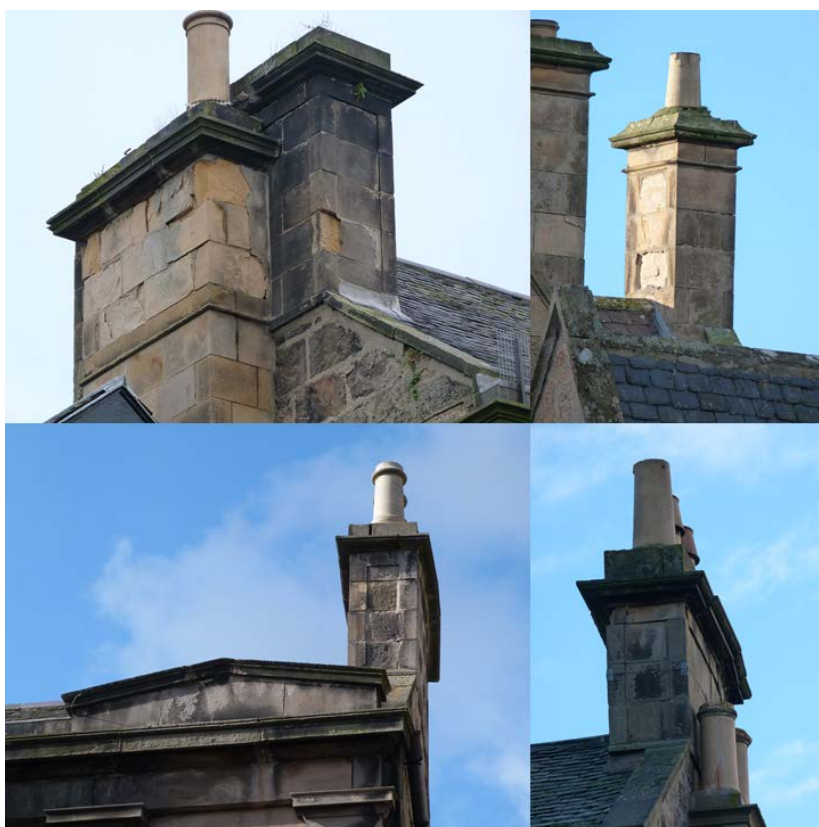
- 4.3.3 The loss of chimneyheads, particularly at gables which have been slated over, or left as a stump, can result in a disturbing loss of symmetry affecting the rhythm of the street or skyline. A gable which is not capped by a chimneyhead will tend to look unfinished. Chimneyheads are among the most vulnerable parts of any historic building due to exposure to the combined effects of a harsh climate and flue gases. Throughout Forres these elements are particularly at risk because of the poor weathering qualities of some of the building stones or of risk where this has been used. Many decayed chimneyheads have been coated with modern dense cement rendered finishes, or will have been heavily over-pointed in cement mortar

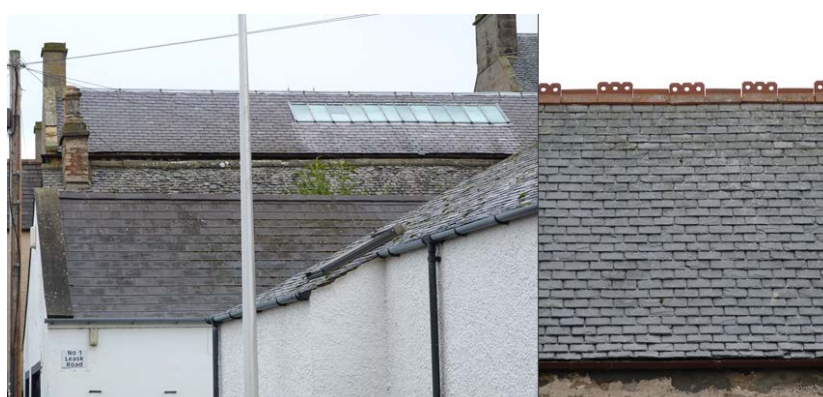
Varied roofscape in the left image, with a modern clay tile, sandstone and lead roll ridge; red clay cresting on the right

- 4.4.1 Stone ridges have survived on Forres roofs in abundant numbers. In the late nineteenth century several appear with raised profiles. They are always an attractive feature of the roof and every effort should be made to preserve them.

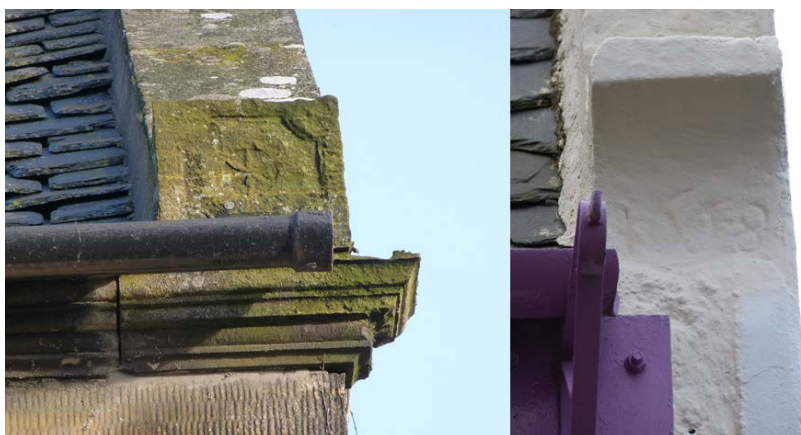
- 4.5.1 Crowstepped gables are important features within the townscape, most closely associated with the earliest buildings in the conservation area. All have distinctive curved skewputts. Sometimes crowstepped gables are found in revivalist buildings of the mid- to late-nineteenth century of which the Tolbooth is one of the best of the examples. They should always be preserved and kept well pointed up to prevent water penetration. In rare cases an inscribed date may appear on the face of the skewputt, as in the case of the oldest known building on the High Street which carries the date of 1668.

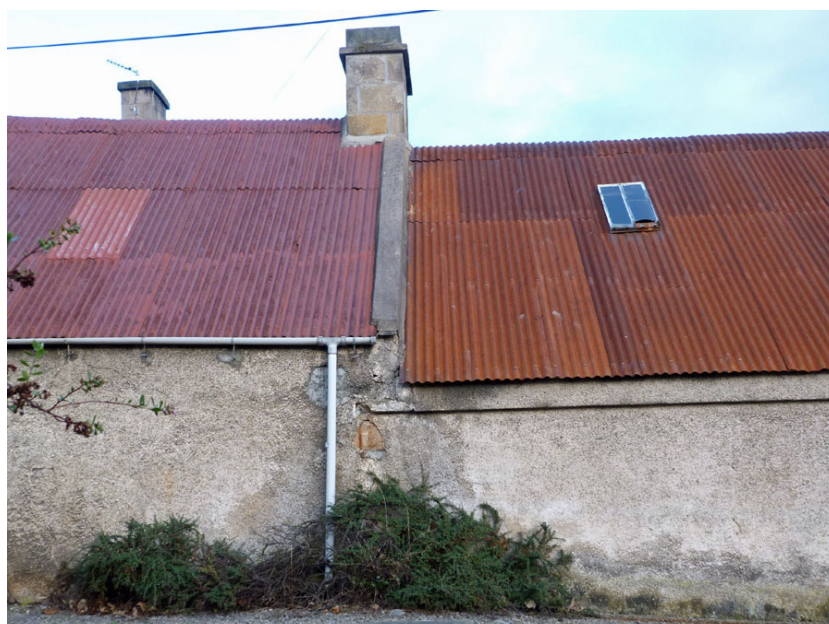
- 4.7.1 There are a few examples of roofs with corrugated iron finishes occurring in the conservation area, mostly as a roof covering to structures such as stores, garages and workshops. In the majority of cases these finishes should be considered as being historic. Often paint may no longer be effective and the sheets will be prone to rusting, and ultimately loss. In the row of cottages behind 154 High Street, the use of corrugated iron is as a replacement for thatching which has failed and the possibility that the remnants of thatching material has survived is high, having the potential for being of archaeological importance.

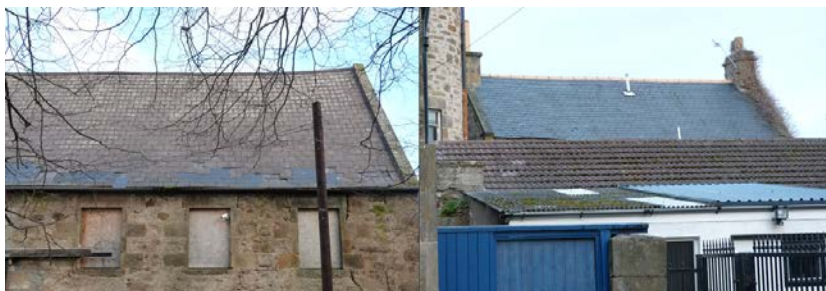
- 4.8.1 Forres has suffered hardly at all from the replacement of failed slated roofs with modern substitute materials such as asbestos cement slates or their modern alternatives, when compared with other historic burghs. Of regular face size, and appearing too thin, they are a poor substitute for slate. The colour washes out over a number of years in use and later examples are held in position with exposed clips which affects adversely the appearance of the roof.

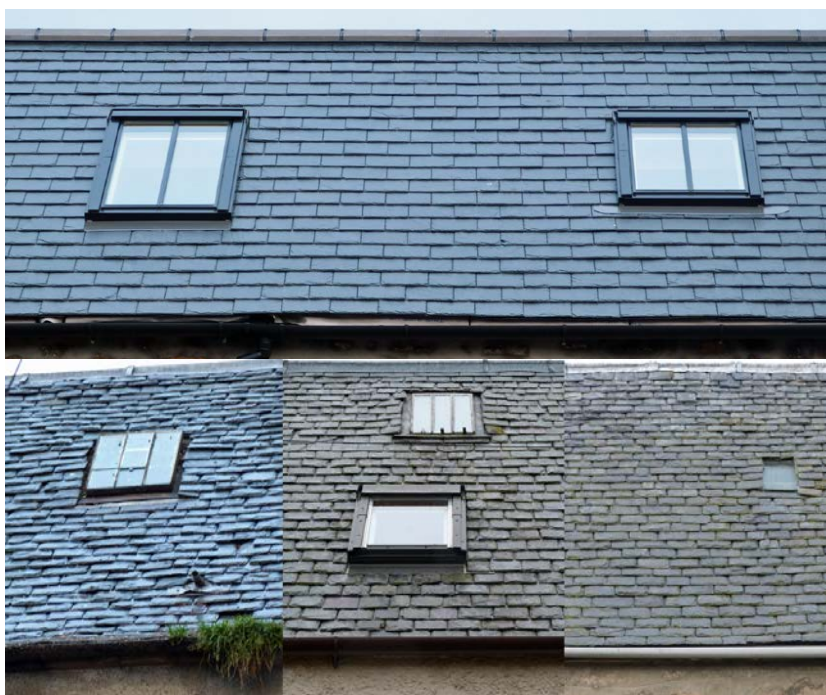
- 4.9.1 Large numbers of traditional cast iron rooflights have survived throughout the conservation area, considerably more than in other conservation areas. Of varying patterns and sizes, and often fitted with small overlapping panes of glass, they make a positive contribution to the roofscape of the conservation area.

- 4.9.2 Modern rooflights can be intrusive where older rooflights are replaced or where roofspaces have been converted for habitation, especially if they are oversized, or of square or horizontal proportions with large single sheets of unbroken glass when viewed from street level. Also, the frames tend to sit considerably higher above the roof finish than traditional cast iron skylights. Rooflights sold as 'conservation rooflights' can be little more than standard items with artificially subdivided glass panes and are considered unsuitable for use in the conservation area. Great care should be taken over the selection of suitable replacement rooflights of which good examples can be sourced from suppliers such as the Rooflight Company or Lumen Rooflights.

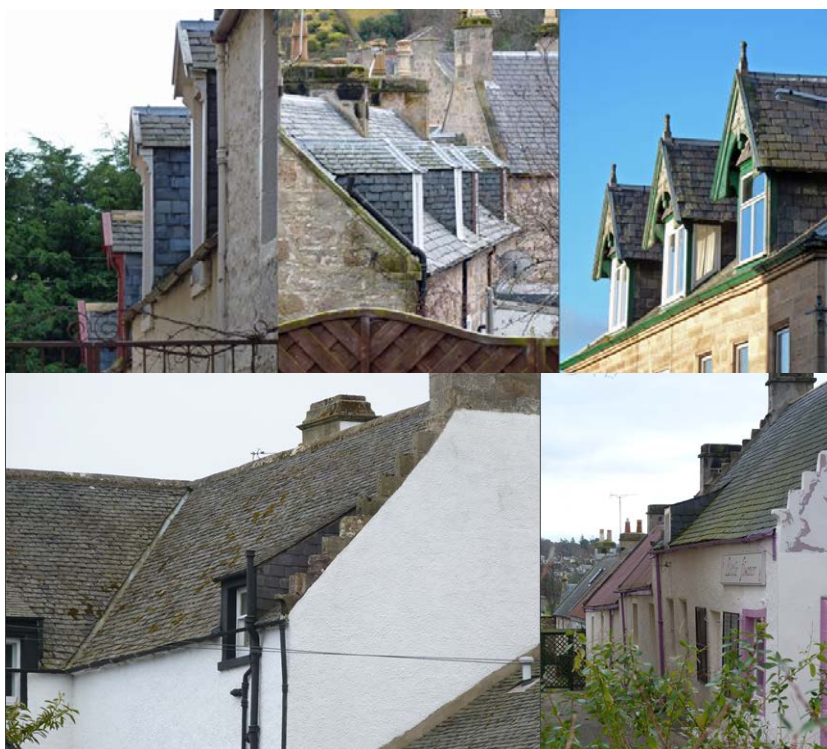
- 4.10.1 Most historic burghs possess a rich legacy of dormer windows, but the sheer quality and variety of those found in Forres surpass the majority, giving considerable rhythm and character to the roofscape of the conservation area.

- 4.10.2 The earliest examples of traditional patterns of dormers are no longer prominent features within the townscape as they had been once, and of these cat-slide dormers have survived to the rear of 154 High Street and appear on the rear roofs of 117-121 High Street. Occasionally cat-slide dormers appear on nineteenth century buildings. Some of the carved pedimented dormers which were once part of this seventeenth century tradition have survived only as replicas of the late nineteenth century of which there are good examples surviving at the former Longview Hotel on the High Street and in some of the finer villas of the residential areas.

- 4.10.3 Towards the end of the nineteenth century the design of dormers became more diverse – while some are plain pedimented, others have semicircular heads or are gables blocked out to complement a gothic façade. There are also some vertically proportioned dormers built off the wallheads. It is not uncommon to find that carved stone detail, for instance in finials, has been damaged through decay, with many features lost, and not replaced.

- 4.10.4 Timber dormers appearing on the buildings of the High Street are equally diverse, with a number of them pedimented with distinctive console brackets, and some with semicircular heads. Most of them have retained the original slate finish. Of the plainer types of dormer there are equally good examples to be found, for instance of angled dormers, or plain dormers with piended, or hipped roofs with lead coverings to the hips and ridges. Slated haffits are commonplace. Away from the High Street it is not uncommon to encounter dormers with decorative bargeboards.

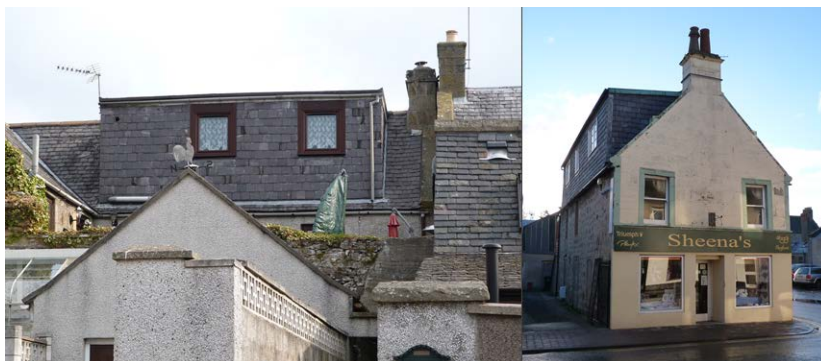
- 4.10.5 Forres has been largely spared large numbers of box dormers or later mansard roofs which have damaged so many other conservation areas,

although several were noted during the audit of properties. Flat-roofed box dormers are normally erected to gain additional headroom for the upper habitable spaces, or to introduce bathrooms at roof level. There is a prominent example to be found on the High Street to the rear of a building of 1778 of architectural importance. Although the vertical surfaces of box dormers are normally clad in slate, without exception they disturb the lines of a traditional roof and always have a negative impact on the conservation area.

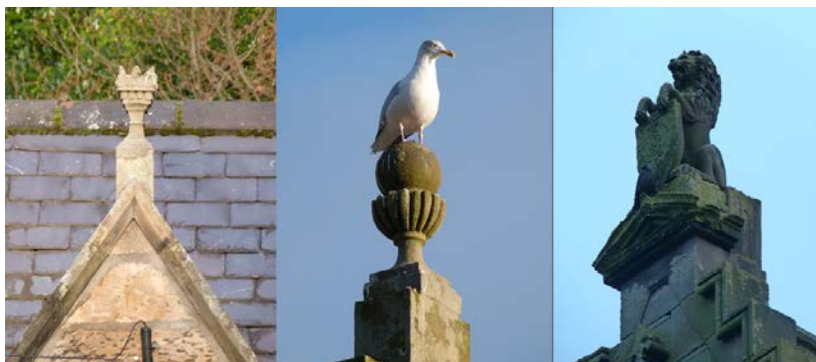
- 4.11.2 Forres has inherited a rich tradition which grew up in the nineteenth century of punctuating the skyline with decorative finials of varying types applied to spires and towers. A gilded flying dragon adorns the spire of Anderson's Institution while gilded cockerels can be observed at the Tolbooth and at St John's Church. Other spires have elaborate weather vanes, and these features are occasionally found on domestic properties.

- 4.11.3 As noted elsewhere, one of Forres's crowning glories is its carved architectural detail, which finds expression here in a remarkable collection of finials to gablets on street frontages. In some cases they are so elaborate that they display the outstanding skills of the town's masons, while in some cases carved stonework will be the work of sculptors. The array of detail and its variety is astonishing – carved thistles, fleurs-de-lys, floral sprays, roses, obelisks, urns, orbs, and ball finials are all to be seen at high level. Through decay and neglect many of them have been lost, and in some cases this spoils the symmetry of an elevation.

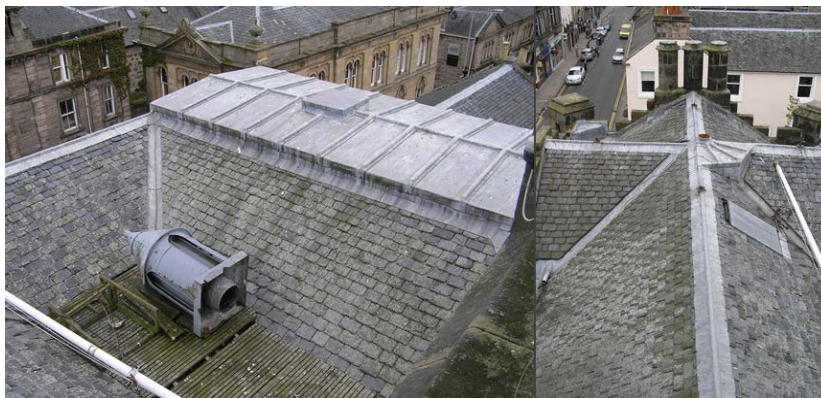
- 4.12.1 Early flat roofs occurring throughout the conservation area would have been finished in lead. There are relatively few flat roofs appearing in the conservation area, and they are mostly found between pitched roofs in the

form of wide valley gutters, or behind stone parapets. Lead lined roofs have the potential to last for many years if laid correctly and maintained.

- 4.12.2 Lead parapet and valley gutters are important elements in preventing water from entering the interiors of buildings. Parapet gutters are mostly invisible from ground level, and where they are not maintained considerable damage can result, leading to severe outbreaks of timber infestation and fungal attack.

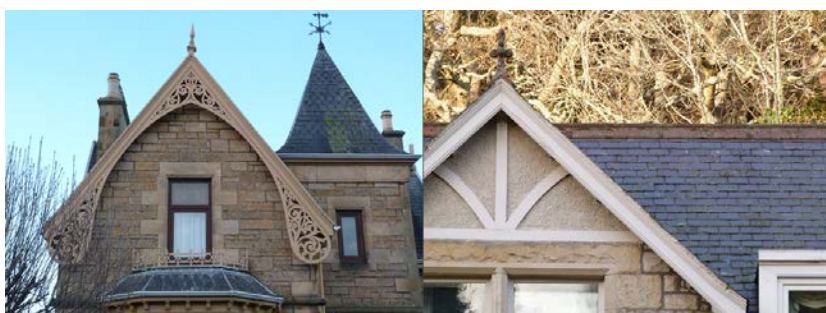
- 4.13.1 Painted bargeboards and projecting eaves boards are absent among the earlier structures in the conservation area, and only began to appear in the last quarter of the nineteenth century. They are features normally associated with domestic buildings, of which there are a number of good examples occurring throughout the conservation area. Some are highly decorative, with curved profiles and elaborate fretwork. On dormers bargeboards may often be supported on attractive brackets. Projecting bargeboards are common in late nineteenth and early twentieth century villas of the residential areas.

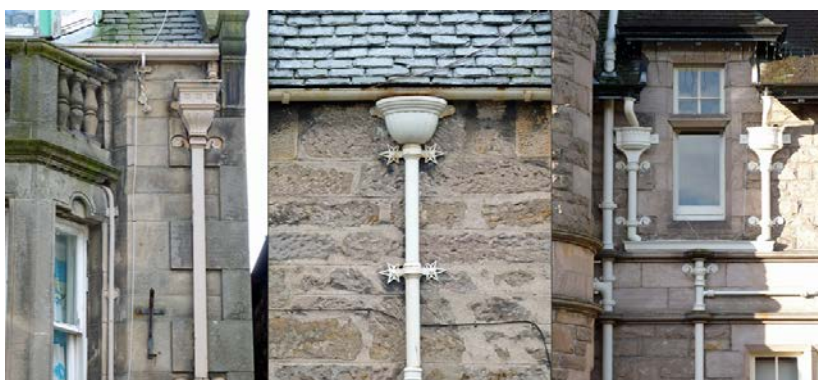
- 4.14.1 The earliest buildings within the conservation area would have had no rainwater goods originally, and would have been reliant on the large stone slates overhanging the projecting wallhead tabling found on buildings of this age. The later introduction of cast iron rainwater goods to these structures recognises the improvements that were made to street drainage in the early nineteenth century.

- 4.14.2 Buildings from the early nineteenth century onwards were normally fitted up with ordinary half-round cast iron rhones and round downpipes. Towards the end of the nineteenth century more elaborate patterns appeared on the principal buildings, of which nearly all have survived. Decorative cast iron rainwater goods were used extensively up to the 1930s. Not all of them are in good condition and some damaged sections have been lost and replaced. Square downpipes with decorative holderbatts, hoppers and ogee rhones supported on wall brackets, supplied by a number of different foundries, are to be seen on the buildings of the principal streets. Of these Forres is considered to have an exceptional collection.

- 4.14.3 There have been problems in maintaining decorative rainwater goods. While many of the systems are capable of continuing in use, difficulties in obtaining replacement parts have led to temporary repairs having to be carried out.

- 4.14.4 For the lesser properties in the conservation area there has been a gradual erosion of original cast iron rainwater systems, and where improvements have been made it is common to find plastic alternatives having been used. Although maintenance free, plastic rainwater goods have a flimsy appearance and can become brittle and prone to damage from ladders. They have none of the lasting qualities of well-maintained cast iron systems.

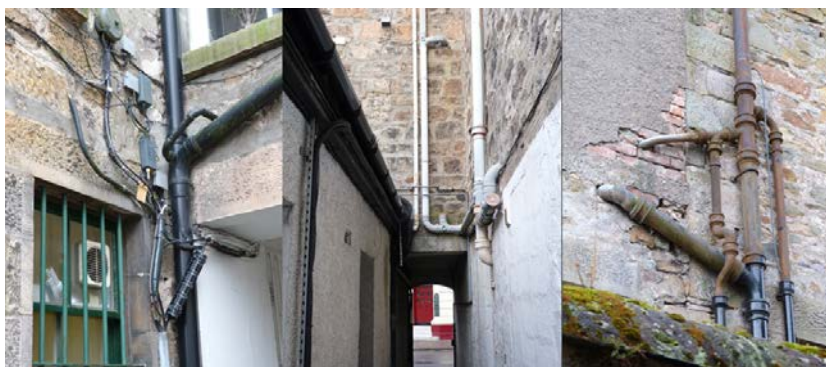
- 4.15.1 Cast iron soil and vent pipework appearing on the face of buildings will be likely to date to the late nineteenth century onwards and reflect the introduction of sanitary regulations. More often than not, in older properties they reflect changes that have been made. Later systems may be of modern materials, such as uPVC. They are, without exception, disfiguring in appearance, especially where they occur on a principal elevation, or where seen along the length of a close.

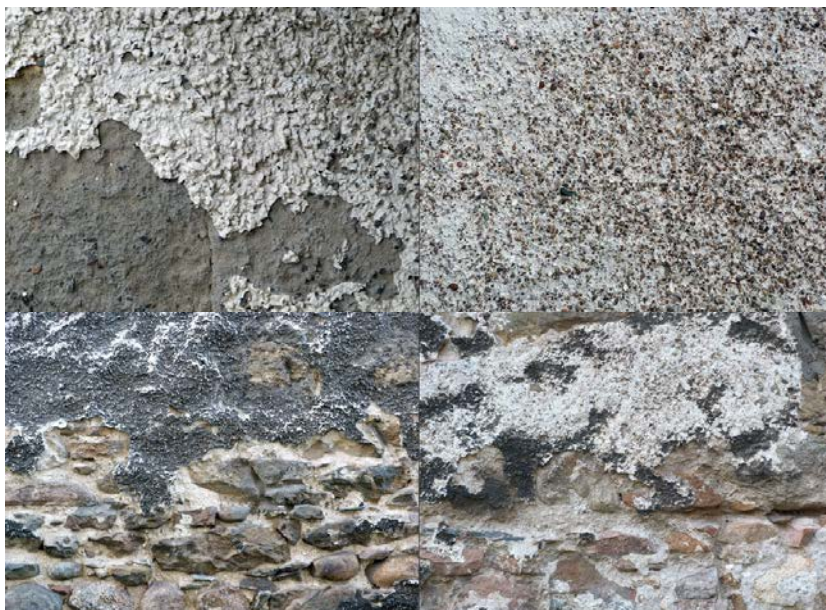
Examples of lime harling surviving in the wynds (see also the photograph on page 28)

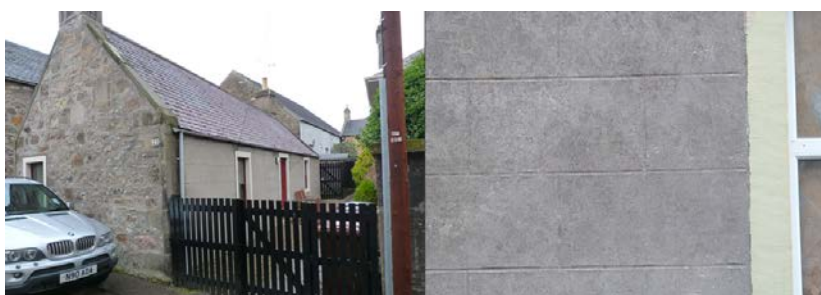
Examples of early Portland cement ashlar renders

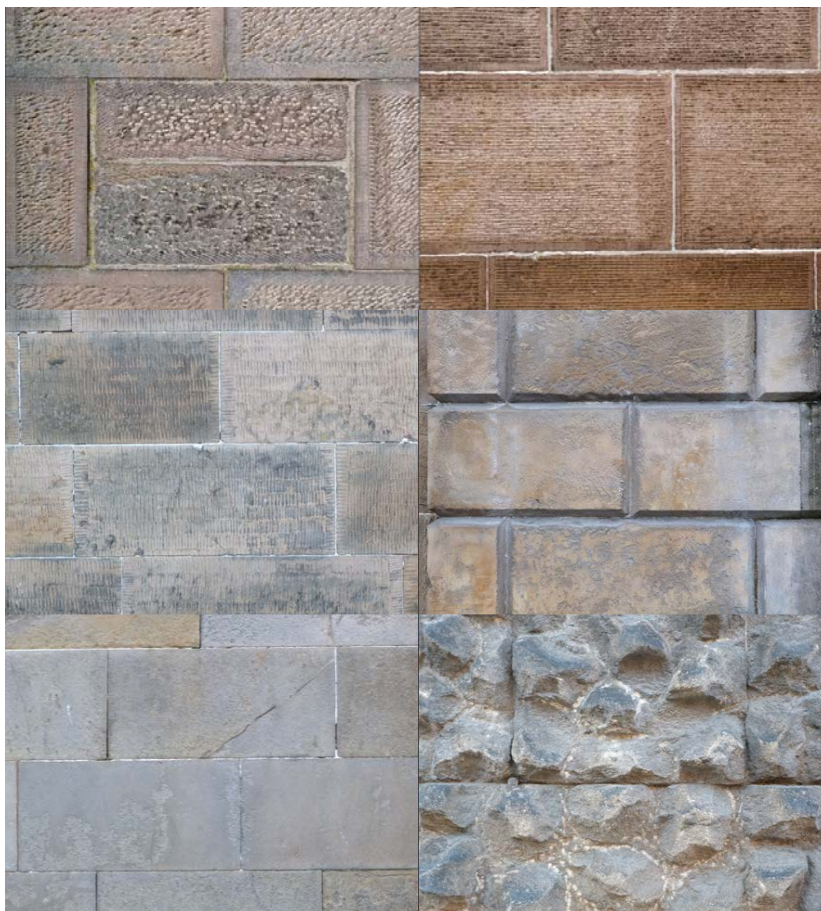
- 4.17.1 Ashlar stone walling from all ages would be reserved for the town's principal buildings, and often would be restricted to the street elevation. As a measure of the skill of the masons virtually every possible form of ashlar masonry has been attempted. There are good examples to be found of smooth (or polished) ashlar, hammer-dressed, rock-faced, random tooled, vertically and angled droved, puncheoned with margins, and rusticated ashlar with both channelled and vee-jointed examples. The rock-faced walling of the ground storey of the ironmongery shop at 107-111 High Street is found normally only in cities like Edinburgh.

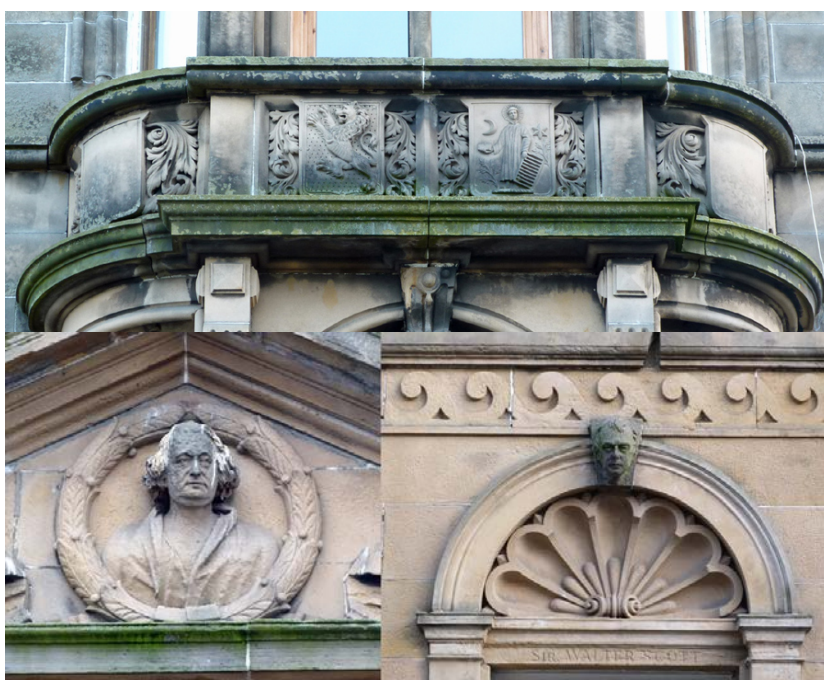
- 4.19.1 The calibre of the carved architectural detail in the sandstone buildings of the principal streets and the residential villas is of a remarkably high standard, reflecting a long tradition of masons' skills fostered in the Laigh of Moray over many generations. By the end of the nineteenth century carvings appear frequently, adorning a number of buildings throughout the conservation area. These skills are translated into carved inscriptions and date-stones on buildings, of which there are many fine examples of the late nineteenth and early twentieth centuries are to be seen. Mention has been made already of the exceptional quality of the carved work in executing skewputts in the form of capstans in the period between 1775 and 1815 (see page 17).

- 4.19.2 It seems to be something of an anomaly that Forres appears to have had relatively few armorial panels which can be dated reliably to the period before 1730. Where they have survived they should be preserved *in situ*. This shortage is compensated to a degree by the exceptional carved pedimented dormers of late nineteenth century buildings where the work is inspired by this tradition.

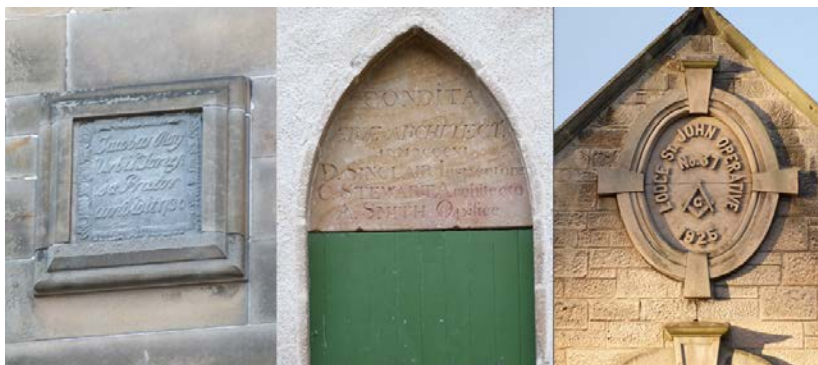
- 4.20.1 Forres has a rich legacy of datestones from all ages of building in the conservation area. They provide important information about the history of individual sites, and often the names or initials of those involved may be recorded for posterity. They add considerably to an understanding of how

the town had evolved, and some of the dates are commemorative – for instance at the Castlehill Bridge and at Nelson's Tower where the history of Nelson's naval engagements are recorded.

- 4.20.2 In a few of the examples stone decay has taken its toll making the carved inscriptions difficult to read.

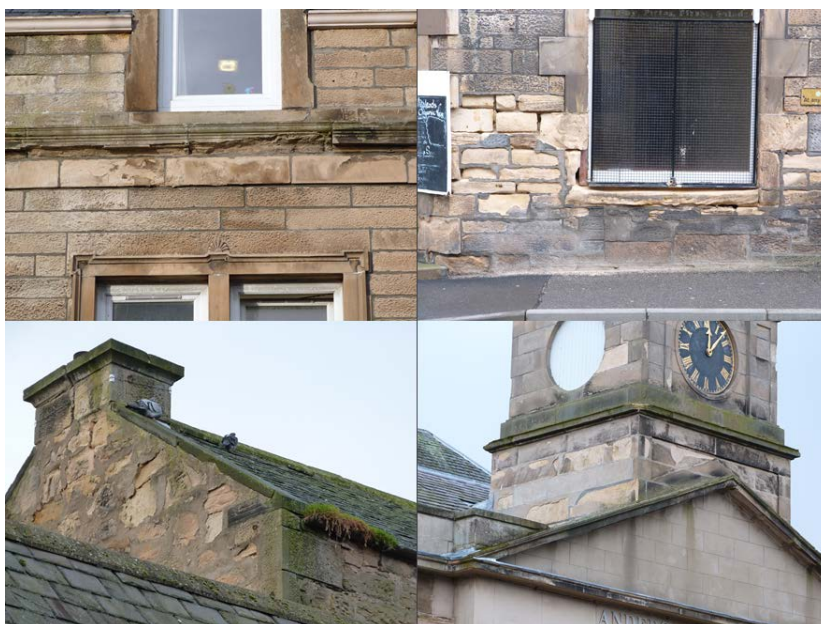
- 4.21.3 Occasionally the decay of sandstone masonry will be caused by embedded iron fixings, resulting in the stone splitting.
- 4.21.4 There are no standard answers to the repair of soft sandstone, and each case will need to be considered on its merits. Sandstone will require to match the colour of the original stone carefully, and although of greater durability than the host stone, it should not be so durable as to accelerate the decay of the walling or feature being repaired. Indenting or re-facing stonework is highly skilled work, and in some cases it may be appropriate to consider the application of a lime ashlar render, or a render on an expanded stainless steel metal lath depending on the soundness of the substrate. Where extensive repairs are needed the application of a limewash finish may need to be considered to maintain architectural integrity where this is considered important.

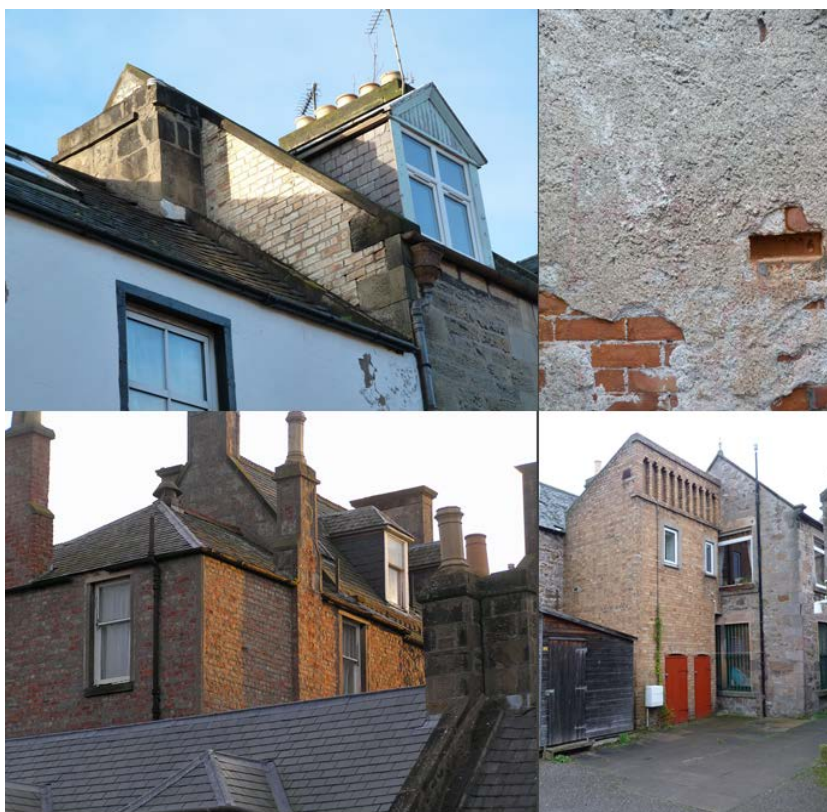
- 4.22.1 Possibly because of the general shortage of working quarries in the vicinity of the town producing building stone, brick has often been selected as a material for external walls. The earliest examples suggest that use of the material was confined to stores and outbuildings, where the brick would be disguised by the application of lime harling. In such cases it is not uncommon to find that the underlying brickwork will have been damaged by frost action.

- 4.22.2 Towards the end of the nineteenth century the use of the material became more common, but it is rare to find brickwork other than in the wynds behind the High Street. Common uses were for bathroom extensions, pend walls leading to closes, gable infill walls and occasionally for rear walls of buildings which were not intended to be prominent when erected. Brick voussoirs are used for the arched windows to the hall to the rear of the Territorial Army Drill Hall on Victoria Road. Occasionally chimneys are built of brick, or have been rebuilt in brick where stonework may have failed, or where a chimneyhead was extended upwards. Red clay bricks are most commonly used, but examples of yellow brick and white glazed bricks were observed.

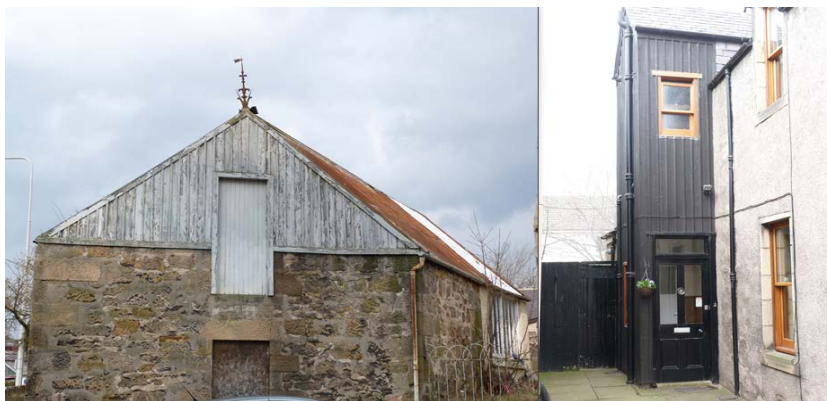
- 4.23.1 Timber cladding is rarely used throughout the conservation area, and where it has survived it takes the traditional form of painted, limewashed or creosoted vertical boards with cover battens, occasionally with rounded profiles. Porches to residential buildings occasionally use timber board linings which may be laid to diagonal patterns.

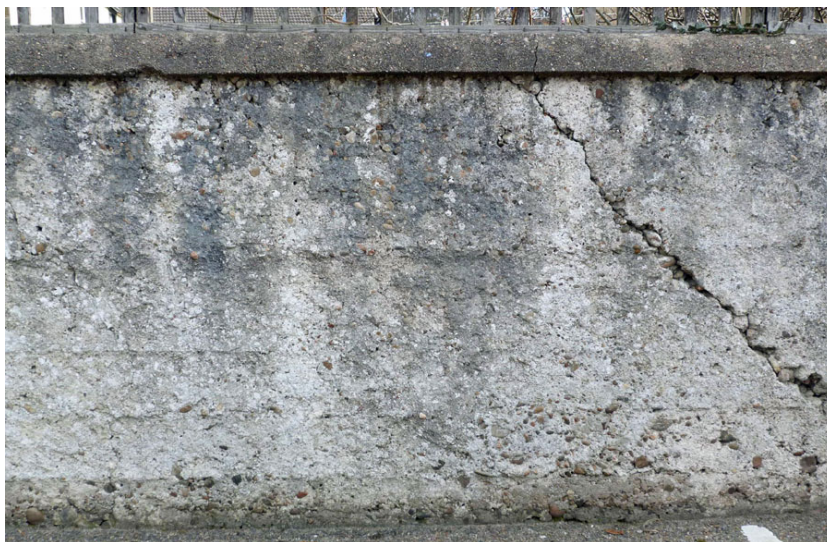
- 4.24.1 The use of walling of shuttered concrete taking advantage of the availability of early Portland cement seems to be rare, but as they are historic they should always be preserved. Often the surfaces will have coated with lime harling. A boundary wall was observed of this construction adjacent to the Orchard Road car park.

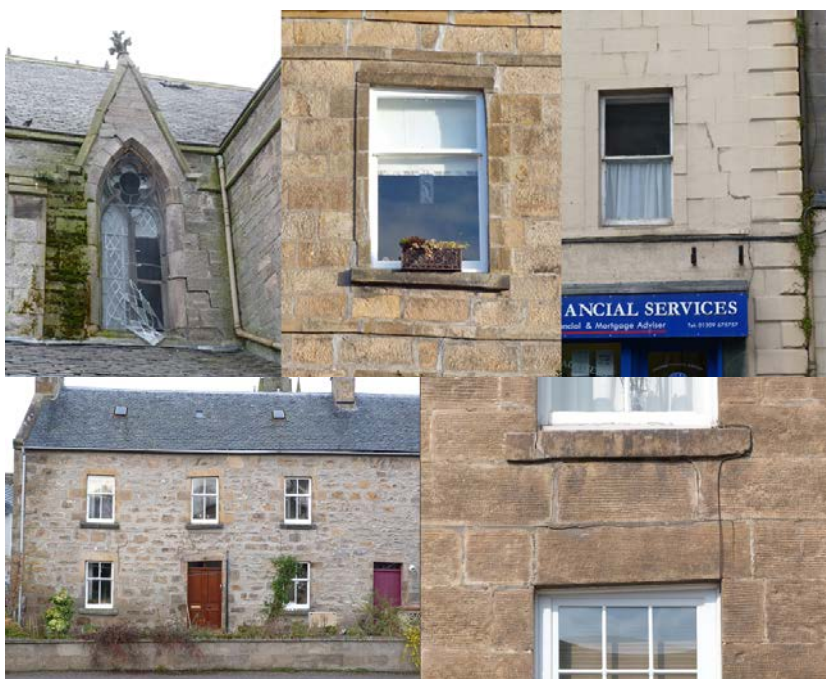
- 4.25.1 Several problems were observed with structural movement most likely caused by poor foundations but some of the façade's on the town's High Street may have been affected by the insertion of modern shopfronts. Where minor problems were observed the route of cracking followed the weak spots in the external walls, focused on lintols, cills and window breasts, and cracked lintols and rybats in raised margins at window openings were observed. Occasionally some outward movement could be observed at the heads of walls suggesting problems with rafter thrust from trussed roofs.

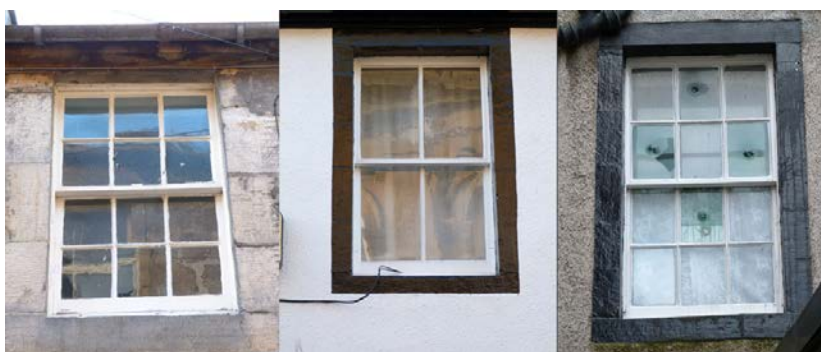
- 4.29.1 Together with the treatment of the surrounds, windows have much to inform us about the history of the building and architectural styles. The earliest surviving windows in the conservation area are likely to date from the early nineteenth century by which time the production of sash and case windows with elegant narrow astragals was well within the capabilities of local house carpenters and joiners. There were limitations on pane sizes producing the universal multi-paned sashes of which there are several examples in the conservation area, more than in many other conservation areas.

- 4.29.2 With plate glass becoming readily available from the middle of the nineteenth century window panes became larger. In some cases window sashes would have been replaced so that single panes of glass could be introduced to each sash. Sashes with plain glass and without astragals are by far and above the most common pattern of sash and case window to be found in the conservation area. In some of the lesser properties of the minor streets and closes 2-paned sashes, subdivided vertically, have survived. Towards the end of the century horns might be introduced to the upper sashes of windows, although the use of horns in windows replicating patterns before this date would be incorrect. From the 1890s onwards, with

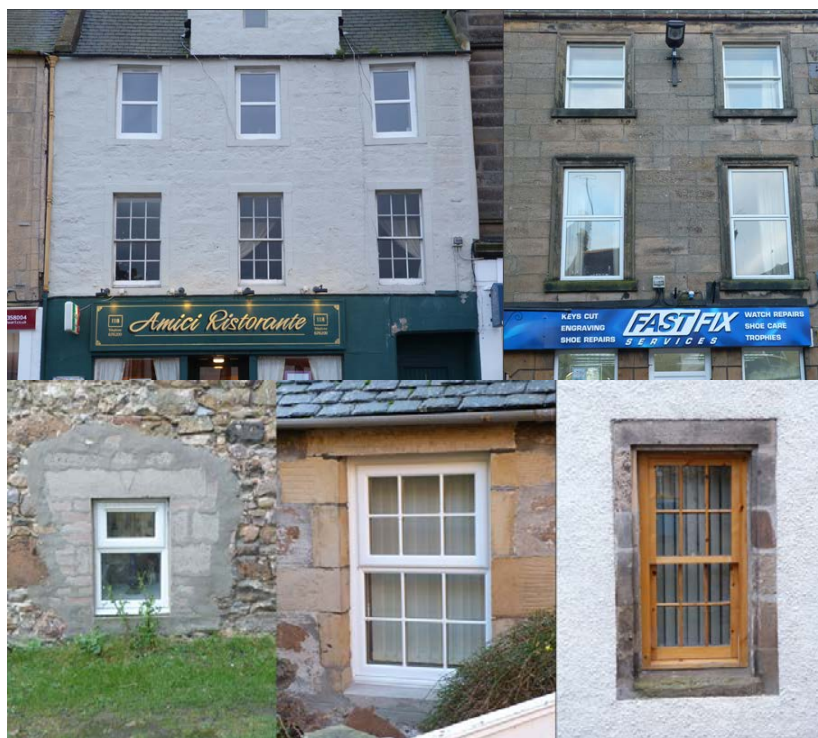
- 4.29.3 The rate of loss of traditional sash and case windows and replacement with modern windows has accelerated in recent years, to the point that the authenticity of the character and appearance of the conservation area has been impaired. It is not a particularly new phenomenon, and is likely to have begun several decades ago. Since then there has been an onslaught of different types of window – aluminium, timber replacements with modern profiles and, more recently, uPVC. While in some cases there has been no endeavour to replicate the pattern of the windows being replaced, where window patterns have been replicated the result bears little more than a notional likeness. In some cases replacement windows have been positively damaging – for instance, where a symmetrical façade has been subject to change over one half of the elevation, but where the sash line fails to line through with the subtlety of the original work. There are also examples where both sets of original windows have been renewed, with neither matching the other exactly.

- 4.29.4 More often the damage caused is incremental, from factors such as oversized astragals, modern glazing beads, a lack of depth in the appearance of the window, differentiations in how windows open (top-hung as opposed to sliding sash, etc), the addition of trickle ventilators, and the impact of modern glass. Sash boxes of traditional sash and case windows in an urban environment would always be disguised behind the stone rybats of the window surround, revealing only the slim profile of the sash itself; in many replacement units the subtlety of this arrangement has been destroyed, changing the appearance of the fenestration pattern.

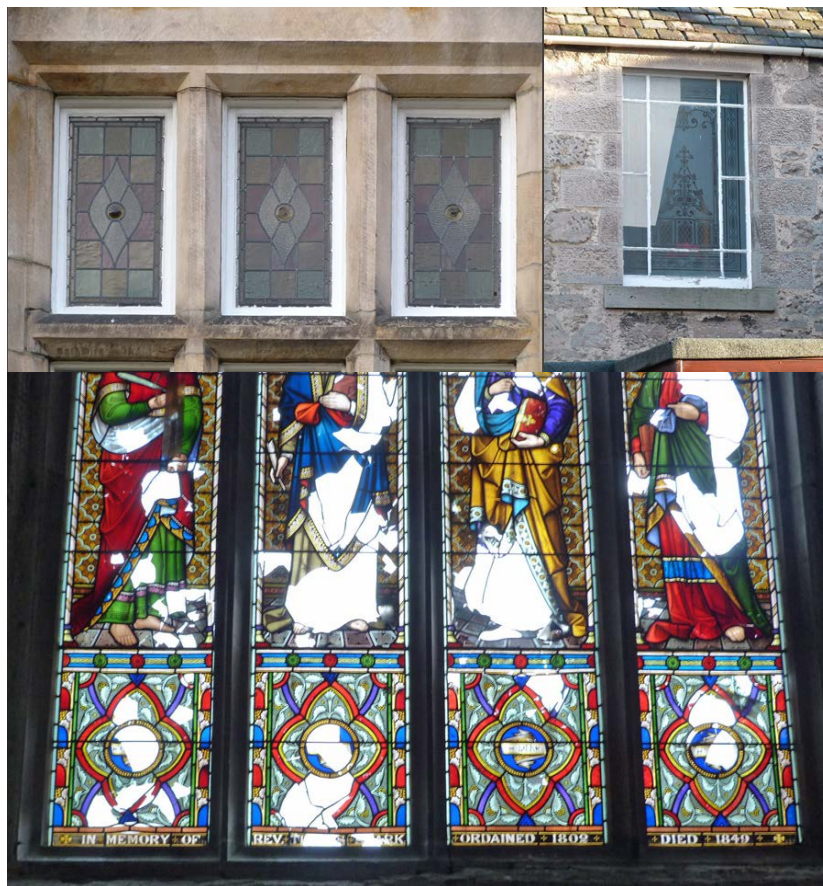
- 4.31.1 All of the principal ecclesiastical buildings within the conservation areas have excellent examples of stained decorative glass, plain glass with lead kames or zinc with coloured borders commensurate with the status of the buildings, and to reflect the generosity of local philanthropy. Not all of the glass is protected against casual damage or vandalism; the protection which is in place at the redundant former Castlehill Church has not been such as to save the stained glass which has been extensively damaged.

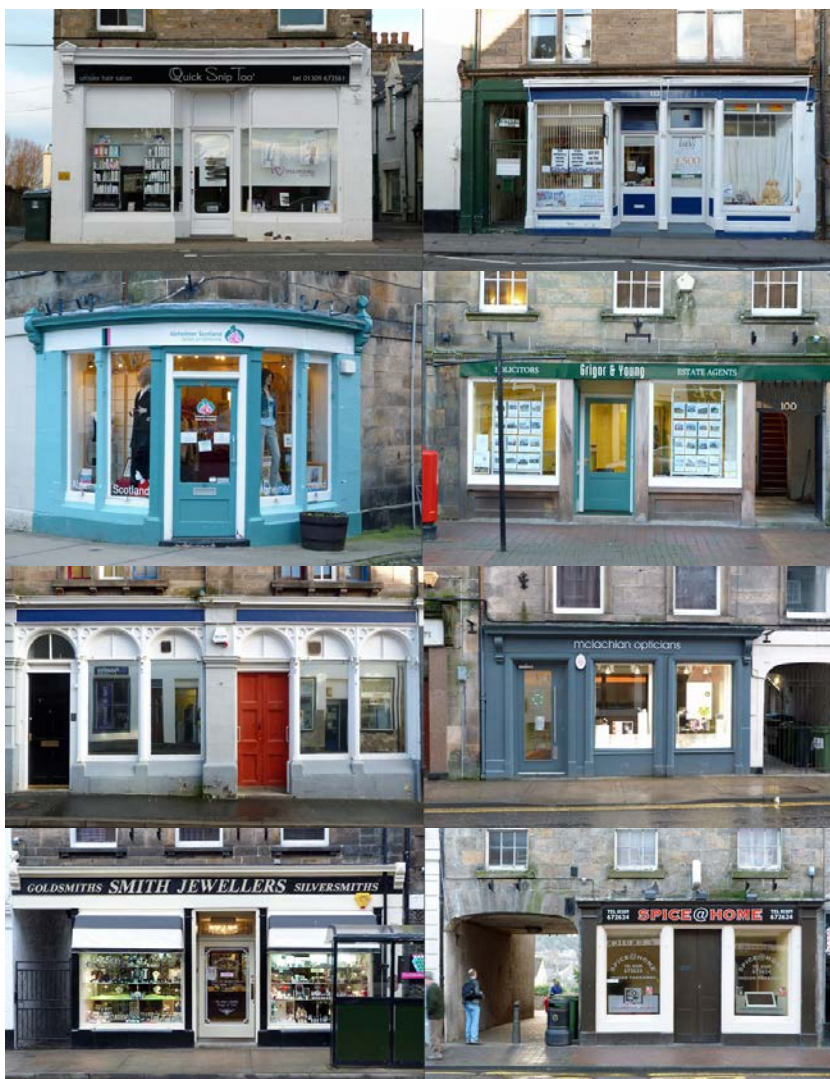
- 4.34.2 As stone shopfronts became more sophisticated the stone pillars were reduced in order to maximise the amount of glass, made possible with advances in plate glass manufacturing and transportation. Cast iron shopfronts would have been supplied most probably from either the Newmill iron foundry in Elgin, or the Rose Street foundry in Inverness, and they are often difficult to distinguish from stone in having chamfered pillars

and lintols. They are often combined with plain iron lintols which can be distinguished by the fact that they are always painted.

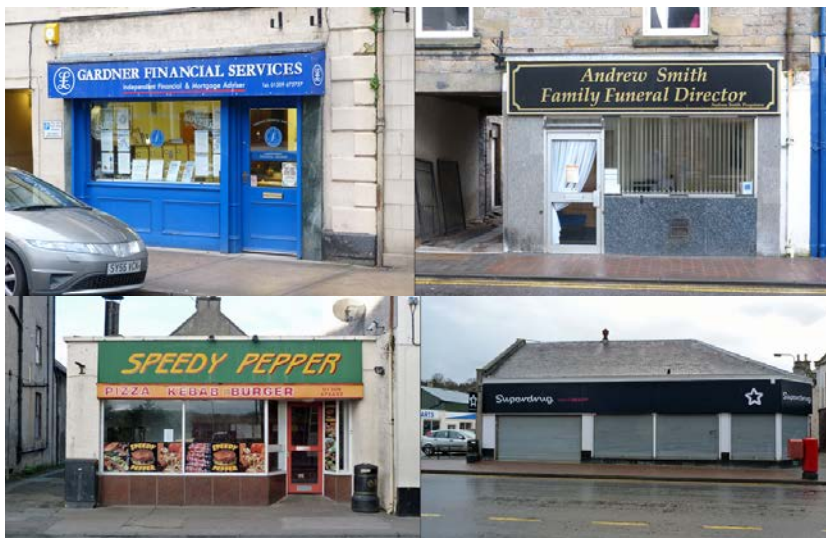
- 4.34.6 Roller shutters have been particularly damaging to the minority of shop frontages to which they have been fitted and have a marked negative impact on the wider conservation area.
- 4.34.7 Several shopfronts have retained original doors and ironmongery.
