Forres Conservation Area

Part 2: Conservation Area  
Management Plan

November 2013

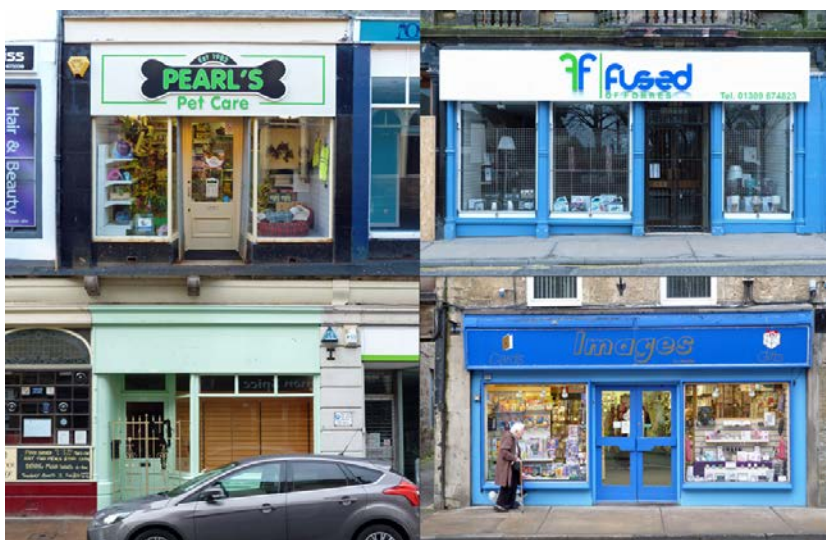
Examples of oversized shop fascias

- 4.35.2 Nowadays none of the original shop signs have survived on the High Street, and signwriting has become much less practised as an art. Some of the signs on the High Street are of highly reflective plastic and, with few exceptions, are intrusive, often with poorly designed computer-generated letters and images. Many of the signs are overlarge for the shopfront, overwhelming any interesting architectural detail that may have survived. In townscape terms, the effect of continuous arcading of columns and shaped lintols can disappear, or be interrupted. Against this, there are exemplary shopfronts to be found which conform with good practice.

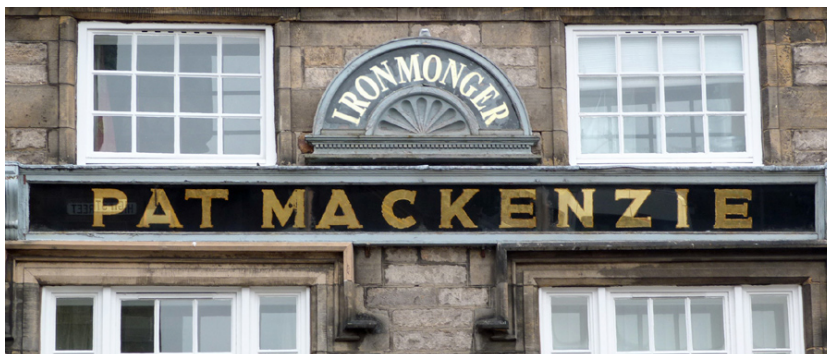
- 4.35.5 In certain instances it has proved possible to retain an earlier shop sign which makes a contribution to the historic streetscape in conjunction with carefully designed signage for a new business operating from the same premises.

Preserved shop sign relating to past uses

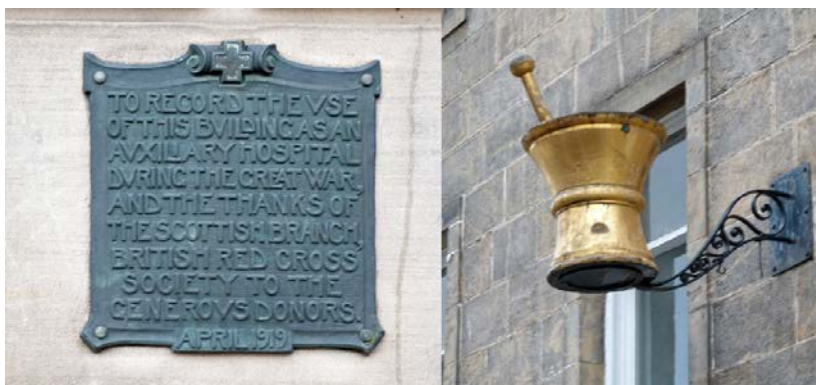
- 4.36.3 A number of historic painted signs, now faded, appear at high level on building facades and on rendered panels at projecting gables within the streetscape. They provide important information about past trading activity.
- 4.36.4 There are a few good examples of painted or stencilled house numerals in the closes.

- 4.36.5 Unusually Forres has two examples of projecting historic symbols for pharmacists' shops, of a gilded mortar and pestle, occurring within the same street block on the north side of the town's High Street.

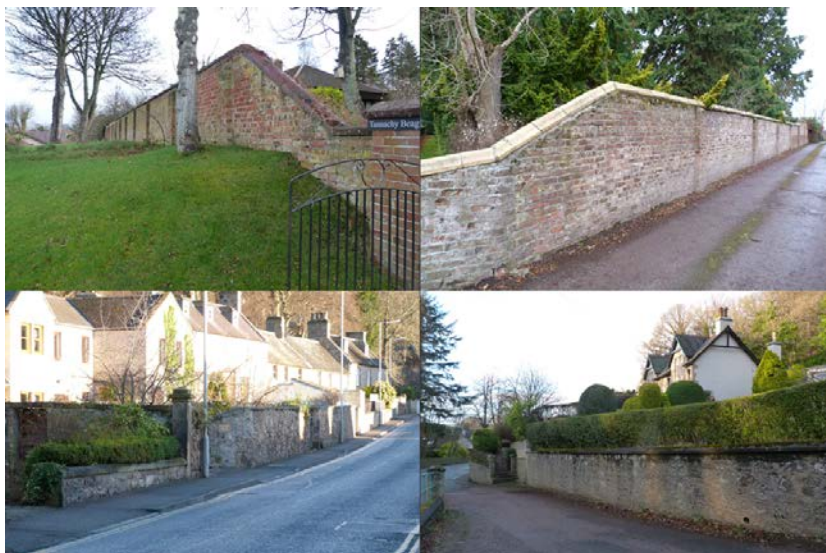
- 4.37.2 Boundary walls may assume particular importance in the backlands where defining the old burgage plots within the closes. Older boundary walls are often defined by rubble work consisting largely of field stones, of which there is also a good example at the foot of St Leonards Road. Some of the boundaries to the rear of residential properties at Victoria Road are in red brick.

- 4.37.3 Decorative gate piers are important elements defining entrances to the more important buildings of the conservation area. There are good examples of gate piers at St Leonards Church, while the late eighteenth century date piers have survived with the graveyard wall at St Laurence Church. The more important villas on Victoria Road have well defined entrances with elaborate gate piers.
- 4.37.4 The treatment of boundaries formed in the late twentieth century, for instance where the car parks have been introduced into the backland areas of the wynds and where social housing schemes have been erected is, in general, much less satisfactory. Boundaries may be defined by unfinished concrete block walls, or in timber fencing.

**Lengths of boundary walls of rubble stonework where collapsed should be preserved and repaired in matching material, or where the profile has been broken. Damaging pointing in dense cement mortar should be raked out and rubble masonry repointed in lime mortar matching historical precedent. There will be a presumption against the demolition of stone boundary walls and rebuilding them in modern materials.**

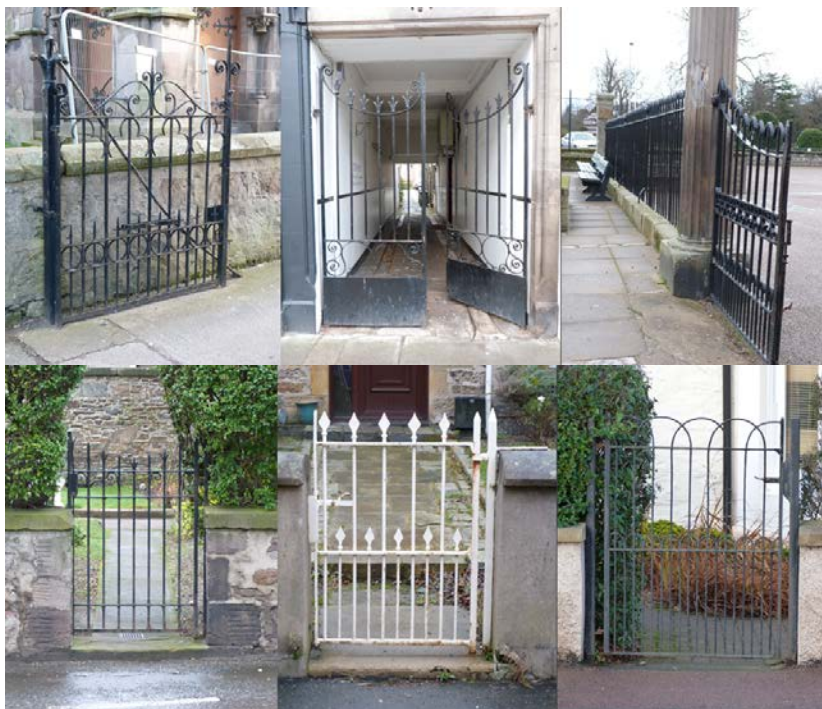
- 4.38.1 Forres has suffered from the loss of decorative cast iron railings cut down for the war effort, but examples have survived in a few of the side streets

and the wynds, some of them in a slightly damaged state. Occasionally fragments of cast iron boundary railings survive within the residential suburbs and these should always be preserved.

- 4.38.2 More than in some conservation areas good examples have survived of gate assemblies and associated railings for the town's key buildings, including Anderson's Institution, the late eighteenth century gates to St Laurence Church and the fine set of cast iron railings and gates of 1848 at the town's cemetery within the Cluny Hills. There are good freestanding cast iron lamp standards outside the entrance to the Tolbooth, and as part of the entrance assembly at St Leonard's Church. There is a small cast iron fountain at the Museum Square.

Decorative cast iron railings to buildings on street facades should always be preserved and, where damaged, should only be repaired by skilled tradesmen experienced in repairing cast iron or traditional wrought iron.

Some of the historic wrought iron gates have survived at the entries to the wynds in the town centre and should be preserved. Opportunities exist for replacing existing gates at the ends of closes with examples made by artist blacksmiths, perhaps as part of a coordinated programme of enhancement, tied in with the public realm.

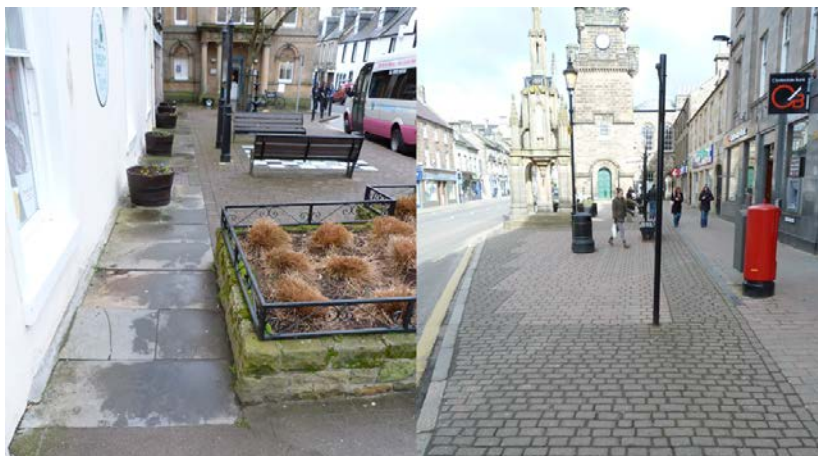
- 5.3.1 Forres in Bloom has been a long standing and highly acclaimed event throughout the town, especially within the conservation area. The programme achieves horticultural excellence while at the same time involving the whole community. During the growing season the display of bedding plants is impressive and, through the use of portable planters and hanging baskets, filters along streets and around boundaries.

- 5.3.2 However, during the winter months relatively large areas of bare earth and empty planters can be unsightly, having a detrimental effect on the character and appearance of the conservation area. During this period hanging basket poles and brackets cause unnecessary visual clutter within the streetscape and, without their purpose, can add to the clutter of the public realm.

Consideration should be given to introducing portable planters to complement a renewed suite of street furniture.

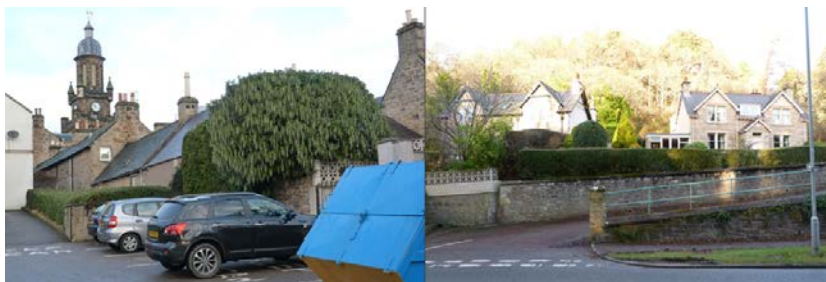
5.4.3 Through the backlands, however, and where open space is more of a premium, gardens tend to be less well cared for and in some cases become overgrown and rampant, especially during the growing season when deciduous species top up the evergreen percentage and spread. The problem becomes acute where land or buildings have been abandoned. In places where gardens or buildings were once laid out the car has moved in, typically on top of grassland and surrounded by longer grassland and wild herb species and a mixture of original and new boundary treatments. This creates a sense of neglect and carelessness, which is not commonly associated with a conservation area.

5.4.4 Private spaces within the wynds are often taken over by storage space for wheelie bins. A few hidden gems of maintained vegetation can be glimpsed through locked gates, but in general the public realm in the wynds appears dated and lacks interest, in some cases comprising poorly surfaced access routes and external storage spaces.

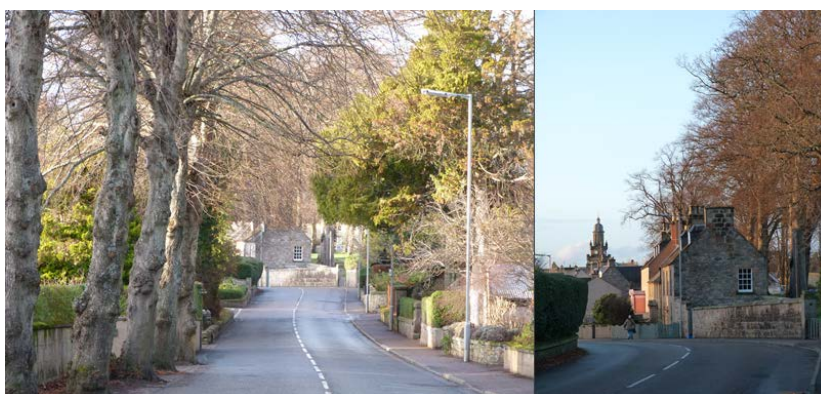
- 5.5.1 The majority of trees within the conservation area are healthy, mature and highly valued with well-lifted crowns. Impressive Lime avenues, for example within Market Green and Grant Park, date back to the 1900s and provide a great sense of history and meaning. Variety is to be found in other mature tree species within the conservation area, contributing to the softening of boundaries and integration into the wider landscape. Mature trees provide a parkland setting of considerable quality for adjoining buildings and streets.

- 5.5.2 The limited space along and within streets throughout the medieval nucleus of the town centre limits the provision of urban street trees. There is, however, one specimen of a broadleaf street, grilled and guarded, within the museum square to the rear of the Tolbooth building.

- 5.5.3 A number of young trees along the upper reaches of Mosset Burn have been allowed to generate and grow naturally with very little, if any, maintenance resulting in long grasses and herbs. This results in a 'natural' river bank unsuited to the well-manicured appearance of the rest of the conservation area, and adds to the problems of litter.

**The retention of all trees within the conservation area contributing to the setting of buildings, the wider streetscape and open spaces will be encouraged.**

**Further pruning should be undertaken to the lower trunks of mature, parkland and avenue trees, to remove sprouting shoots and tidy up the**

**open space below – the need for this was noted within Grant Park along South Street.**

**The potential for including further street trees where feasible to soften the urban fabric and strengthen the woodland setting of the conservation area should be reviewed.**

**Encourage tree work and vegetation clearance along the upper banks of Burn of Mosset within Mosset Park to improve the appearance of this attractive public park within the conservation area.**

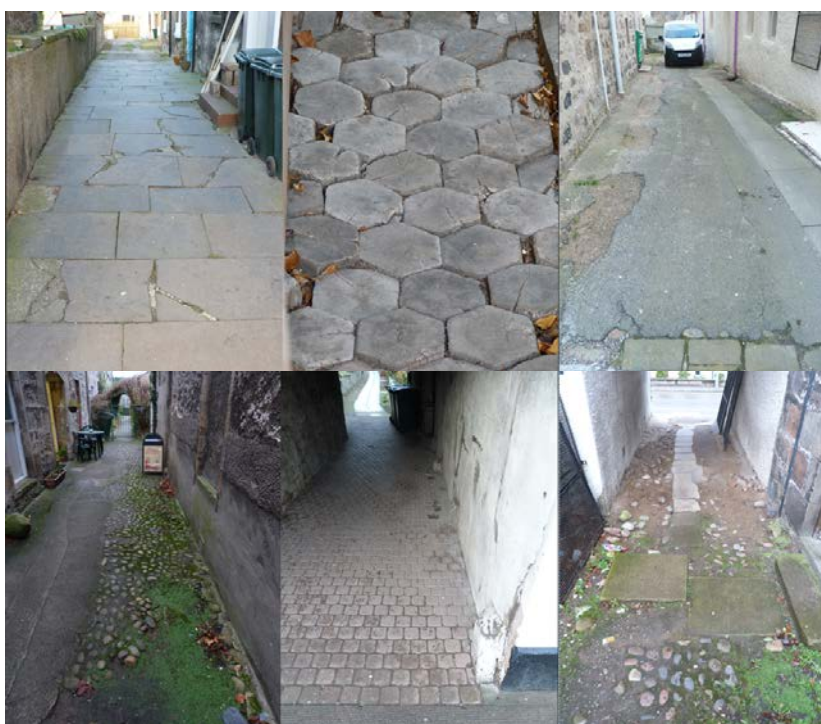
- 5.7.1 There has been an attempt to improve the public realm along the southern side of the High Street, with new paving and kerbs and the inclusion of street furniture. However, the conservation area as a whole remains tired and disjointed through the use of too many differing materials and details, and through piecemeal development. Apart from a few remaining, historic details within some of the wynds, the majority of the conservation area footways are largely utilitarian in nature comprising Council standard detailing and materials. In some instances detailing and materials might be considered better suited to private gardens rather than for use in public spaces.

There is a strong case for further investment to be made into the High Street and wynds, particularly the privately owned wynds, to improve the public realm and replace substandard pavement surfaces.

Encourage unity within and appreciation of the conservation area by formulating a robust and quality palette of appropriate hard landscaping materials and methods, paying particular attention to local detailing, from which all future landscape development can stem, thus enhancing the character and appearance of the town.

Resist development that does not conform to an approved palette of material, methods and/or standard detailing. Consideration should be given to the preparation and implementation of a Design Code.

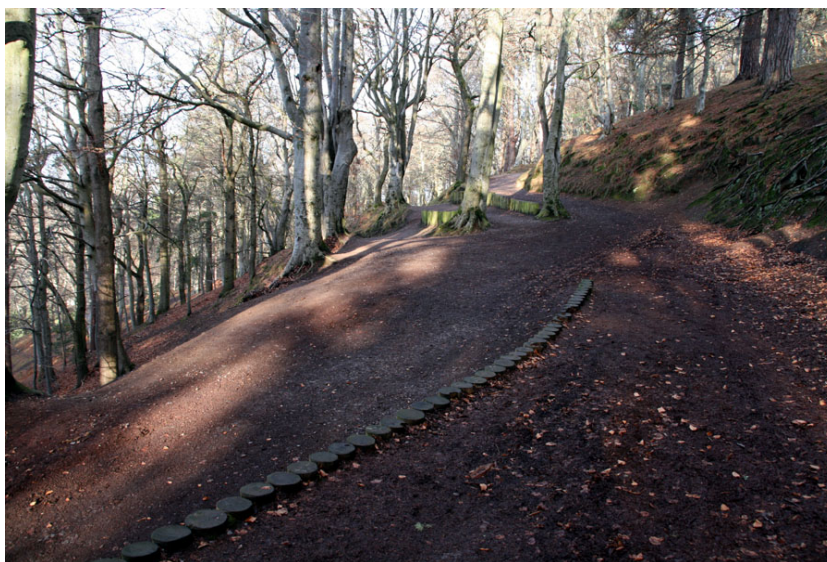
- 5.8.1 There is a vast web of footpaths linking many areas of the conservation area, many of which form part of the adopted Moray Core Path network. One footpath has been resurfaced along the western edge of Grant Park, but to maintain coherence and quality within the conservation area as a whole all footpaths should conform to the same standard. A number of them are suffering from erosion and wear.

Consider resurfacing and re-edging all self-binding gravel footpaths (including the surround to Nelson's Tower) to remove dips and hollows and enhance the overall appearance of the conservation area. The successful resurfacing of footpath FR38 along the south-western boundary of Grant Park should be noted.

Repair woodland footpaths where run-off has eroded the surface and edges, including the repair and re-establishment of log-retaining features.

Consider improving the immediate approach to Nelson's Tower, to be in keeping with the wider conservation area footpath network.

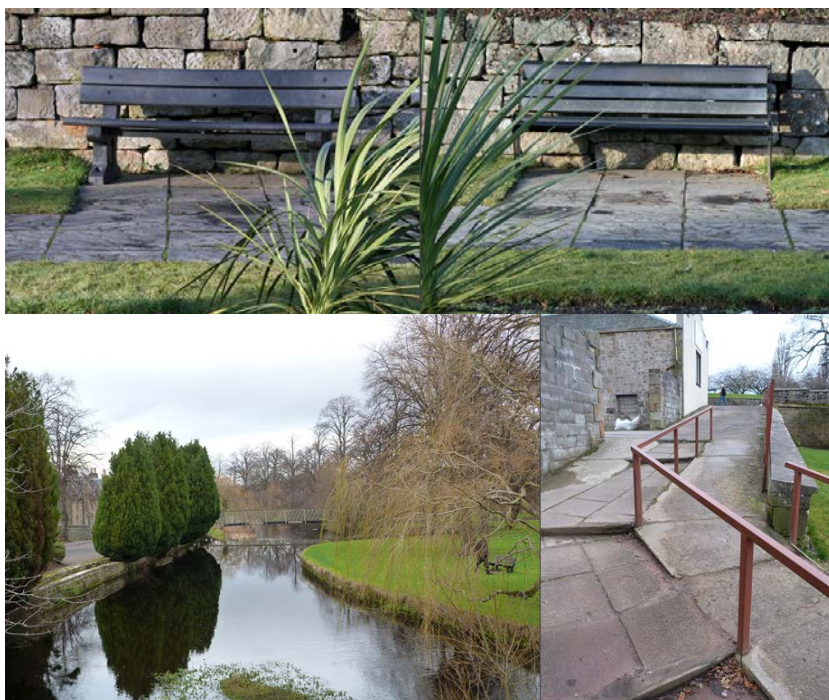
- 5.9.1 Street furniture within the conservation area is, in general, well-maintained and adequately provided for; however, a number of items are mismatched and the style and quality does not enhance or complement the character or value of the conservation area.

- 5.9.2 The extensive network of paths at the Cluny Hills lacks appropriate furniture. Seating should be located to exploit the potentially magnificent views on offer and the atmospheric shelter of mature woodland.
- 5.9.3 Mosset Park boasts a number of attractive iron lattice bridges over the burn of historic importance. However, they are suffering from peeling paint and from rust.

**Consider refurbishment of iron lattice bridges within Mosset Park – rust should be treated and the bridges repainted in matching colours having regard to historic precedent.**

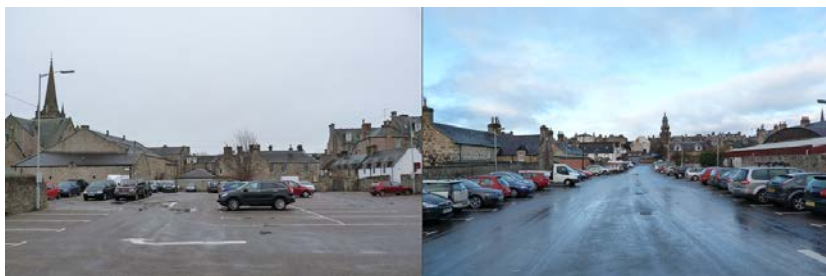
- 5.10.1 Public and private car parking within the conservation area is well provided for and makes use of the numerous open, unused spaces between buildings and boundaries. Unfortunately, there is little that is inspired about the present provision of public parking; in most cases where the edges are taken up with concrete set cobbles or open grass. Boundary treatments are typically mixed, with some in a deteriorating condition.

- 5.10.2 It is often the case that private car parking, as mentioned under 5.4 above, adopts gap sites and old disused, gardens. Along North Road, a gap site has been occupied by a set of privately owned timber and corrugated iron garages.

**The pattern of losing gap sites in the conservation area to car parking should be resisted. Encouragement should be given to establishing appropriate uses - for example, pocket parks or community gardens. Careful consideration should be given to suitable boundary treatments. All car parking areas (including privately owned areas) should be evaluated to determine whether additional space can be gained for enhancement through soft landscaping and tree planting.**

Where car parking areas are underutilised, it is recommended that soft landscaping and tree planting is considered for which a robust maintenance plan should be established. Review all boundary treatments to public car parks and seek to enhance the character and appearance of the conservation area by making improvements to schemes which appear haphazard.

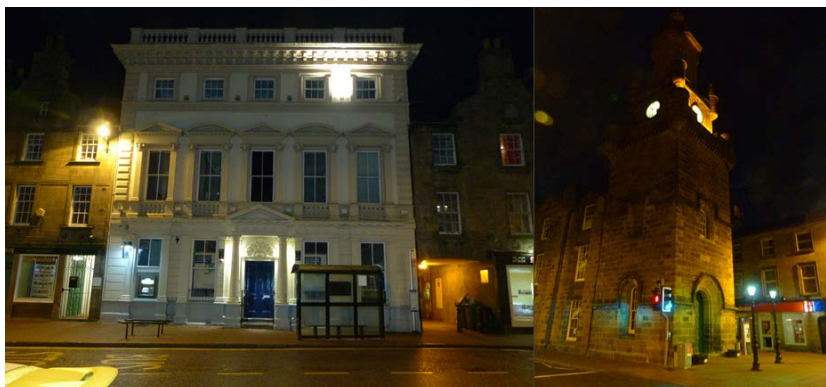
5.12.1 Night illumination of the town centre is nothing short of disappointing: many of the lighting systems already installed are either ineffective or have not been maintained. It is not uncommon to find that systems already installed are not fully utilised and the majority of the shop displays are switched off.

5.12.2 While lighting of the principal streets of the town centre is effective and carefully considered through the absence of intrusive lamp posts, for a historic burgh the wynds at night are uninteresting and lighting is often substandard. Opportunities have been identified for enhancing the conservation area through the public realm improvements.

Encouragement should be given to property owners to ensure that the benefits of night illumination of shop displays, fascias and the facades of buildings are exploited.

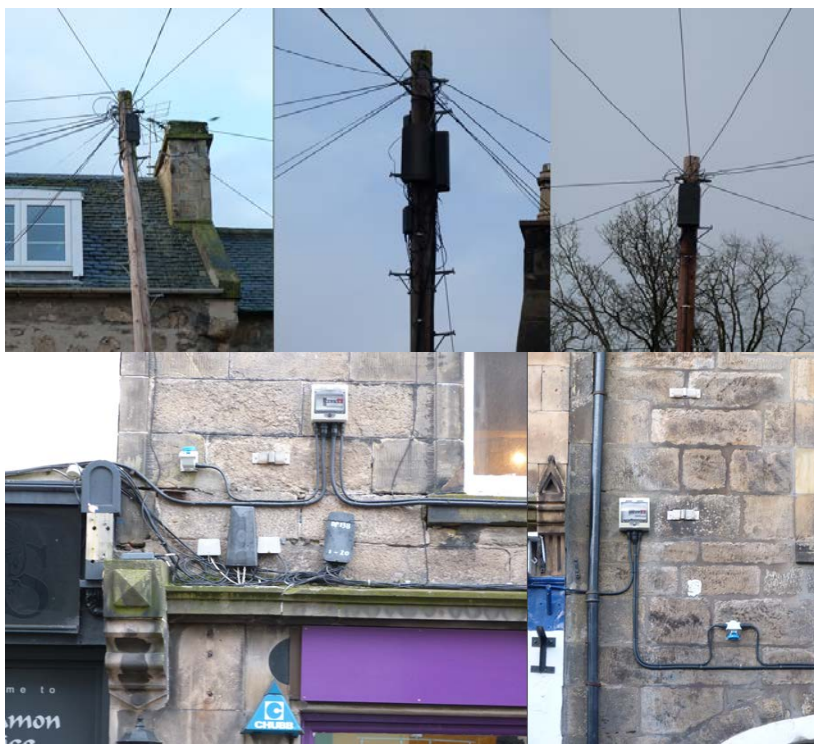
- 5.13.3 The facades of the town's buildings are littered with the evidence of cables, junction boxes and sundry fixings for housing floral displays and for supporting banners and bunting; taken collectively, these fixtures, especially when not in use, have a marked detrimental effect on the conservation area.

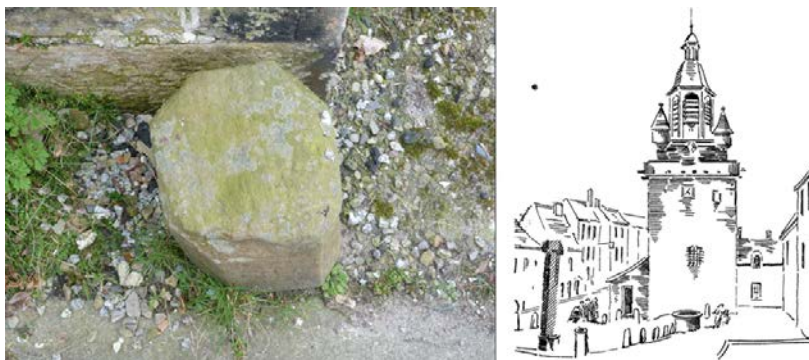
It has been postulated that this hexagonal bollard in the wynd behind 101-105 High Street could be a relic of the old Market Cross shown in the illustration on the right

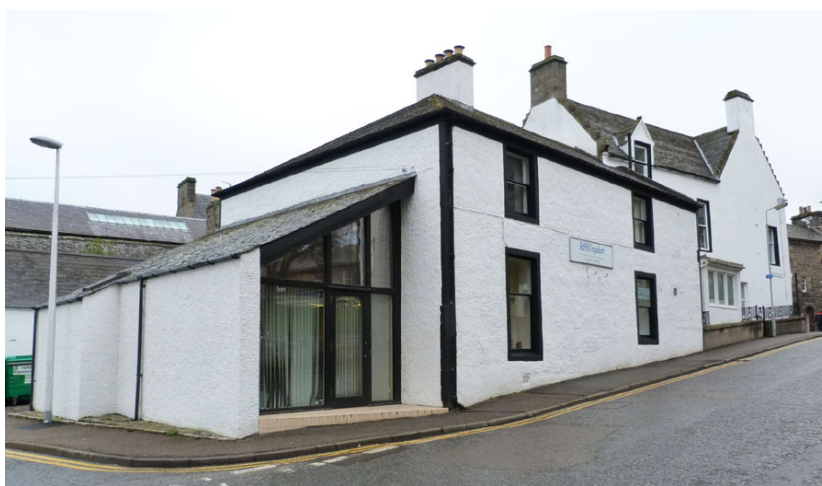
An extension to a historic building which has stood the test of time: built c1980 originally as a photographer's studio and now incorporated into the offices of a firm of solicitors

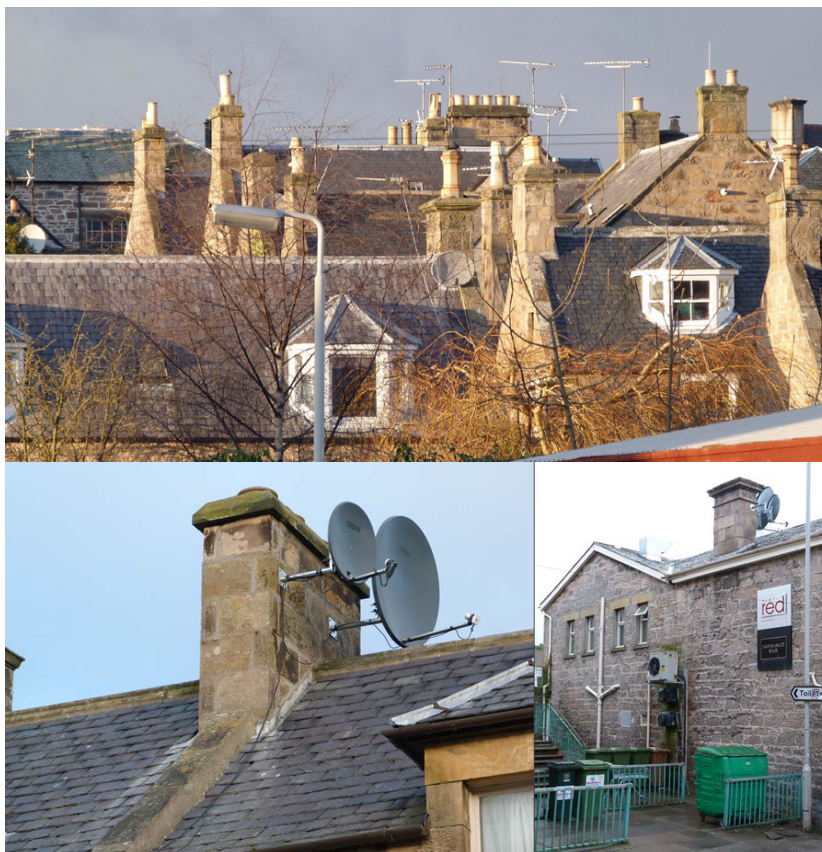
- 6.6.1 Without careful siting, satellite dishes are intrusive elements within the streetscape and their fixings and associated surface cabling can be damaging to the fabric of historic buildings. They can be particularly damaging when large numbers of these fixtures appear on the same elevation where houses may be in multiple occupancy. There will be a presumption against them being seen on any elevation visible from public streets or from within the wynds, including gables and chimneyheads.

- 6.6.2 Radio or television aerials, taken collectively with the associated brackets, poles and surface wiring, can have a disruptive effect on the character and appearance of the conservation area. They can also cause damage to the chimneyheads to which they may be fixed. Wherever possible, they should be mounted within roofspaces of buildings, or in locations where they will not be visible from public streets or wynds.

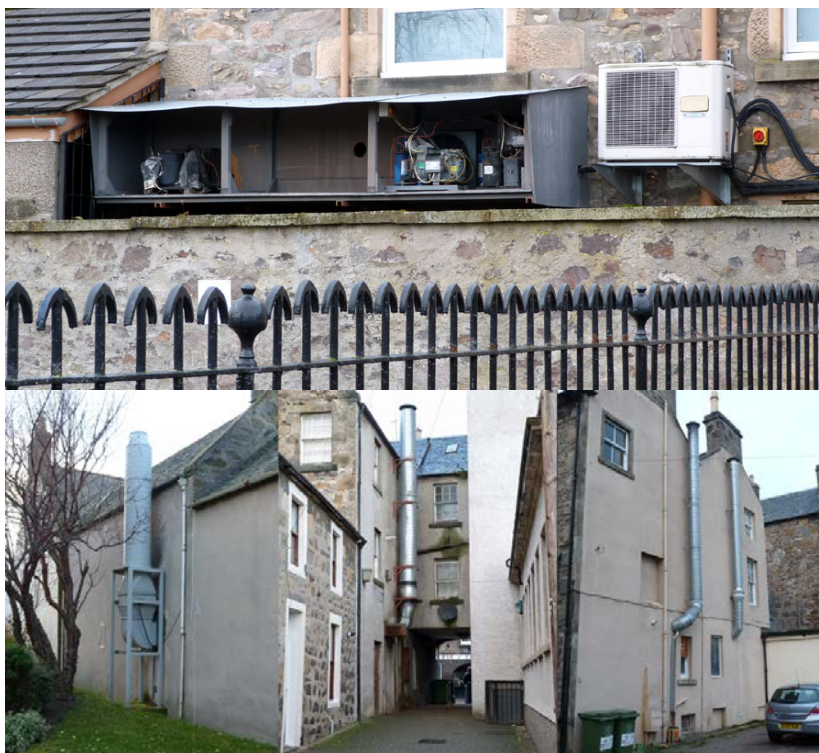
- 6.7.1 Modern developments undertaken in the conservation area have demonstrated that it is possible to disguise air handling plant and air conditioning units in such a way that the equipment is not visible from ground level. Often air conditioning units can be mounted within the reverse slopes of roofs where they will not be visible, and the impact of a heat exchanger within the entrance to a pend will be less than if it were to be fixed to the surface of the building. These issues can, however, be more difficult to resolve with older buildings. Where heat exchanger units appear on external walls, or where air extractor units have been fitted to the sashes of windows, the visual impact is always high. The appearance of pitched roofs can be damaged by poorly sited extractor fan terminals, especially where commercial in scale and oversized.

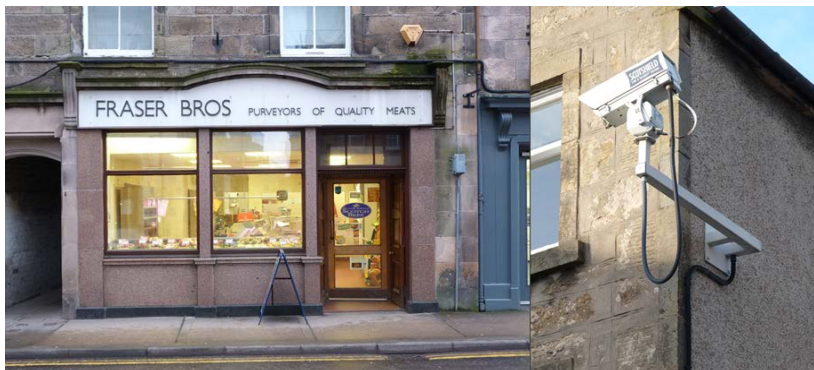
- 6.8.1 Security alarm sounders may require to be positioned where they are obvious to intruders as a deterrent to entering the premises, and for surveillance in identifying the possibility of forced entry. Invariably the boxes are brightly coloured, and positioned without regard to the architectural features of the building. Redundant alarm boxes are unsightly and should always be removed.

- 6.8.2 There are numerous examples of badly sited security alarm boxes in the conservation area. Consideration should always be given to mounting security alarms on elevations other than the principal street elevation where this is possible, or on overhanging eaves. If this is not possible the unit should be mounted having regard to the architectural features of the façade, for instance, centred on gables at high level or aligned with shop fascia boards. Units should be restrained in appearance and should not be brightly coloured. Wiring or conduits for cables should never be visible.

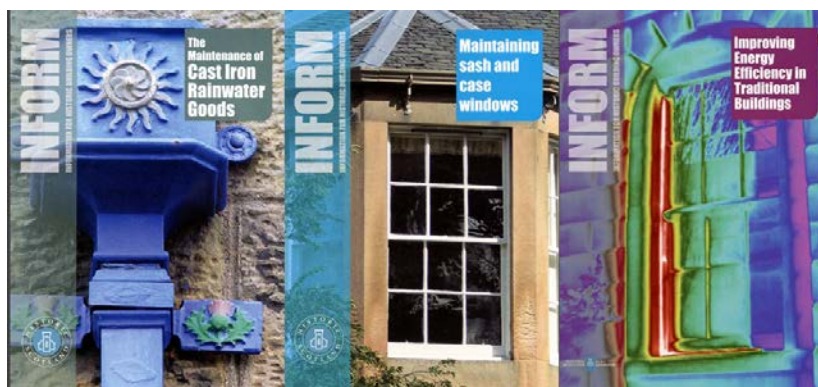
INFORM guides published by Historic Scotland
