Elgin High Street Conservation Area

Part I: Conservation Area Appraisal

February 2012

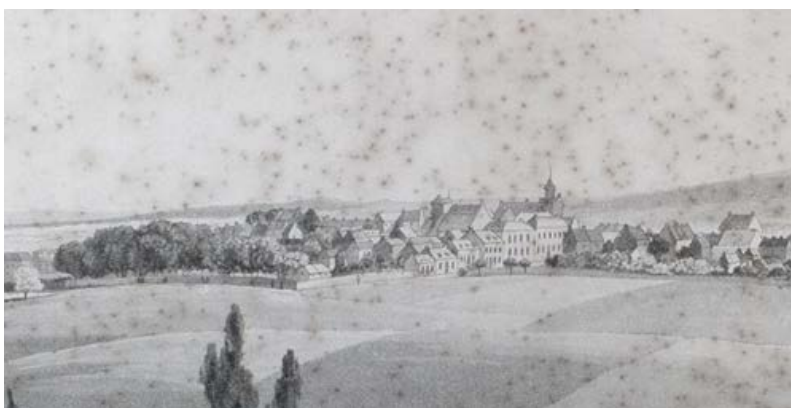
Detail from Clarke's view shows the profiles of the old Tolbooth and old St Giles Parish Church before the major improvements which took place from the 1820s

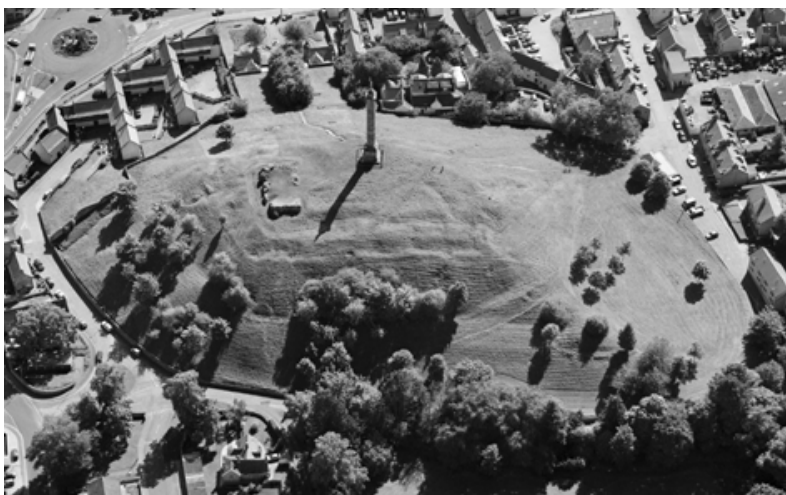
This aerial photograph shows clearly the extent of the structures of the royal castle erected on the motte and the foreworks to the north and west © Crown Copyright RCAHMS, licensor rcahms.gov.uk

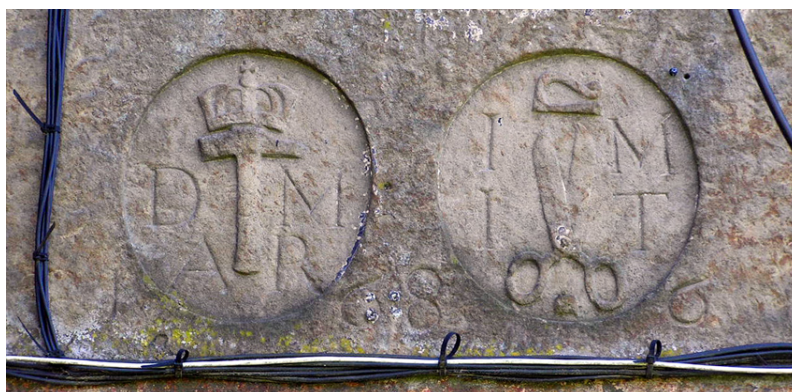
Symbols of the guildry: a reused stone lintol carrying the date 1686 appearing in one of the closes at the west end; the stone is mutilated by surface cabling

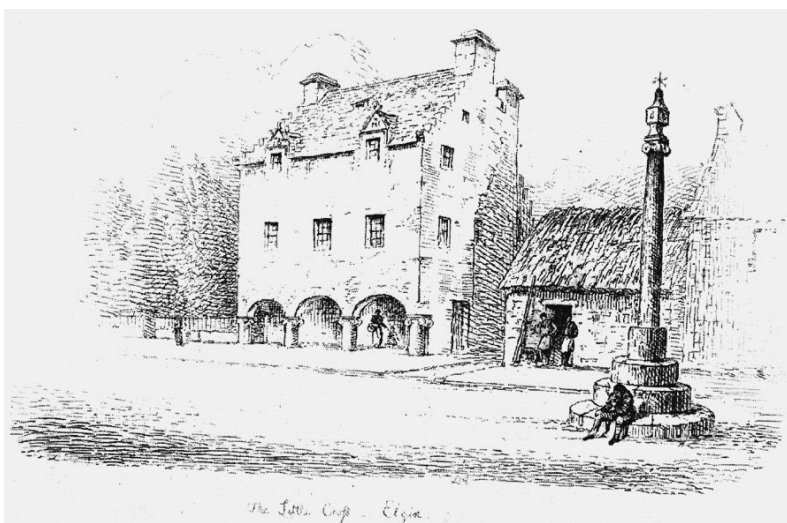
D Alexander's sketch of the fifteenth century Little Cross (1838) shows Braco's Banking House, one of three surviving merchants' houses built with piazzas; all traces of thatched cottages of the type shown in the illustration seemed to have disappeared from the city centre by the end of the nineteenth century. The arcade had been filled in later in the century, but was restored to its original state by the early twentieth century

- 3.3.2 The rapacious William Duff of Dipple and Braco capitalised on the buoyancy of Elgin's trade at the beginning of the eighteenth century when he set up his banking house in the merchant's dwelling built by John Duncan and Margaret Innes in 1694 near to the Little Cross,

known now as Braco's House. Operating from Elgin as a merchant and money-lender across the North of Scotland he became one of the wealthiest men of the time, laying the foundations of the wealth of the Earls of Fife, a family which enjoyed a long association with Elgin.

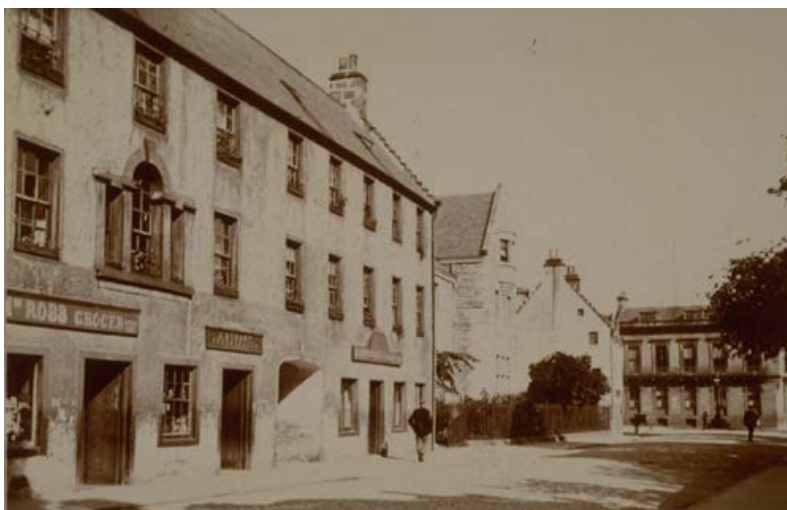
A Valentine image, c1920, shows the building at 15-25 High Street of 1728 in close to its original state, with early shopfronts and harled walls. The shopfronts were enlarged in the interwar years, and then in 1971 the ground floor was given a range of arches, the fenestration was changed and the harling removed, changing its appearance and character © University of St Andrews Special Collections

- 3.3.6 The rate of building slowed down during the eighteenth century, if not quite to a standstill. From the first half of the eighteenth century the most significant buildings are to be found at 15-25 High Street and although they have been heavily restored in the late twentieth century

the tall roofs with crowstepped gables and the primitive Venetian window mark them apart. There are old dwellings on the west side of Braco's Close, and some of the former dwellings of Harrow's Inn Close, closest to the High Street, are likely to date to around the mid-century, but could be earlier.

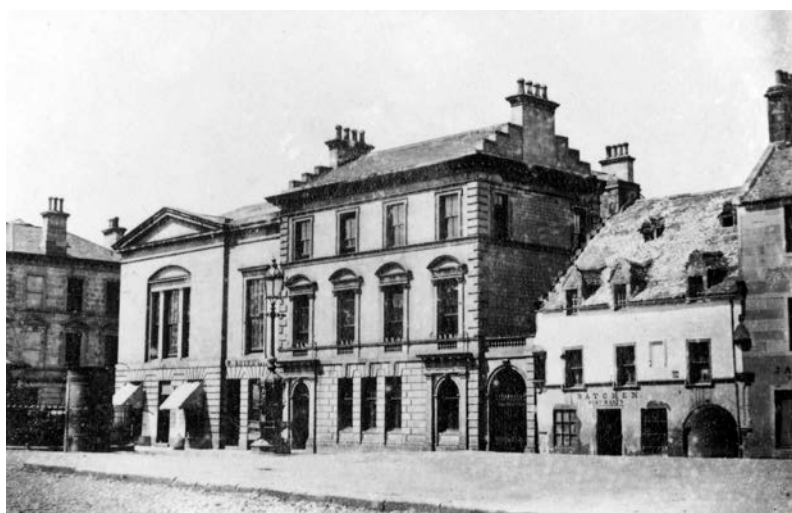
This early photograph shows William Burn's Assembly Rooms (1822) and a fine Italianate bank of 1857, swept away in the late twentieth century orgy of redevelopment which afflicted the city, while the venerable building of the early seventeenth century where Batchen had his shoemaker's business was replaced around 1880 by Alexander Marshall Mackenzie's building at 147-149 High Street © The Moray Society

- 3.4.3 The insertion of Batchen Street into the city fabric increased pressure on the cross-city circulation, necessitating the widening of North Street in 1822. Although this saw the loss of yet another venerable building – on this site had once stood Calder House of 1634 – the streetscape gained a distinguished new classical building in the form of the Assembly Rooms by William Burn. Ironically it was to fall, for exactly the same reason, in 1970.

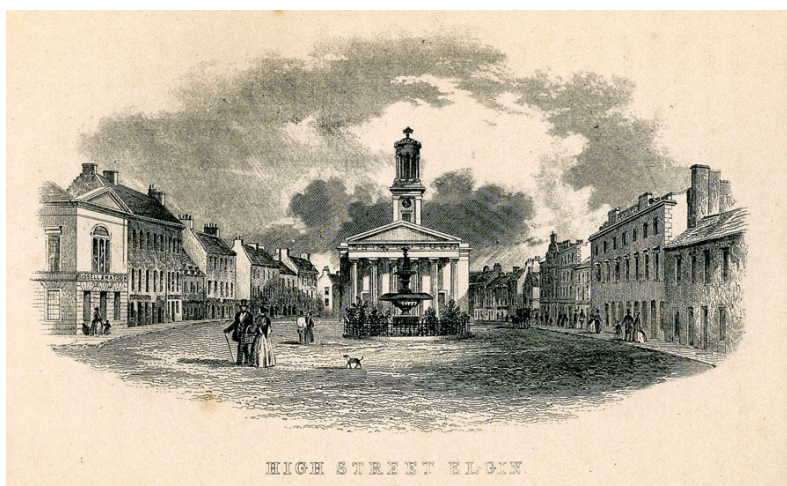
St Giles Church, by Archibald Simpson, dominates Elgin's skyline and the Plainstones, seen here (1868) with the fountain designed by Thomas Mackenzie

- 3.4.6 Opinion seemed to be equally divided over the merit of Simpson's chaste and beautiful temple – now regarded as one of the finest neoclassical buildings in Scotland. The highly distinguished Highland engineer and Forres loon, Joseph Mitchell, tore into the young architect, berating him for his design 'said to be Grecian, but really of no character'. A gazetteer of Scotland published mid-century summed up the debate with 'though it may be said that a new town has sprung up, but the old has, in a measure, cast its skin....'. Robert Billings had already commented in the mid-1840s 'Few places impress, in what remains, a deep regret for what has gone'.

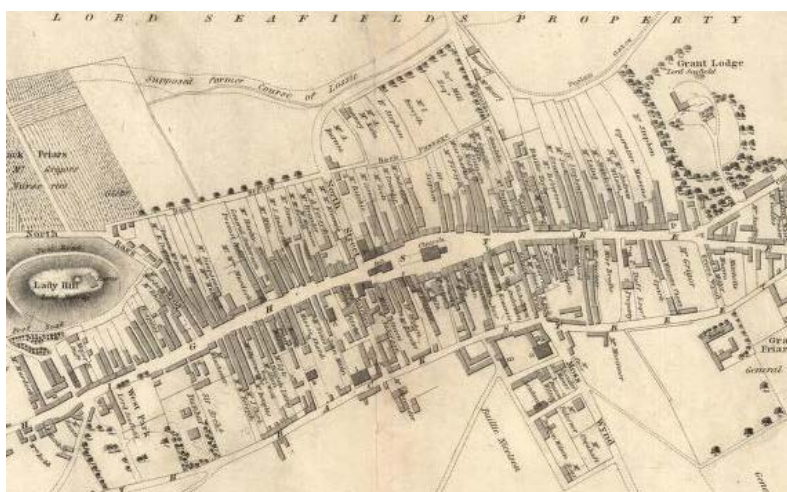
John Wood's map of Elgin (1822) (upper) and Robert Ray's map of Elgin (1838) © both National Library of Scotland

- 3.4.9 Subtle changes in the townscape can be seen by comparing Wood's map of 1822 with Ray's of 1838 (previous page). While superficially they may seem similar, the changes to the principal thoroughfares are instructive, not least to the degree that they indicate the constraints imposed on the townscape by these older buildings. Already it can be seen that the burgh was expanding southwards on the sunnier slopes following the line of the trunk road leading into the city from Rothes. By 1835 it was being said that the south side was preferred for building, and in 1868 J&W Watson would state in *Morayshire Described* that the High Street was being 'forsaken by the well-to-do merchants and the wealthier class of tradesmen' for the suburbs.

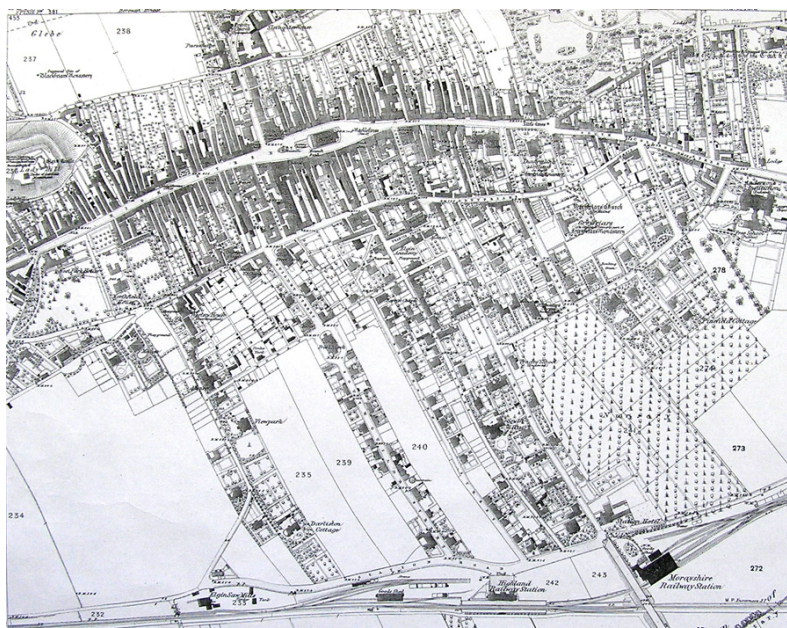
The Ordnance Survey map of 1868 shows the extent to which the town had extended southwards to meet the railways © National Library of Scotland

- 3.4.15 The Ordnance Survey map of 1868 (following page) shows the extent to which the city had expanded, mainly towards the south where some of the suburbs had been laid out. All the street blocks which are closest to what is the present south boundary of the High Street conservation area had been laid down by this time, with a reasonable density of development having been achieved.

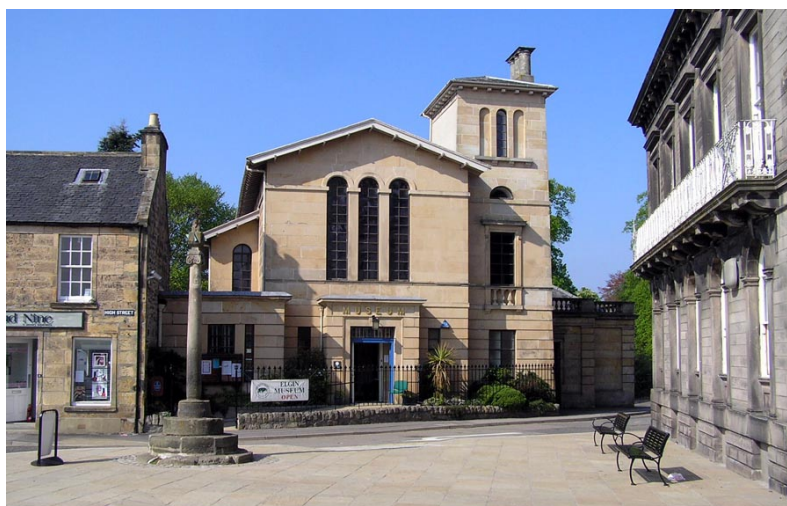
The Little Cross and Thomas Mackenzie's Elgin Museum (1843)

fine courthouse (completed 1841) by Elgin's first architect of note, William Robertson, followed by the Elgin Museum (completed 1843, architect Thomas Mackenzie). The brainchild of the energetic Elgin and Morayshire Scientific Society founded in 1836, it would have been the first private museum in Scotland to open its doors had the museum at Montrose not opened fractionally sooner. A&W Reids' fine sheriff court of 1864-6 sat next to their uncle's earlier building, once more a finely wrought essay in classicism.

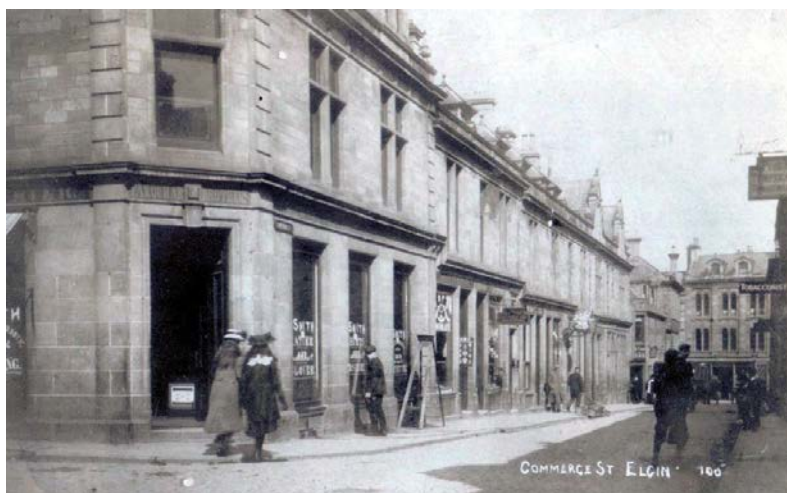
Commerce Street, around the turn of the twentieth century © The Moray Society

- 3.4.17 Commerce Street was the next street to be superimposed on the medieval layout, replacing the old School Wynd. It was devised in the late 1850s so as to establish a more suitable direct route into the city centre from the railway stations. As its name suggests, it provided further opportunities for retail development at the corner with the High Street, and along the length of the street, although some of the frontages were not developed until later in the century. A bank and the Elgin Club of 1869 were built here, both distinguished buildings in the continuing classical style by A&W Reid.

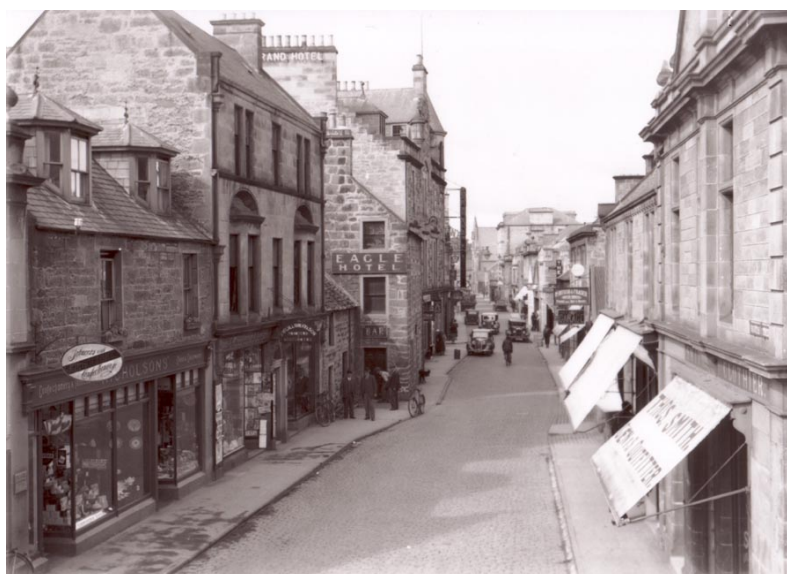
South Street in the mid-1930s, before the Argyle Buildings were erected in 1937 on the site of the Eagle Hotel © The Moray Society

- 3.4.18 As the century progressed, South Street assumed increasing importance as a retail thoroughfare from its earlier role of accommodating the stabling to the principal hotels of the High Street. The market hall was accommodated here mid-century, to which the fine vaulted arcade at Newmarket Close gave direct access from the High Street. Hotels remained a part of the street scene, mainly at the eastern end of the street, where they were closer to the point where visitors to the city would arrive from the railway station. The appropriately named Grand Hotel by Reid & Wittet (1898) incorporates fine carved detail and stained glass. The 1868 map (page 23) indicates the extent to which development of the sites had been sporadic, and many of the backland sites to the High Street were not to be developed until the interwar years of the twentieth century.

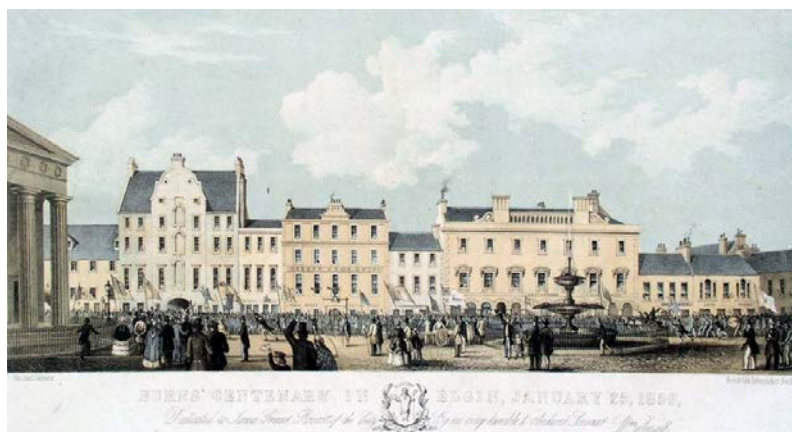
The south side of the High Street at the Plainstones in 1852 shows James Grant's house of 1776 - the tallest at that time - and the arcaded ground storey giving access to the Newmarket; the building with the Venetian windows at the corner of Batchen Street stood until the late twentieth century © The Moray Society

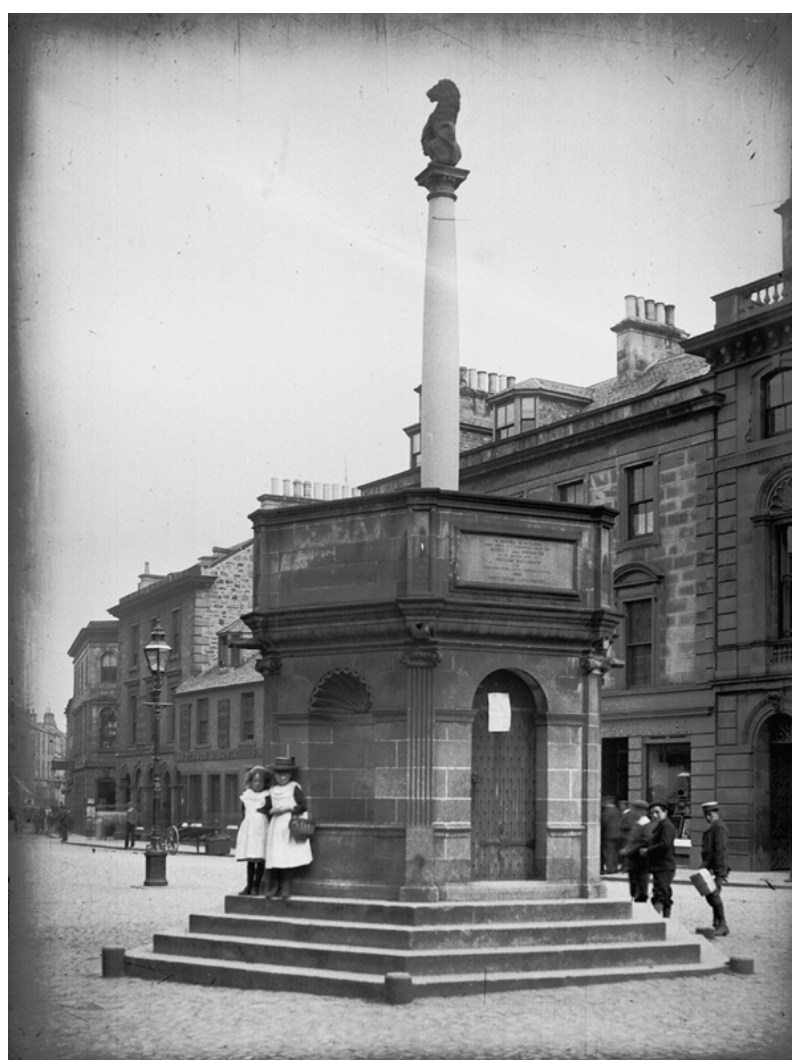
Sydney Mitchell's reconstruction of the Muckle Cross, dismantled in 1792, shortly after completion in 1888 © RCAHMS, Licensor www.rcahms.gov.uk

- 3.4.20 After Thomas Mackenzie's elegant fountain had been erected on the site of the old tolbooth (1845), the public realm continued to improve. In 1888 the Edinburgh architect Sydney Mitchell was called upon to resurrect the design of the Muckle Cross on its original site to the rear of St Giles Church, from which the original had been removed, without sentimentality, in 1792 with the other street improvements.

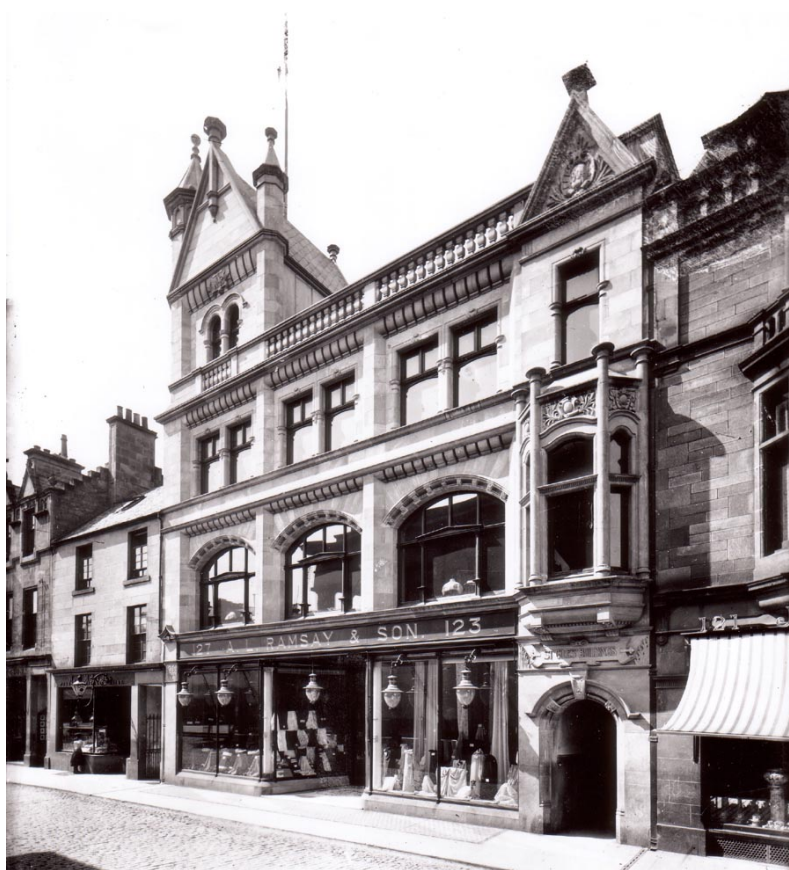
Ramsays' store, the photograph taken shortly after opening in 1904, is now part of the St Giles Shopping Centre. This impressive frontage was extended to the west, for which the three storey building was demolished. The stone carvings around the large window openings of the extension were never completed. The store became Benzie & Miller, and was latterly Arnotts', part of the House of Fraser dynasty © The Moray Society

- 3.4.21 Retailing dominated the streetscape of the principal thoroughfares of the city, with many good shopfronts introduced, most of them cast iron, springing up in large numbers everywhere after 1875. As the new century dawned the redevelopment of sites across the city centre continued unabated, and several buildings display datestones from this era, the last of them 1916 at the Union Buildings at the head of Lossie Wynd. Two distinguished retail facades were added during the first decade of the twentieth century heralding a new direction in their scale and ambition. They dominate the north street frontages of the High Street of the city centre, and of the two, the store built for Ramsays the drapers in two phases, one of them dated 1904, is now the tallest building on the High Street, assumed into the St Giles Centre modern shopping complex.

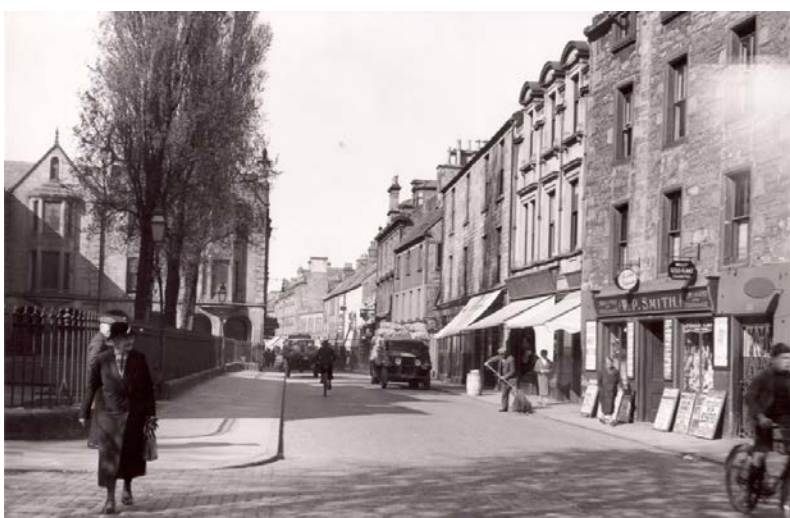
East end of the High Street looking towards the city centre, before the erection of the County Buildings in 1937 © The Moray Society

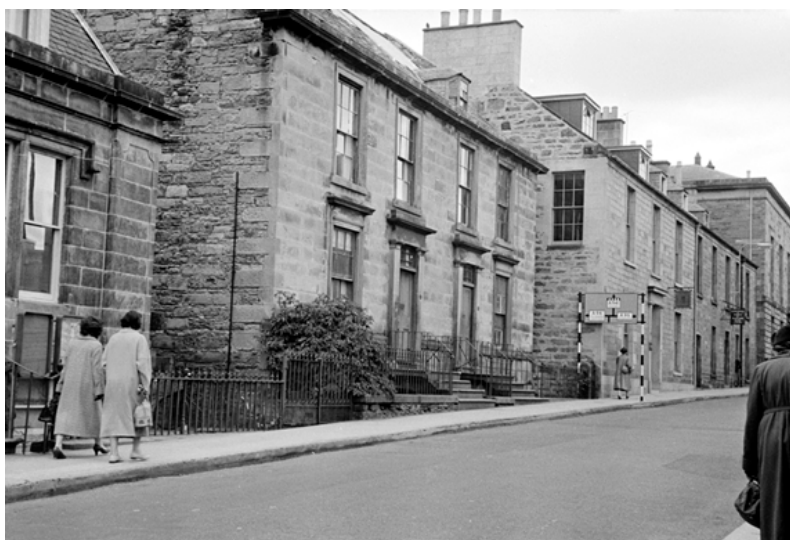
The destruction of North Street, seen here in the 1950s: the Assembly Rooms at the head of the street were demolished in 1970, while the houses on the left had disappeared for the building of Elgin's relief by the end of the decade. The buildings adjacent to the Assembly Rooms have survived, and are in use as solicitors' offices.
© Crown Copyright: RCAHMS Licensor, rcahms.gov.uk

- 3.5.9 In 1970 the fine Assembly Rooms, and the good bank building of 1857 adjacent to it (see page 21), fell prey to the redevelopment of the High Street frontages following the widening of North Street some years before work on the relief road was begun. The damage to one of Elgin's more pleasant streets was compounded by the featureless modern extension to Woolworth's store on the opposite side of the

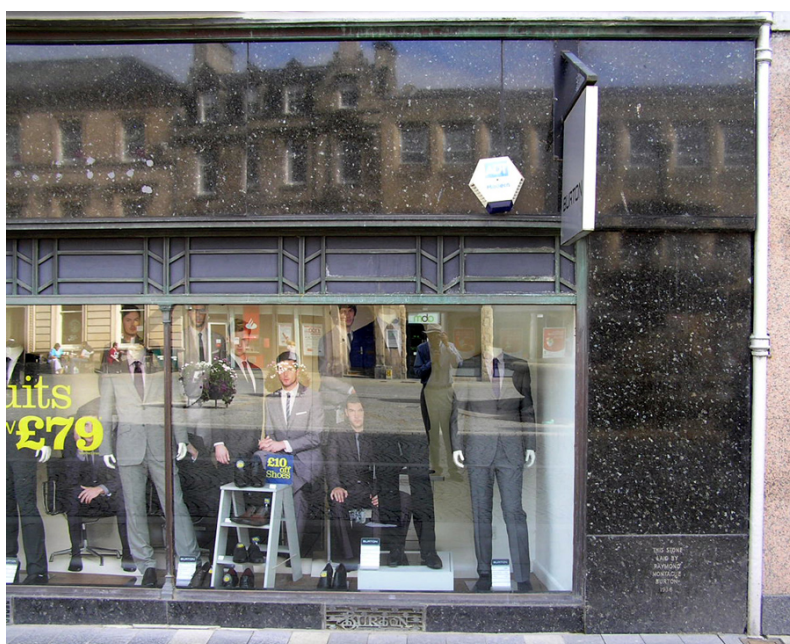
Burton's shopfront retains its bronze shopfront of 1936 with the chevron window pattern characteristic of the time; it also features two inscriptions recording the opening of the store by members of the Burton family

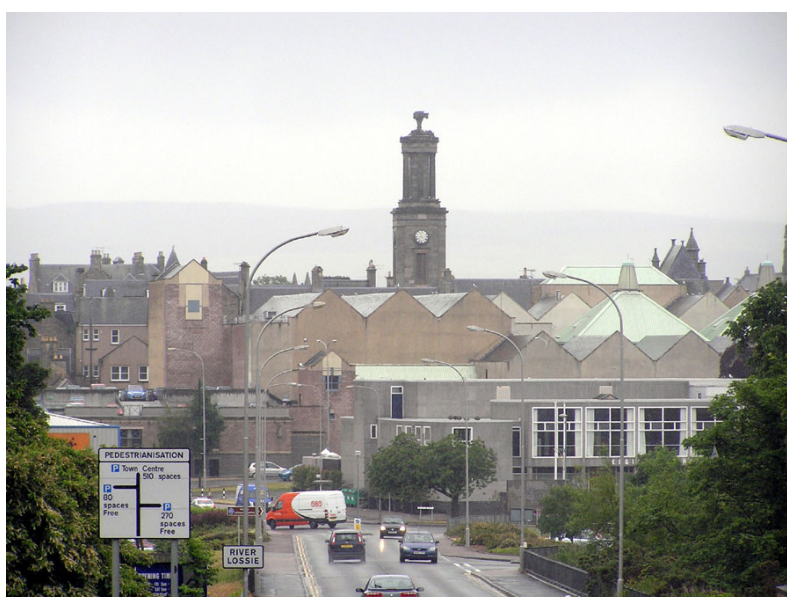
The St Giles Centre shopping development seen from Bishopmill; the Town Hall is in the foreground

- 3.5.15 The need to underpin city centre retail activity saw the comprehensive redevelopment of sites to the north of St Giles with the demise of the Arnotts department store in the mid-1990s. To a certain degree this had been facilitated by the proximity of the relief road. The scheme allowed for the relocation of the bus station. The facades of older buildings were retained to minimise the impact on the historic townscape. Although the scheme was a large one, its bulk was broken down convincingly in the blind gabled elevations facing north, and the overall heights were deferential to the tallest of the structures on the High Street. There are, however, local problems of scale, and walking around the edges of the development where the walls are unrelieved by openings is an unpleasant experience for pedestrians.

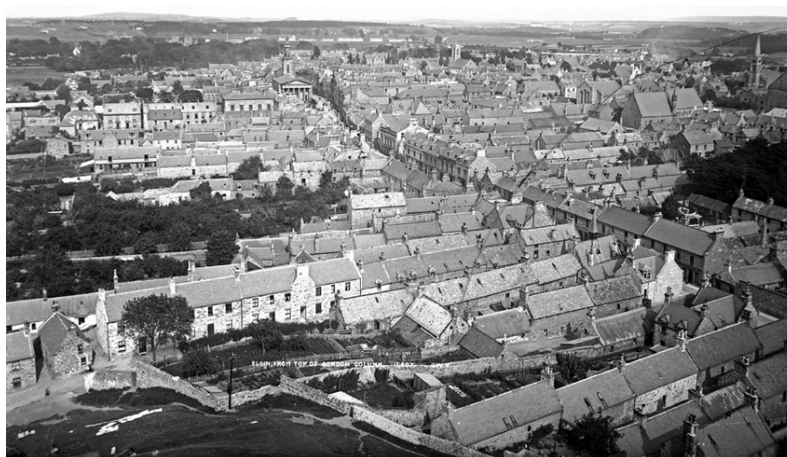
George Washington Wilson's remarkable glass plate photograph of the 1870s taken from the top of the Gordon column at Ladyhill shows clearly the medieval layout of the burgh and the extent to which gardens and greenery infiltrated the closes to the north of the High Street © University of Aberdeen Special Collections

The Elgin High Street Conservation Area viewed from Ladyhill – the view should be compared with the historic image on page 36

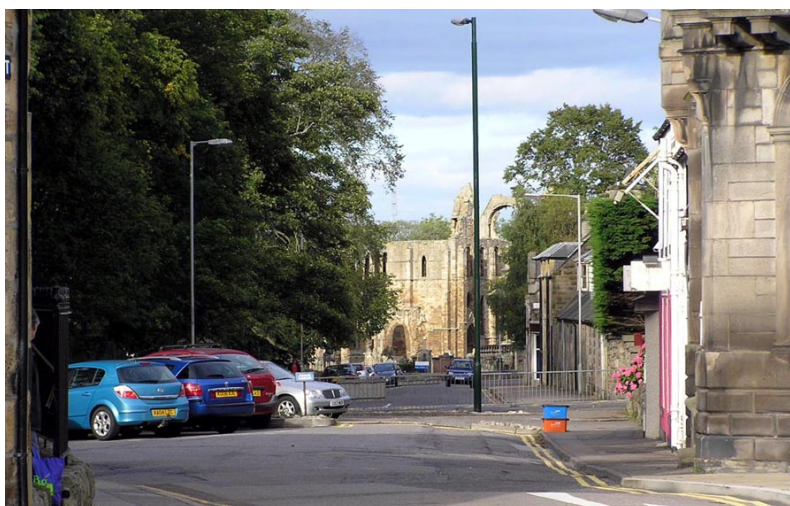
Framed view of the cathedral along North College Street, with which there is no longer any direct physical connection due to the relief road (compare with below): the prospect would be improved by relocating the green lamp standard even if nothing else were to be considered

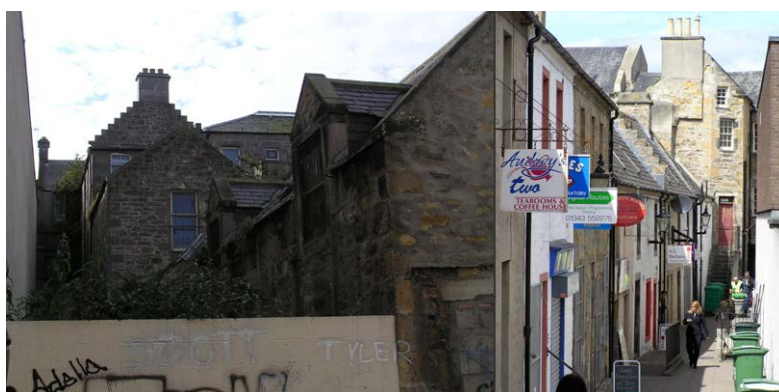
Access to the High Street has been blocked off at both ends of the close shown on the left, adjacent to St Giles Centre; Harrow's Inn Close is shown on the right

- 4.2.3 Activity in the closes is variable. Often closes with no active frontages in the long line of buildings will be used on grounds of convenience if on a shortcut to the High Street, but too many of the closes are underused and their potential left unrealised. Among the most successful of the closes is Harrow's Inn Close which houses a range of early eighteenth century buildings: although entered by a narrow pend from the High Street, and affected by a blind wall from the adjoining unattractive modern development along part of its length, historic building frontages and active retail and business units give it life and vitality. It is also wider than most of the closes of the city centre.

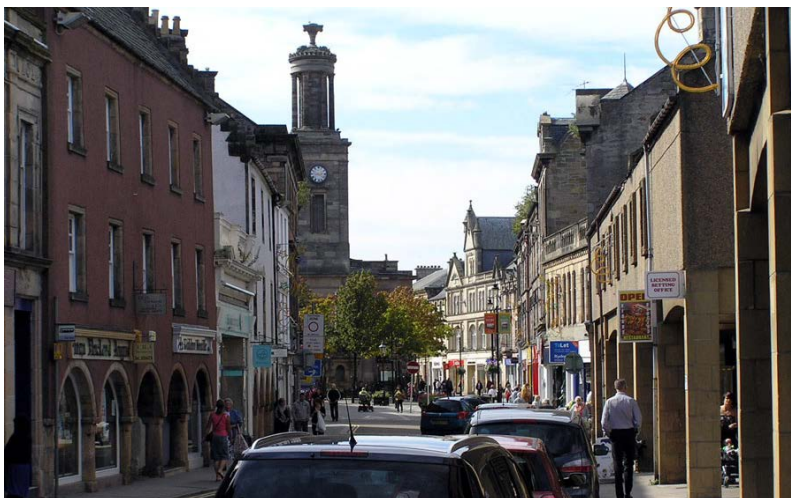
The merchants' houses with the piazas on the left contribute to a historic townscape of great interest

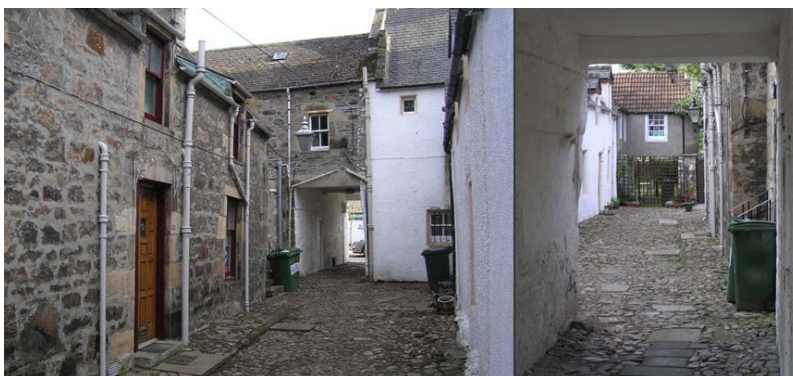
Braco's Close, at the east end of the High Street

Braco's Close at the east end of the High Street is a rare survival which, remarkably, has retained its historic buildings and, at the same time, preserving early cobbled surfaces.

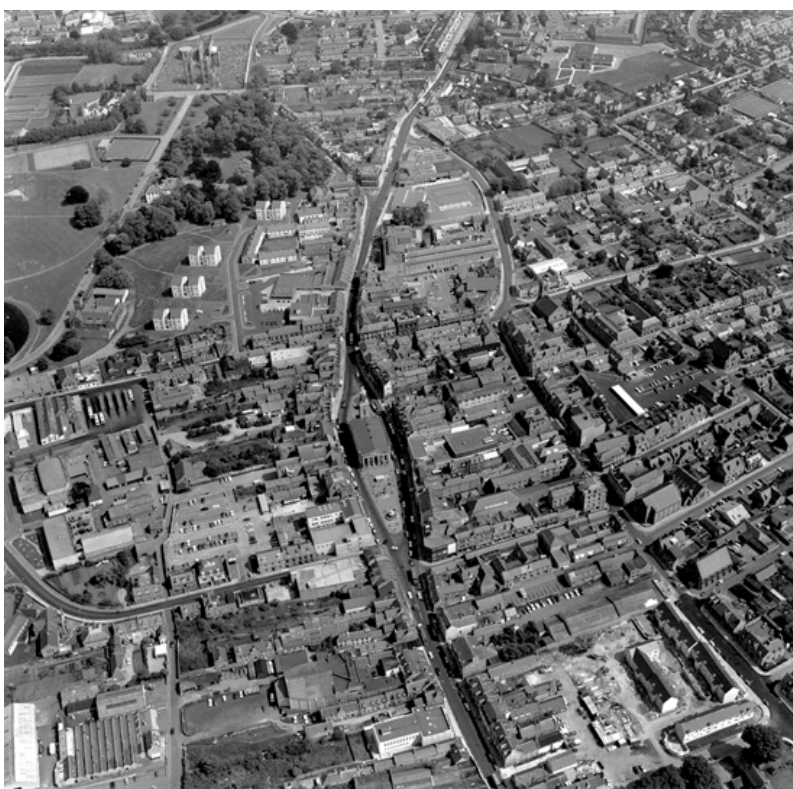
Aerial view of the conservation area (1975) before the relief road was inserted to the north © RCAHMS (John Dewar Collection), Licensor www.rcahms.gov.uk

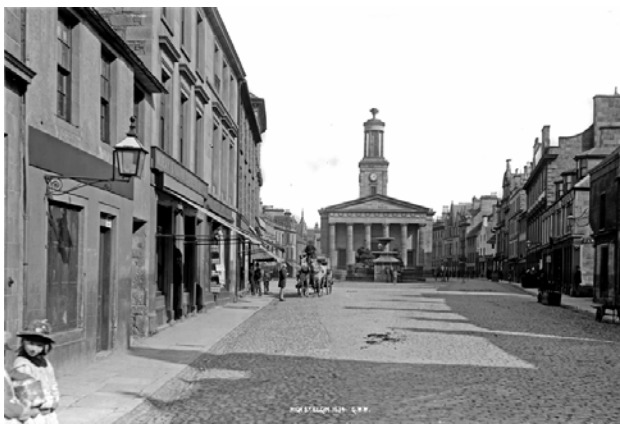
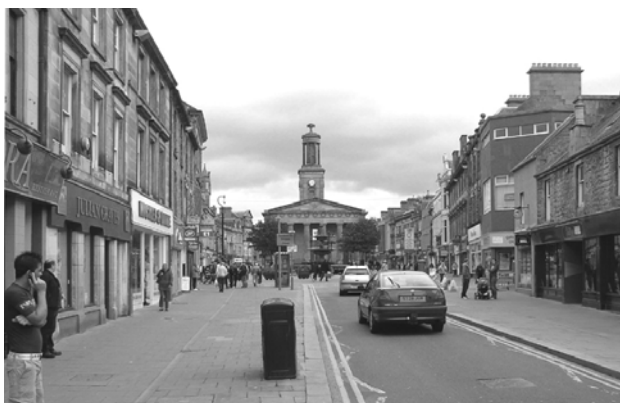
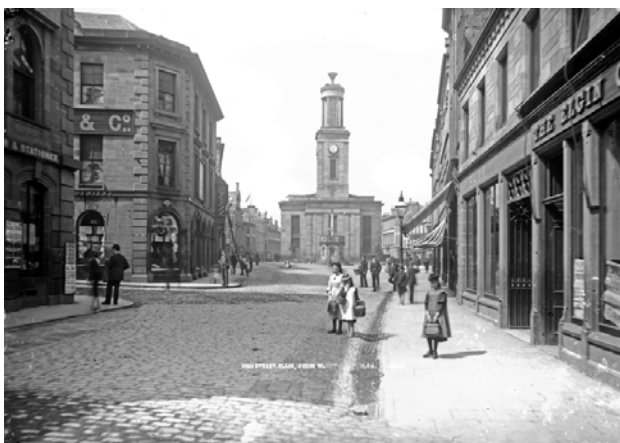
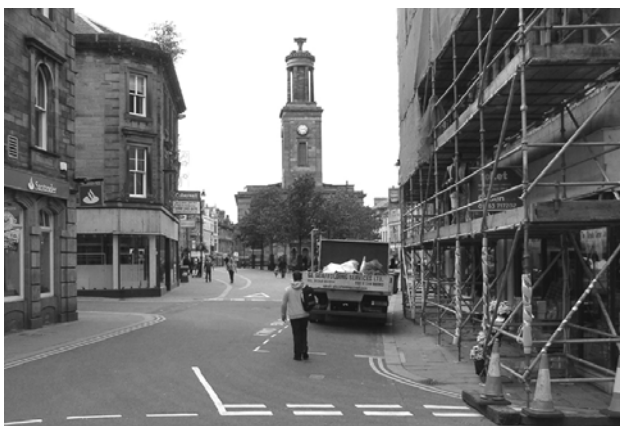
Comparison between George Washington Wilson images of the 1870s and 1880s with contemporary images of the same scenes (1)

- 4.5.4 With the possible exception of the view towards St Giles from the east, the photographs confirm McKean's thesis regarding the generally damaging effect of modern development. The loss of historic buildings of such considerable distinction, one of them being the Assembly Rooms (most probably by William Burn) - for the widening of North Street - has been particularly regrettable as has been noted already. Despite the mediocrity of the structures that replaced them, at least it might be said of them that they retained a sense of the rhythm of the streetscape from using vertical elements in the design. Sadly this cannot be said of the prominent corner building that replaced the *douce* early nineteenth century two storey building with twin Venetian windows at the junction between the High Street and Batchen Street.

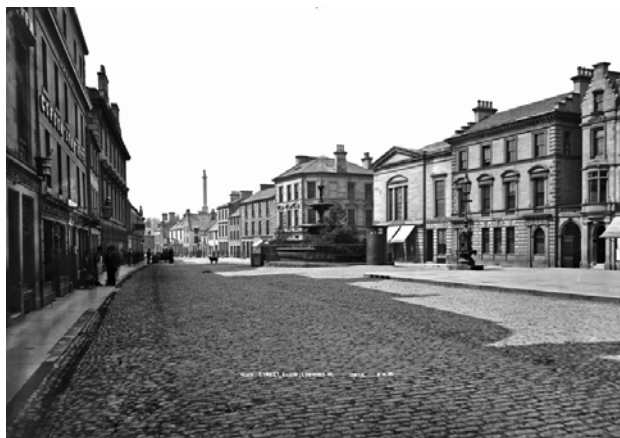
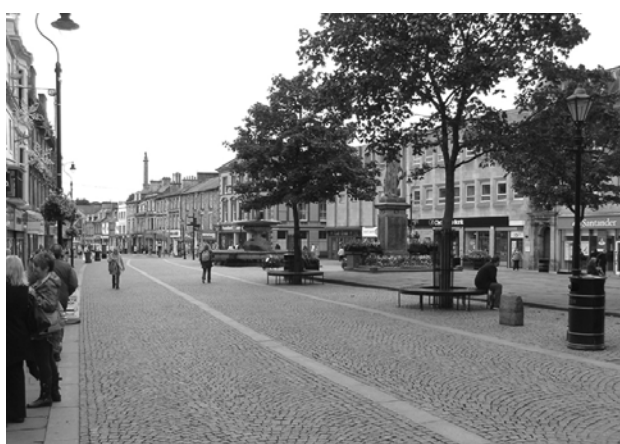
Comparison between George Washington Wilson images of the 1870s and 1880s with contemporary images of the same scenes (2)
All historic images © University of Aberdeen Special Collections

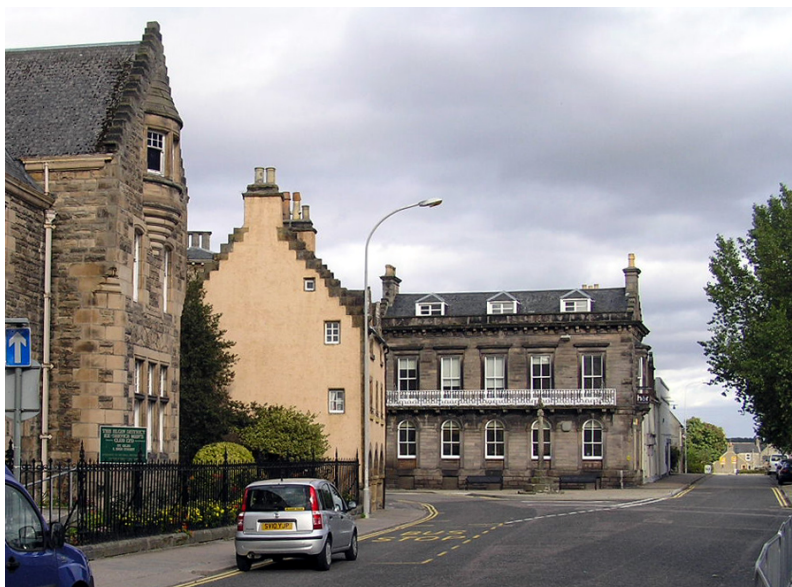
The building aligned north-south at the east end of the High Street provides an effective stop where the road forks left in the direction of the cathedral, and the setting for the Little Cross

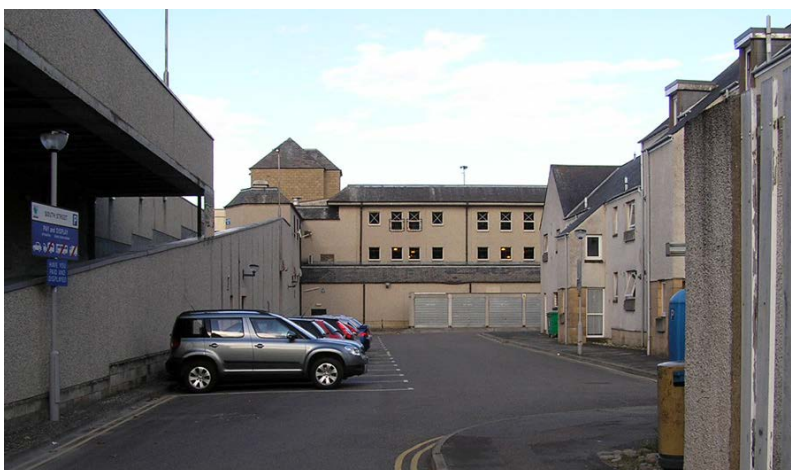
The development built originally for William Low has in some respects had a negative impact on the conservation area

- 4.8.4 To the immediate south of the High Street the old closes have been curtailed in length from modern development, carried out in two separate phases, the first of which was the social housing development around which the multi-storey supermarket and car park, built originally for William Low, was later erected. It has damaged the setting of the earlier scheme.

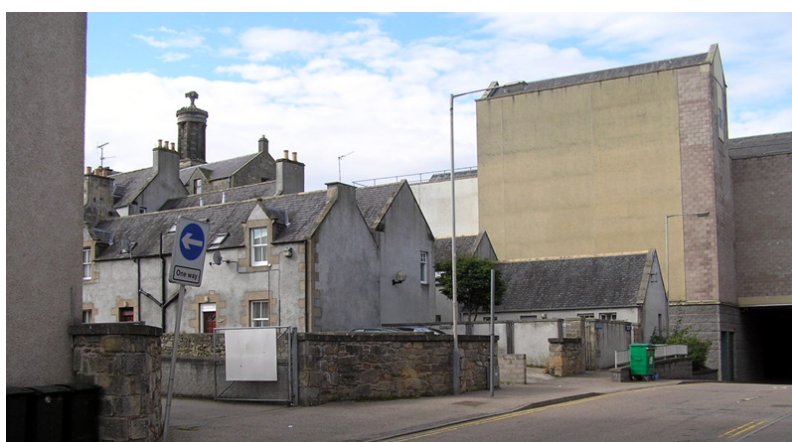
Problems of relative scale: the blind walls of the St Giles Centre contrast with developments of a traditional scale and appearance within the adjoining closes

- 4.8.8 To the north of the High Street there has been extensive modern redevelopment. The St Giles shopping centre retains the street facades of the High Street buildings, and extends to the relief road to the rear of the site where the bus station is currently located. Although the apparent bulk of this large building has been broken down, the skyline is largely unaffected by its presence, but there are inevitably problems of scale, especially where the blind walls of the retail units meet the traditional closes alongside to the east of the site. It seems surprising at first sight that some of the more interesting traditional closes have survived here, but they are well knitted with the urban fabric of the area.

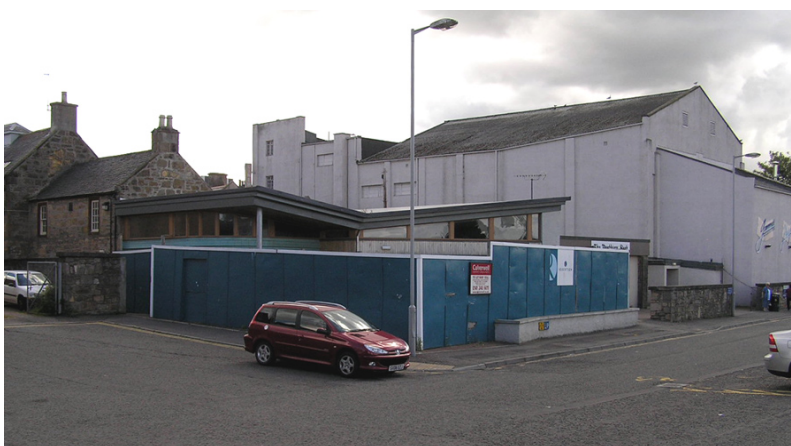
The ragged northern edge of the conservation area where it meets the A96 relief road

- 4.9.2 While in one respect at least the insertion of the relief road has been beneficial in reducing the impact of vehicular traffic on the city centre, in another it has caused untold damage to the historic environment. In one fell swoop it severed the historic core of the city from the open recreational ground to the north and civic buildings such as the Town Hall, and it violated the continuity of the High Street at both ends.
- 4.9.3 Particularly damaging has been the severance of the historic links to the city's recreational and cultural assets of the castle, Grant Lodge and the Cooper Park, and the cathedral. Virtually the only direct physical link now is the elevated pedestrian footbridge, which although reasonably well used, acts as a physical barrier to movement.

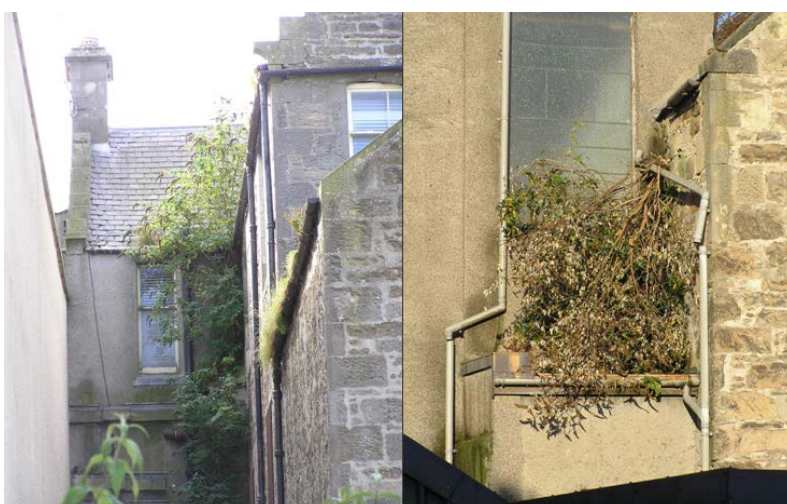
Problems of vegetation growth from lack of maintenance; the tree growing out of the wallhead on the right image has brought down the rainwater pipe

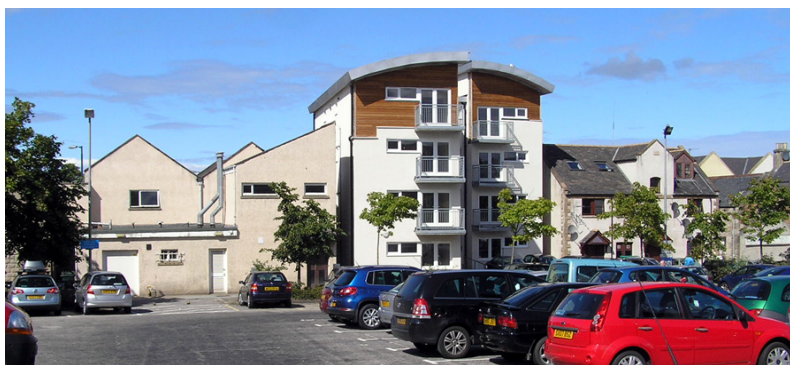
Residential development at the west end of the conservation area which fails to match the urban grain of the townscape in form, height, and materials

- 4.9.9 In the absence of effective guidance throughout the conservation area, planning decisions do not always appear to have been well founded. An example of this is the recent residential development approved upon appeal, but only after a public inquiry. It sets a poor precedent for the western end of the conservation area. The building is taller than the characteristic general height of the surrounding properties, a problem exacerbated by the fact that it is constructed of modern materials which jar with the appearance of the surrounding buildings, and has an intrusive non-traditional roof form of reflective metal.

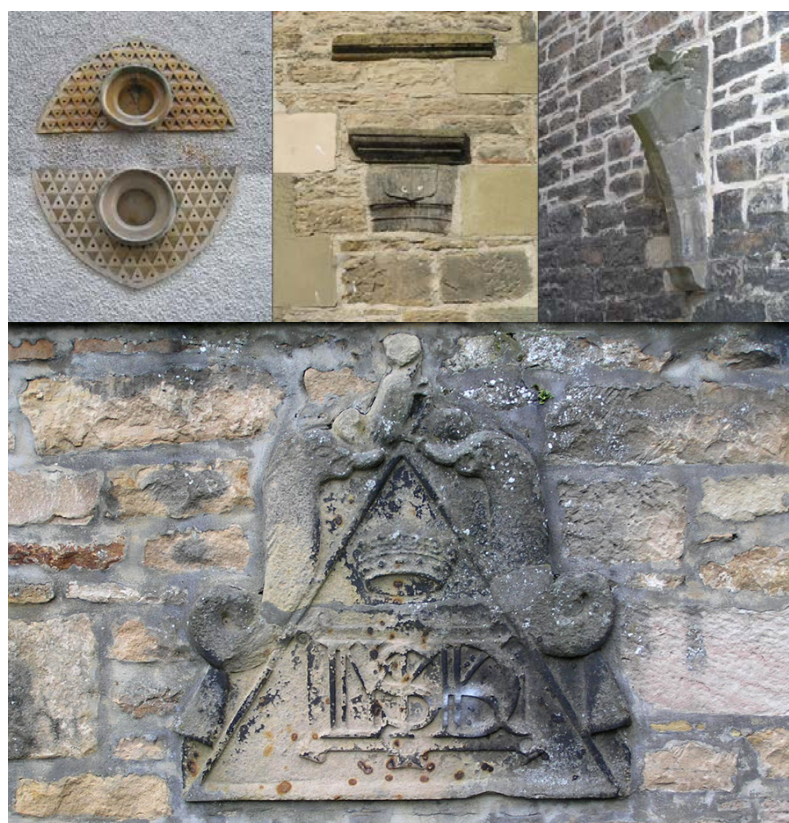
Salvaged armorial panels and archaeological features are to be found on buildings and boundary walls throughout the conservation area

- 5.3.5 Elgin has always had a strong sense of civic pride and this is manifested in the carved initials, arms, and dates liberally scattered over its buildings. Where earlier buildings themselves have been lost, carvings from many were saved, and placed in new buildings and walls, adding considerable character and interest to the streetscape.

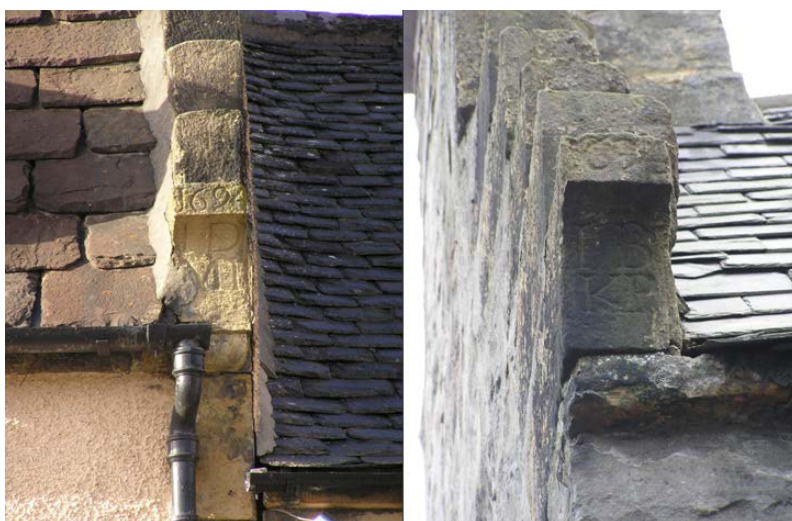
Distinctive carved monograms and dates carved on skewputts of late seventeenth century merchants' houses

- 5.5.5 Crowstepped gables are found on the earliest buildings in the conservation area, and among the buildings of the seventeenth and eighteenth centuries can be found carvings and datestones on the skewputts (see page 59). A common feature is the use of pedimented wallhead dormers, sometimes with datestones, and elaborate carving in the pediment. Later dormers of the nineteenth century often have distinctive carved finials. Good examples of, mostly yellow, chimneycans survive, with some ranges intact. There are examples of both decorative and plain designs.

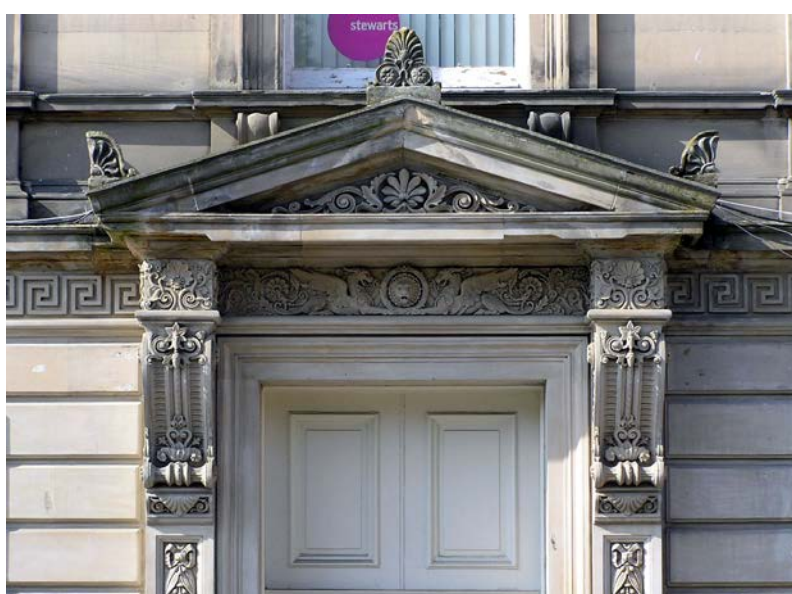
Carved architectural detail on the doorcase of a former bank (1867) designed by Peddie & Kinnear

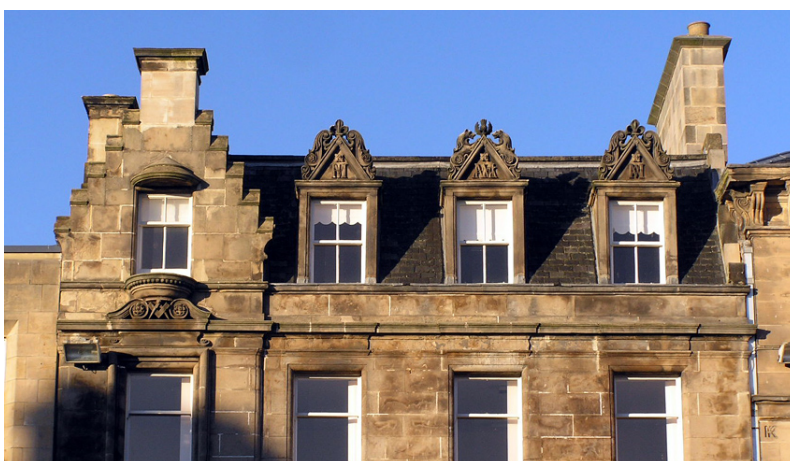
Supremely well carved stonework to pedimented dormers was a feature of Thomas Mackenzie's work, and also that of his son, Alexander Marshall Mackenzie, architect of 147-9 High Street (1880); the window of the gablet on the left is modelled on that of Duffus Manse in the Chanonry, taken down in 1838

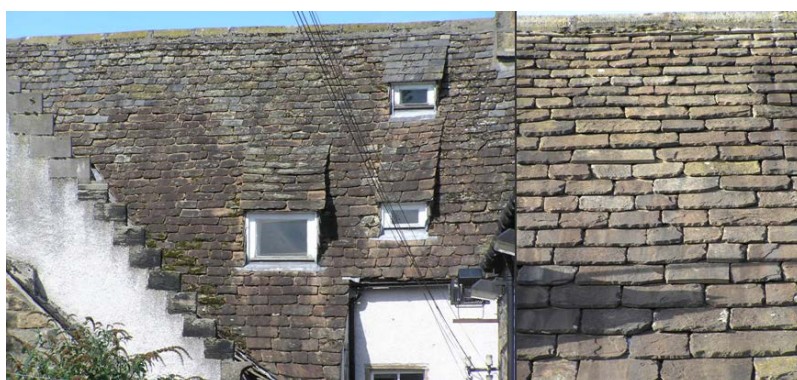
Distinctive stone slates survive on a few roofs of the late seventeenth century houses
