Elgin High Street Conservation Area

Part I: Conservation Area Appraisal

February 2012

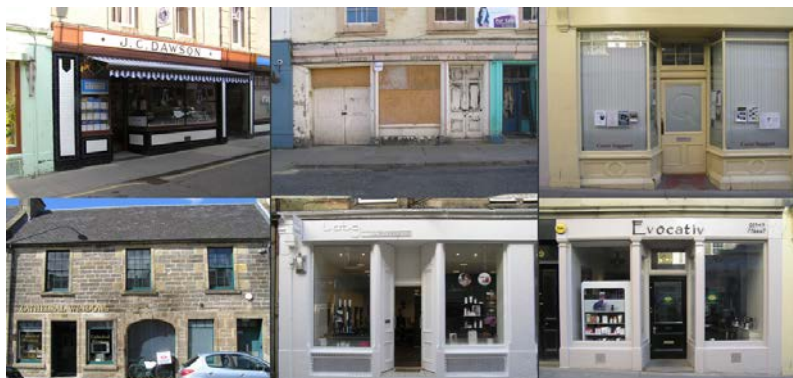
A sampler of the wide array of traditional shopfronts to be found across the conservation area

- 5.5.7 A good number of original nineteenth century shopfronts have been retained and make a considerable contribution to the townscape. These are mostly in cast-iron, but also of ashlar sandstone, both painted in a variety of colours. Good examples are found at 27-33 Batchen Street and 184-188 High Street. An excellent Art Deco shopfront is found at Burtons on the High Street, with original bronze grilles and chevron patterned lights, and with foundation stones inscribed with the names of the original owners and the date when the shopfront was installed (1936) (page 33). A good interwar shopfront remains at 30-32 Batchen Street with a tiled frontage, stained glass and awnings. Where modern signage has been incorporated into traditional shopfronts, this is not always successful, but could be easily remedied.

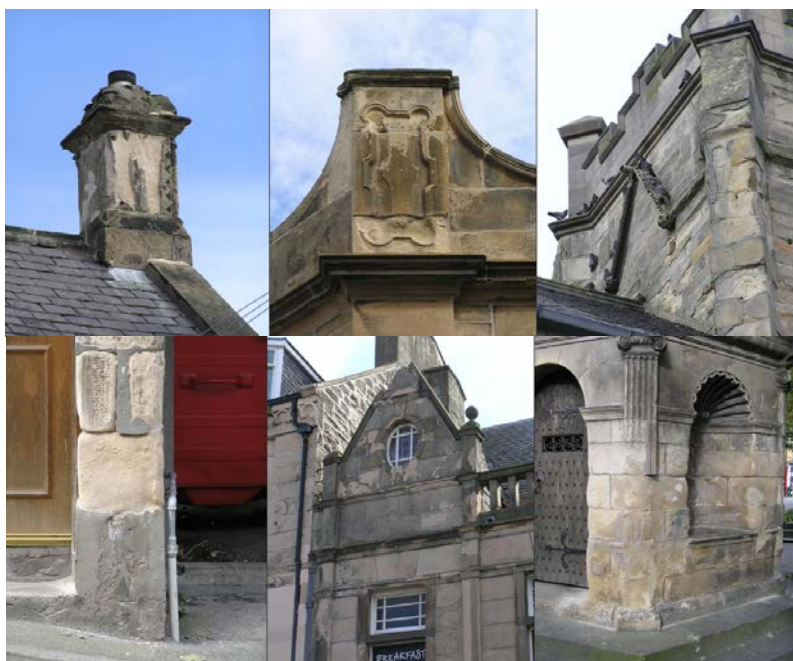
Examples of masonry decay, which in some instances has resulted in the loss of carved architectural detail

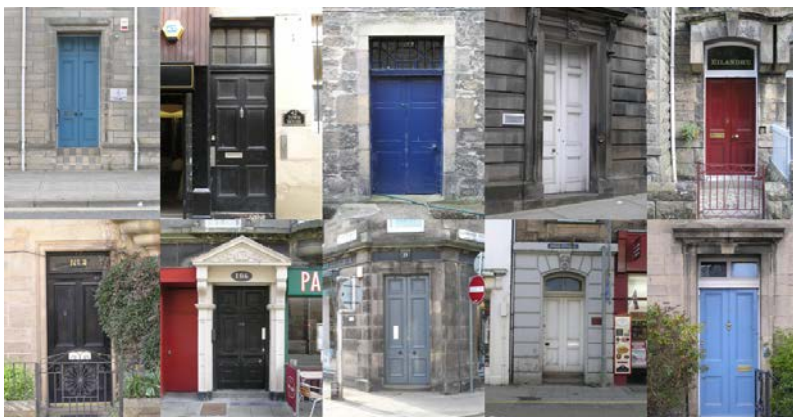
Traditional paneled doors have survived in reasonable numbers throughout the conservation area

- 5.6.3 Replacement windows and doors are commonplace, often with a variety of styles utilised across one building. Compared with some conservation areas large numbers of original doors have survived. Replacement windows are rarely a close match to those that have been replaced. Historic glass and windows does remain in upper floors, particularly on South Street.

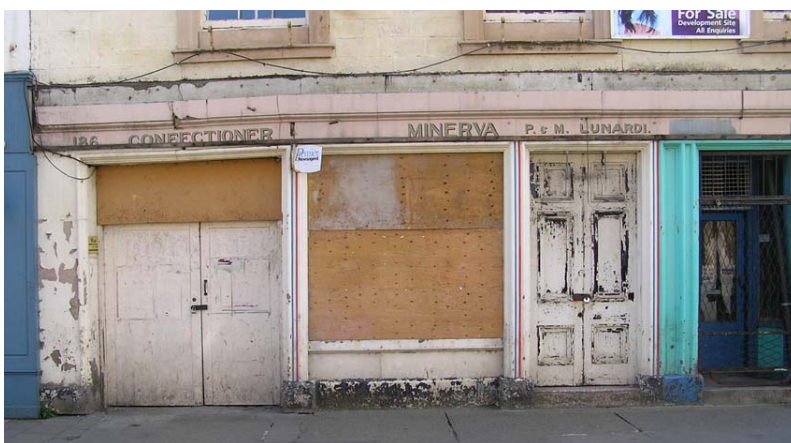
Shopfront at 186-188 High Street (see also below)

Original shopfronts, dormers and 12-pane sashes. The building is currently vacant and in poor condition with slipped slates and broken rooflights. The modern shop signage has been removed revealing hand painted signage for a confectioner underneath. The dwellings to the rear are potentially attractive. The property is currently being marketed for sale as a development opportunity.

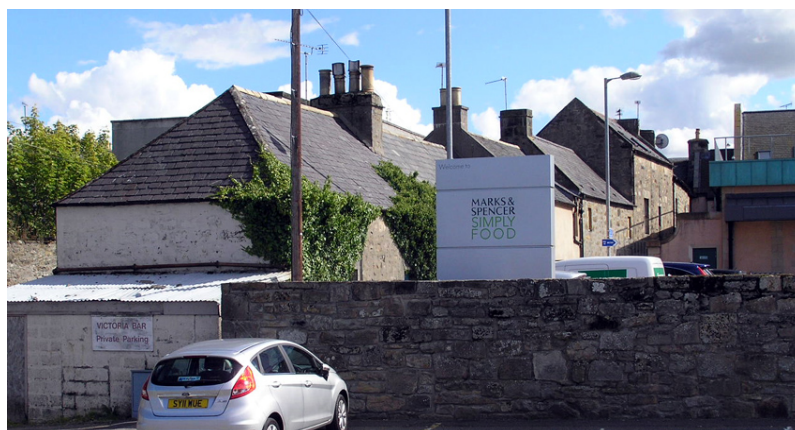
The listed buildings within the close have been renovated at some stage but are presently unoccupied, with windows and doors boarded up. The properties are visible from the car park to Marks & Spencer's store.

The former dwellings in the close at 211 High Street are boarded up, and are visible from the public car parks adjacent to the A96 Trunk Road

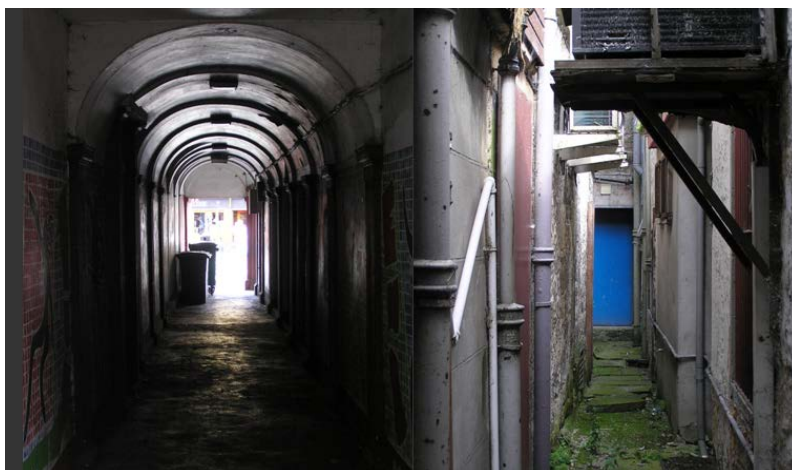
130 High Street: Newmarket Close

The arched entry to the Newmarket Close and the structures in poor condition to the rear

A former bar set behind the building on the street façade and large building housing a former leisure and fitness club approached the close which has attractive vaults and pilasters. The structures appear to be in poor repair with extensive vegetation growth apparent. The building within the backlands has been reduced to a shell as a result of fire damage.

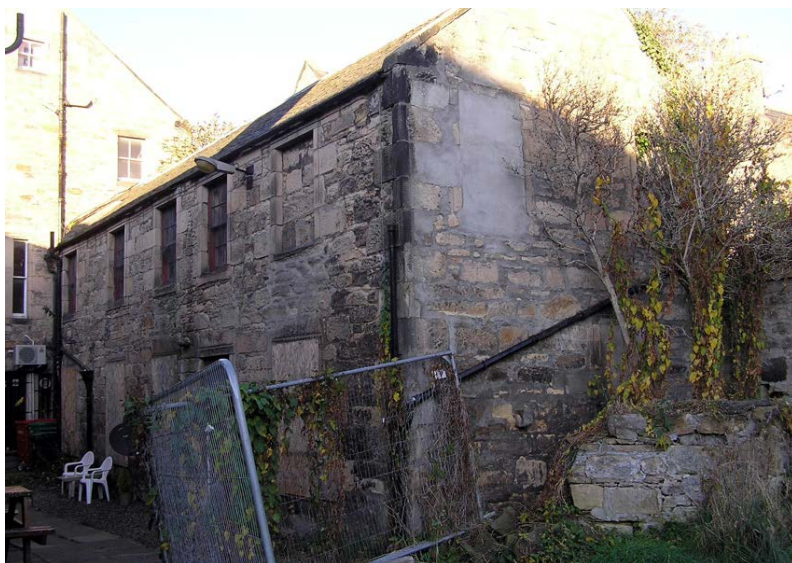
76-78 High Street

Properties behind 76 High Street

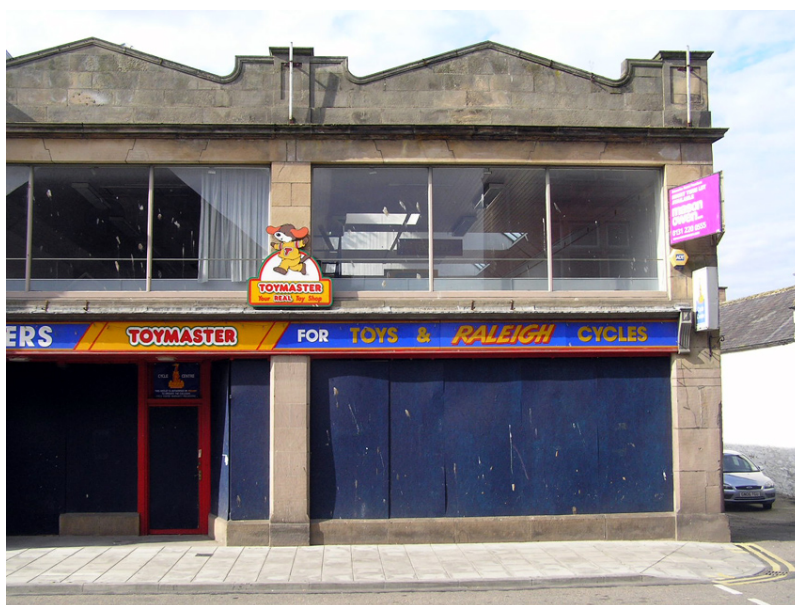
South Street: former Junners shop

Junners' former shop on South Street

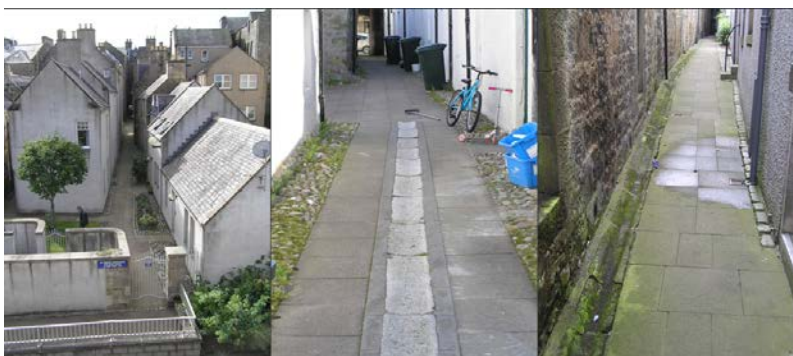
- 6.1.3 The resurfacing of the High Street has perhaps exposed the patchy public realm of the closes, which would benefit from enhancement. Historically the closes were cobbled, and Mary Byatt tells us that many were cobbled up until the mid-twentieth century. The only close to retain a cobbled surface is Braco's Close. Remnants survive elsewhere, particularly where closes have been gated, or otherwise closed off, and remained inaccessible. Some closes have remnants of the stone drain that would have run down each close to carry waste water to the High Street. Seceder's Close at 166 High Street, which is gated at both ends and is now only visible from the upper floors of the car park behind, contains original cobbles and a drain.

Finishes in the closes and evidence of former drainage channels

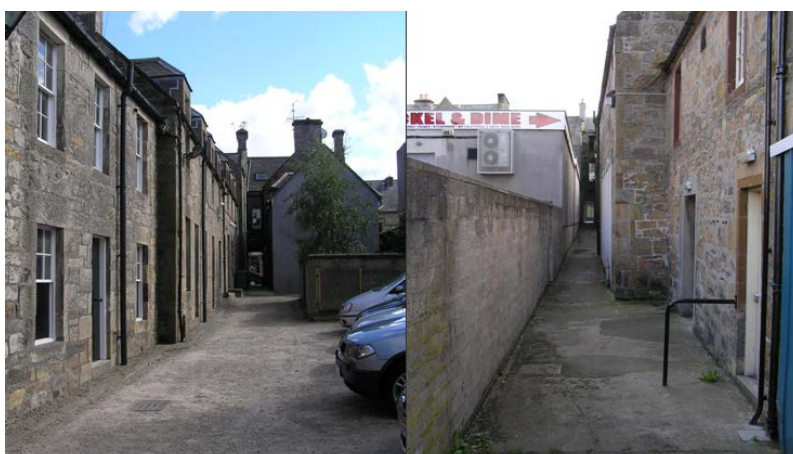
- 6.1.4 Many of the closes are in private ownership and the surface finishes vary considerably. Some closes such as Walker's Close at 175 High Street have very poor public realm, in this case an unmaintained concrete surface, although with some remnants of a stone drain on the eastern side. The public realm in the closes in this area of the High Street in particular tends to be poor quality and unmaintained. In some of the closes there are problems with surface drainage. The close at 203-205 High Street has a simple gravel surface, which does little to enhance the historic character of the area. This creates an unpleasant pedestrian environment and gives an air of neglect. This is particularly important in this area where these closes link at their northern end to car parking on the fringes of the conservation area, and have the potential to form a pedestrian link to the High Street for visitors.

Poor standards in the public realm of the closes, with a gravel finish for car parking (left) and concrete surfaces (right)

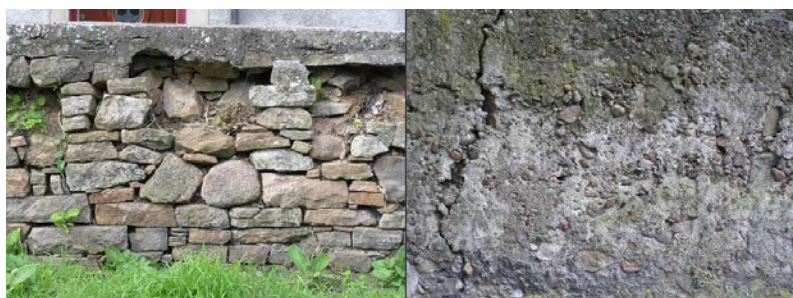
Rarities in the conservation area: a 'rig' wall and a boundary wall of rubble stonework bound with clay mortar, and of mass unreinforced concrete

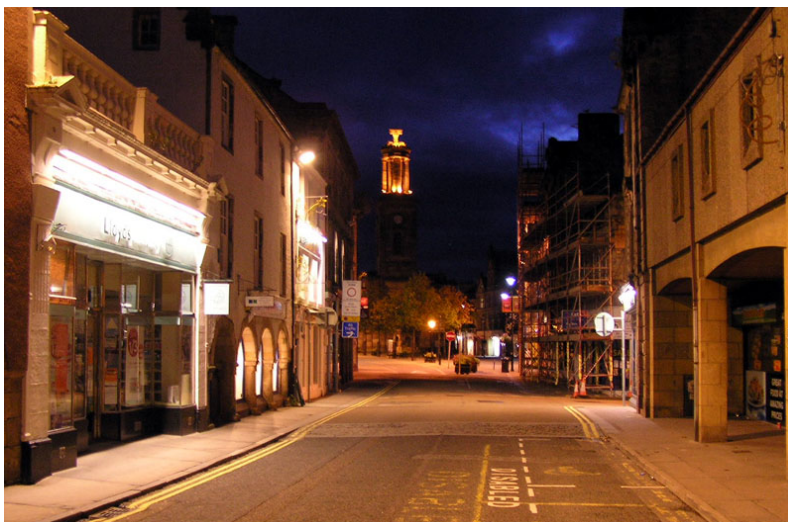
An over-reliance on sodium street lighting, the partial illumination of the tower of St Giles, and a lack of lighting to ground planes and trees suggest opportunities for enhancement

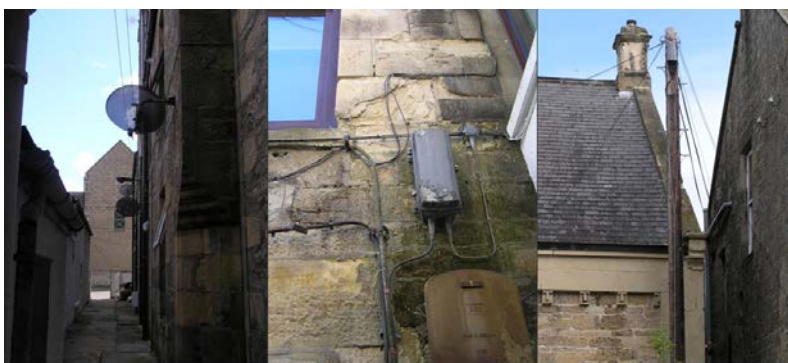
Concentrations of satellite dishes placed prominently on buildings, surface wiring and overhead lines all detract from the character and appearance of the conservation area

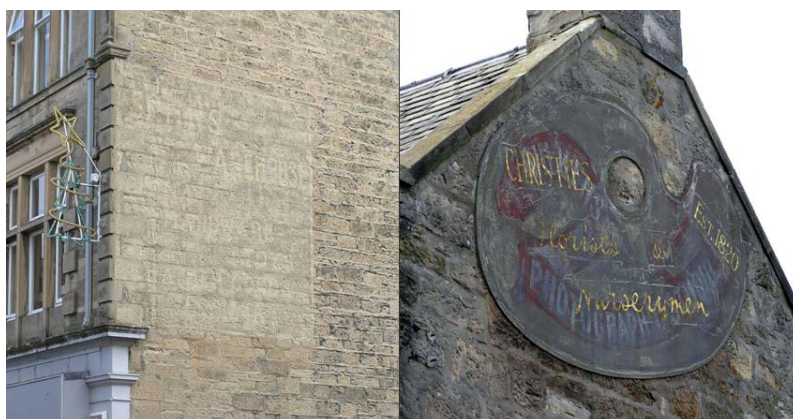
- 6.4.1 There are some delightful examples of painted cement rendered signs to be found on old buildings, providing information on the names of businesses which have long disappeared and the nature of their trade. Many of these signs are now quite badly faded.
- 6.4.2 There are occasional survivals of old road name signs in blue enamel, or earlier pattern cast nameplates to closes which add to an appreciation of the history of the city. Although there are now much fewer than they were at one stage, there are good examples of traditional painted house numerals still to be seen.

Old painted cement rendered signs, although fading, provide a fascinating insight into past uses of buildings and the names of the business proprietors

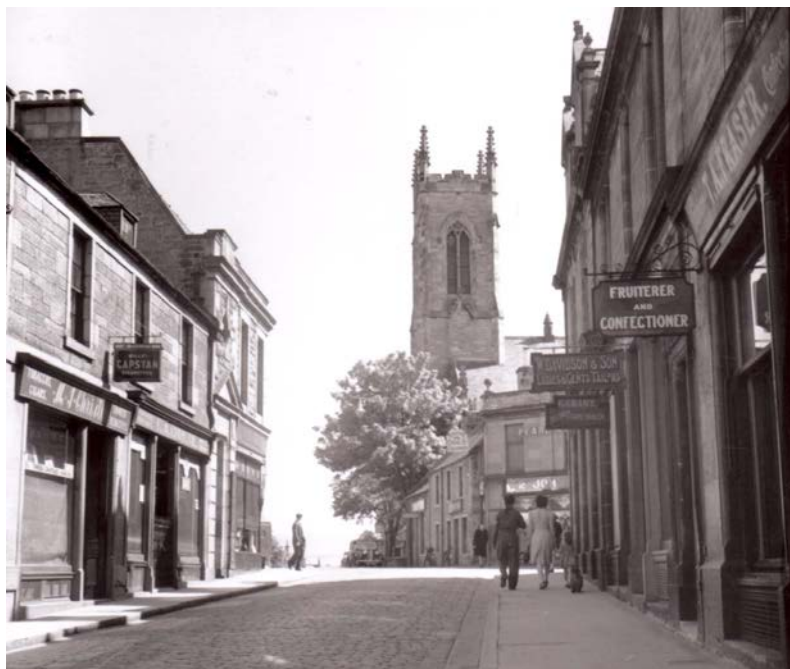
A&W Reid's finely proportioned tower to the former United Free Church (1858) on Moss Street dominates the view on Commerce Street looking southwards in the 1930s: sadly, as a consequence of advanced stone decay, the tower has since been reduced to little more than a stump © The Moray Society

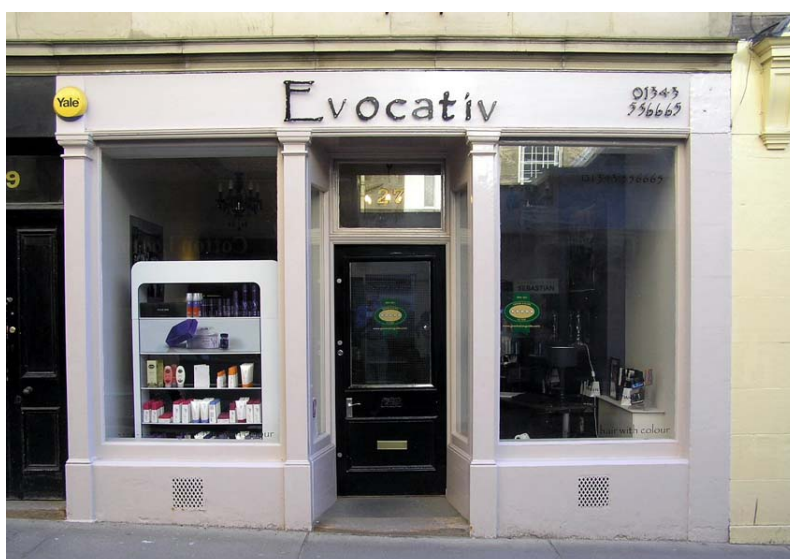
Shopfront on Batchen Street which has preserved the original cast iron pillars and moulded lintol, door, fanlight, and vents in the stall risers; the lettering has been kept within the depth of the fascia

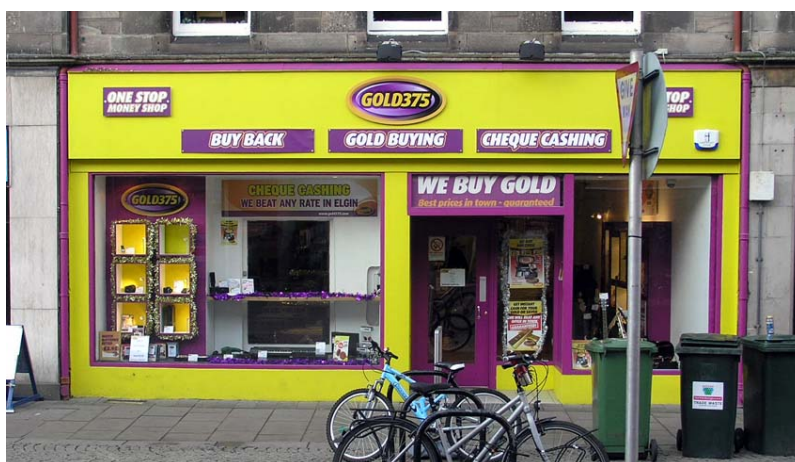
Example of a shopfront having a disruptive effect in the streetscape: colours are strident, lettering is poor and the fascia oversized, while the shopfront is a modern replacement

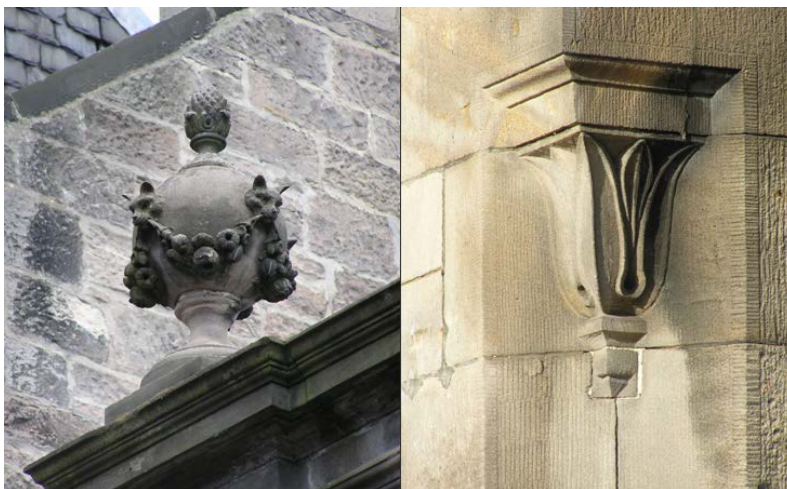
Skilled carved stonework of the mid-nineteenth century

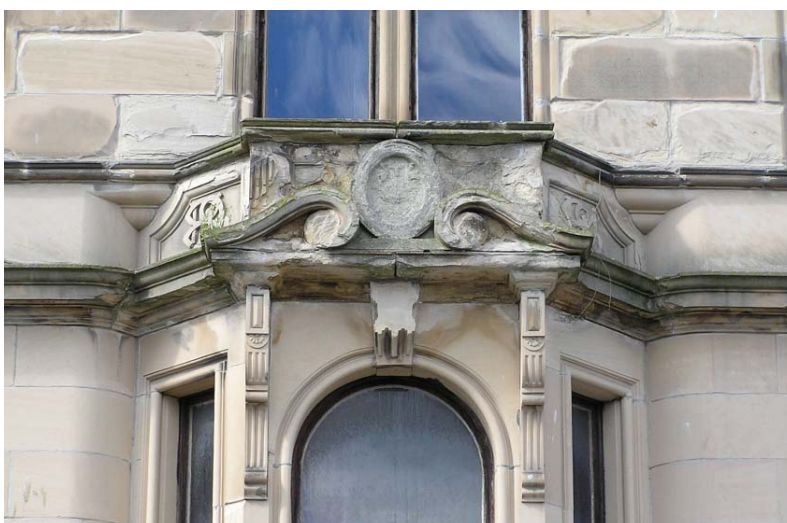
Carved stonework detail to a projecting bay window obliterated from stone decay; weathering back of the face of the stone can be seen around the joints in the ashlar masonry

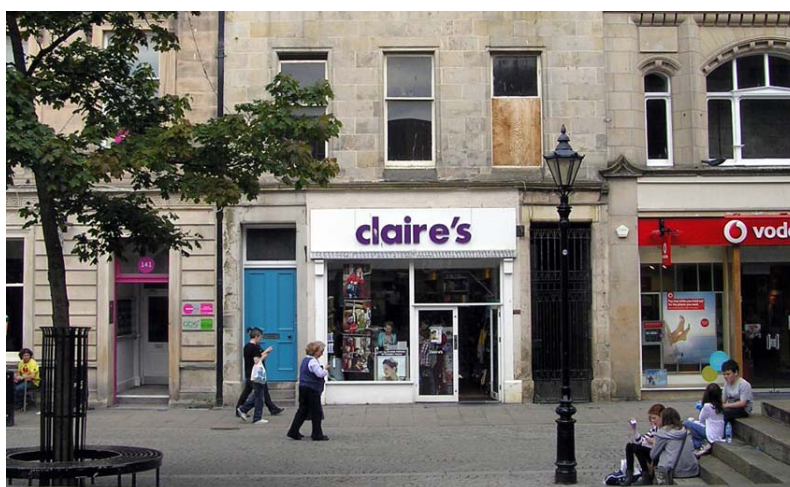
Vacancy of the upper floors of this property has led to neglect and has a negative effect on the character and appearance of the conservation area, and an impact on adjoining properties

- 8.4.1 Buildings that are redundant - displaying their redundancy in obvious ways with protective boarding, or where windows are boarded up and broken glass has not been repaired - have an immediate negative effect on the character and appearance of the conservation area. While in certain cases redundancy may have come about because of property neglect, this does not always appear to have been the case and the majority of buildings are eminently capable of being saved and given continuing, or new uses.

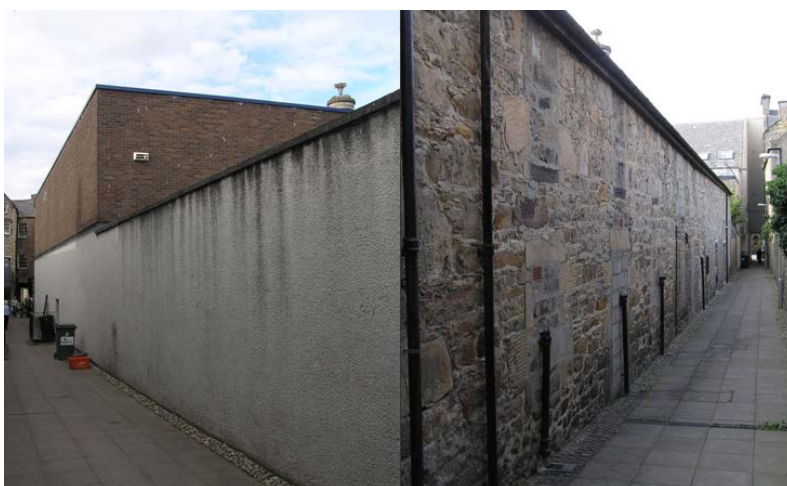
Closes blighted by twentieth century developments within the backlands, resulting in bland walls lacking in interest

- 8.5.4 The consequence of this is that closes adjacent to these sites are heavily compromised in terms of their potential attractiveness to pedestrians. Blank walls tend to dominate, and the display of archaeological relics, where they occur, do little to overcome blandness and lack of interest. Spaces to the rear elevations of these large flat-roofed extensions where they have been opened up, for instance on the north side of the conservation area, have a negative impact on the character and appearance of the conservation area.

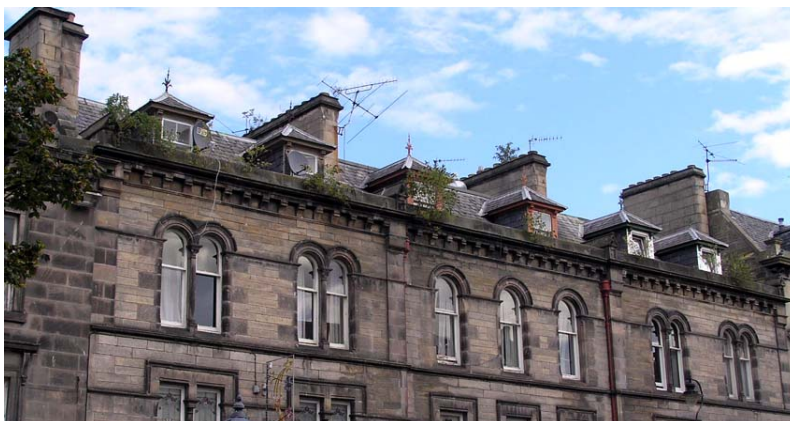
Appreciation of the skyline of a fine late nineteenth century buildings is marred by trees growing out of gutters and open joints in masonry at high level

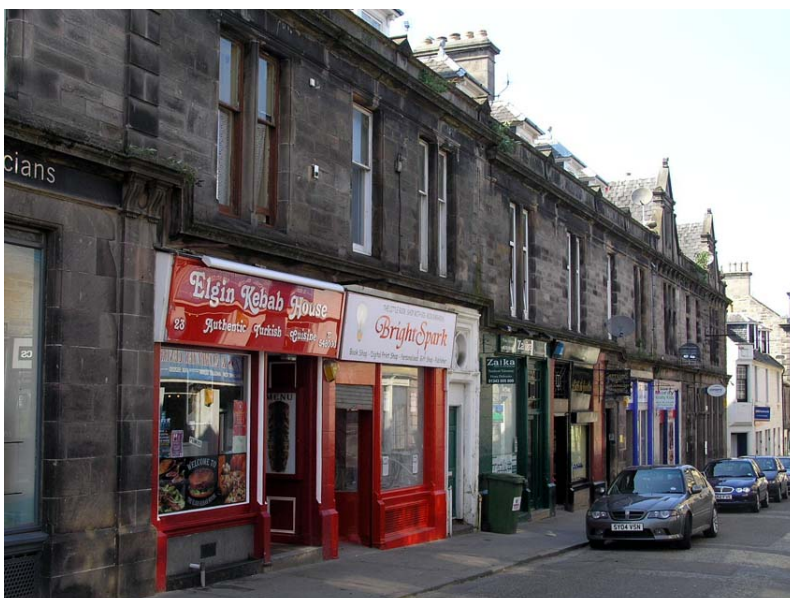
A fine range of late nineteenth century buildings on Commerce Street with high levels of authenticity, complete with the original cast iron shopfronts, panelled doors and rich carved architectural detail, some of which has been lost at high level

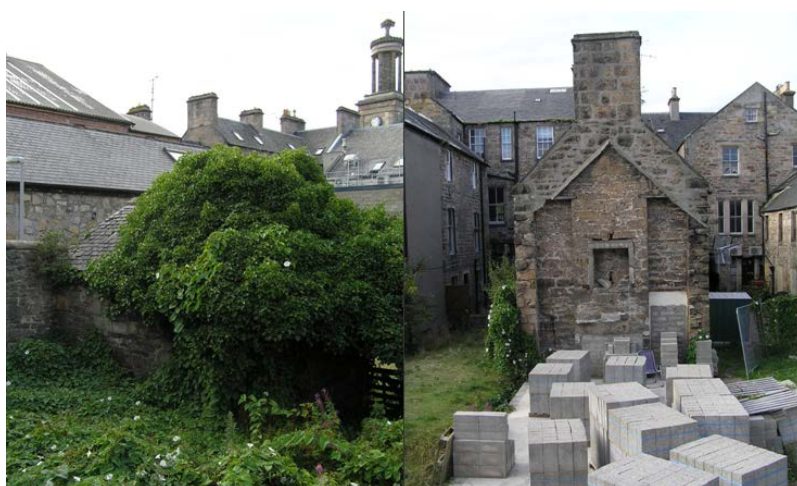
Undeveloped gap sites within the backlands of the central character zone of the conservation area: the development shown in the right image has stalled

- 9.1.4 Within the closes a number of gap sites were observed from demolitions having taken place over the years, which is considered to be detrimental in diluting the close-knitted historic urban grain of the closes. Some of these spaces are completely enclosed, occurring at the heart of the conservation area. They are overgrown with vegetation, and are generally unkempt. In one or two of the closes development has commenced but has been abandoned due to the current economic downturn.

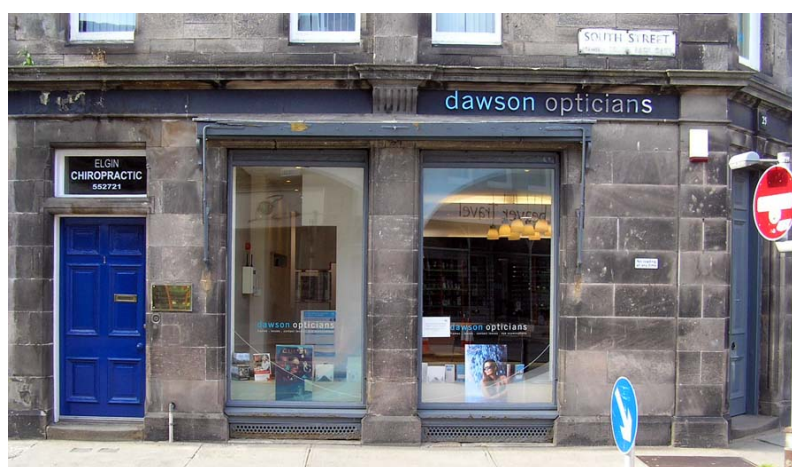
Exemplary standards in the enhancement of a traditional shopfront at the junction of Commerce Street and South Street – original panelled doors have been preserved, cast iron ventilator panels at the stall risers have been retained, colours are subdued, the blind box has been retained, and the shop name lettering is subtle and retained within the depth of the fascia

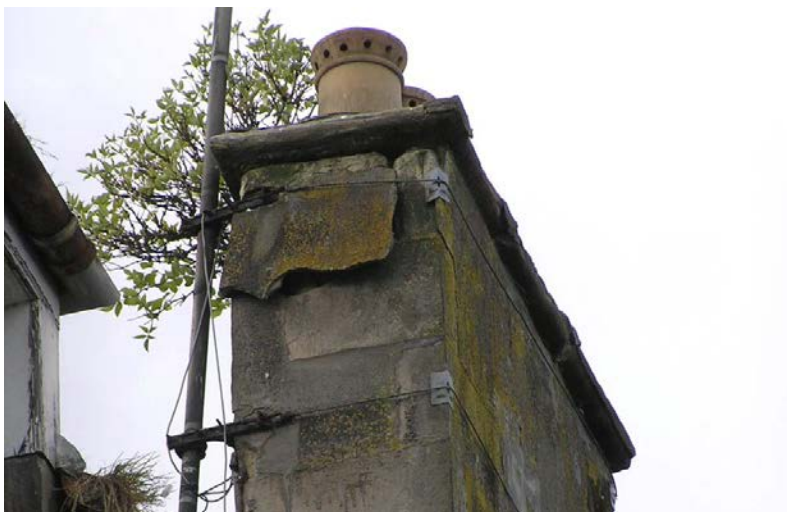
Masonry in a dangerous condition, at risk of falling and causing injury or damage to persons or property

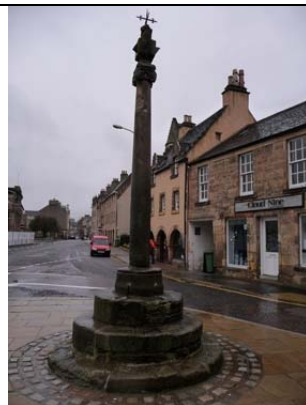
Little Cross, High Street The finial may date from the original cross of 1402. Ionic capitals, shaft, plinth and sundial may all date from a 1733 rebuilding. Repaired 1867. Present sundial and finial is a 1941 replica, original in Elgin Museum. Original site of cross erected by Alexander Macdonald in 1402 at entrance to Cathedral Chanonry. Category A-listed.

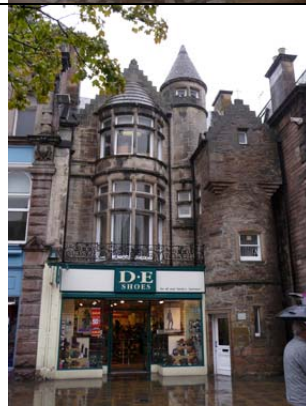
The Tower, 103-105 High Street Dated 1634 (oldest building in the High Street) then remodelled by Dr Mackay after 1859. The tower is only surviving portion of house built by Andrew Leslie of Glen of Rothes, merchant and magistrate of Elgin. Datestone and pediment bear arms of Leslie and Abernethy, initials A.L. and I.B. for Andrew Leslie and Jean Bonyman his wife. Rubble built circular tower of 2 stages with small square cap house corbelled out at 3rd stage. Tower now attached to 3-storey remodelled asymmetrical house. Modern shop front at ground floor with cast iron balustrade above.

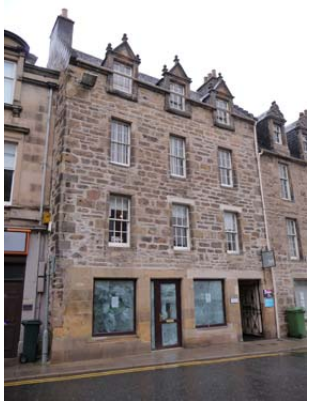
<p>25 High Street 18th century. Renewed shop windows and doorway. Vacant on ground floor. Appears to have been heightened for the dormerhead storey (list description). Restored by Elgin Restoration Fund in 1971. Category B-listed.</p>

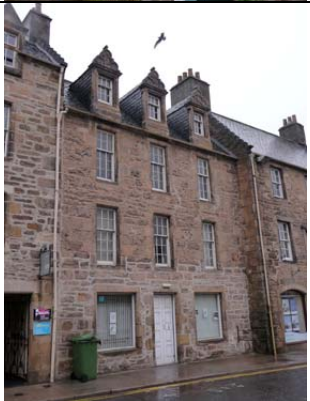
<p>23 High Street Circa 1700. Altered 1853. 3 wallhead dormers with carved pedimented gables in the style of Thomas Mackenzie, the centre bearing 1853 date, those flanking with initials W M. Restored by Elgin Restoration Fund in 1971. Category B-listed.</p>

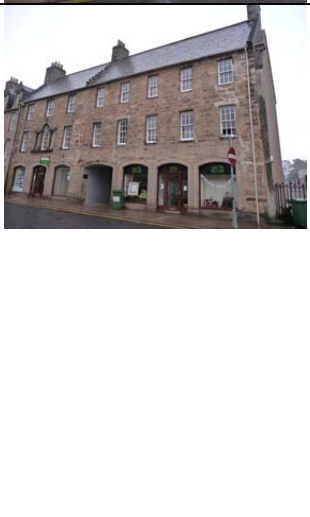
<p>15-17 High Street Dated 1728. Ground floor remodelled 1971 by John Wright for Elgin Fund but had been altered already from the original arrangement. Ground floor of both buildings now symmetrically treated with centre segmental-headed arch to pend (original), flanked by 3-bay shop fronts, with 20th century segmental-headed doorways and windows replacing earlier square-headed windows and doors. Formerly was harled in the late 19th century, stonework now bare, though recently reharled to rear. Home of Kilmolymock Lodge of Freemasons. Masonic Close much altered. Category B-listed.</p>

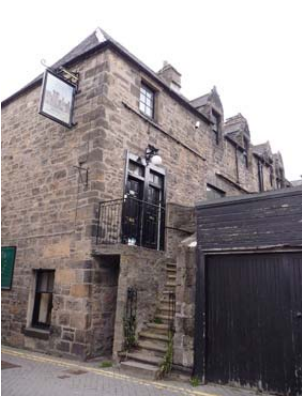
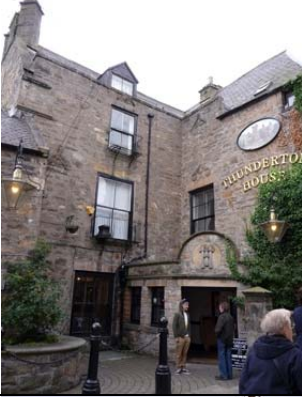
<p>Thunderton House, Thunderton Place Early/mid 17th century, probably incorporating earlier work but remodelled and reduced in size to present L-plan in 1822. The 17th century house survives only at the south elevation with the four 17th century pedimented dormers carved with Duffus, Dunbar, Innes and Mackenzie monograms, and the north gable with grouped rectangular and diagonally set stacks. The courtyard elevations are largely of 1822 and are liberally decorated with carved stones from previous buildings. Tower and west wing demolished in early 19th century to make way for Batchen Lane. Category B-listed.</p>

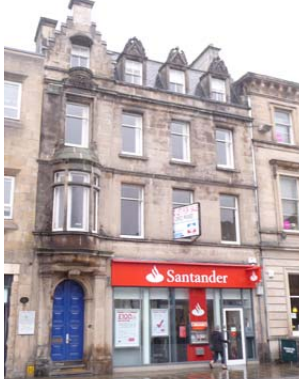
<p>147-149 High Street A Marshall Mackenzie, 1880. Vacant upper floors. Carved details. Timber sashes with curved glass. Modern shopfront (Santander). Banffshire slate roof. Wallhead pediments, copied from those on Ritchie's House formerly on the site, demolished 1880, bear initials of the architect owner, A Marshall Mackenzie. Category B-listed.</p>

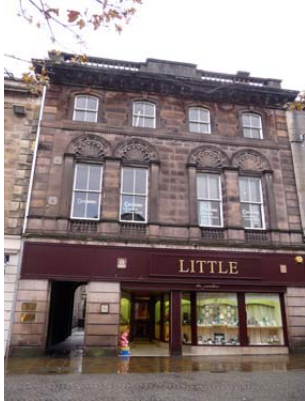
<p>82-86 High Street Matthews and Petrie, 1857 Former Union Bank. Courtyard behind probably same period. Wrought iron gate at entrance to pend. Paved with stone slabs. Ground floor much altered. Category B-listed.</p>

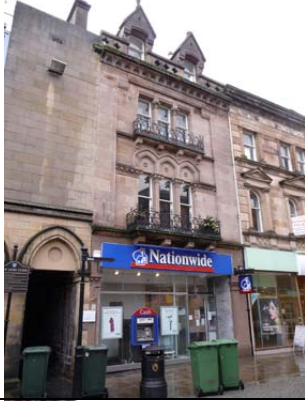
<p>94 High Street Later 19th century. Modern shopfront to ground floor. One over one timber sash windows to upper floors on front elevation. Two over two sashes to the rear. Category B-listed. Decorative iron balustrading.</p>

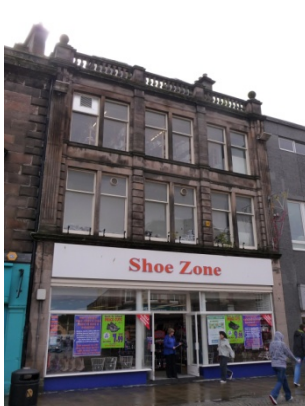
<p>134-136 High Street Late 19th century. Modern shop front. Category B-listed.</p>

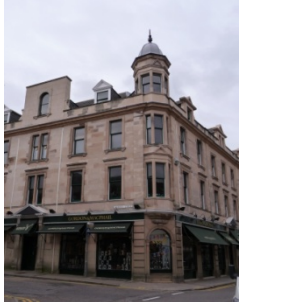
<p>56-58 South Street Charles C Doig, 1894, alterations to ground floor shop front, also by Doig, 1962. Significant masonry repairs have been carried out. Category B-listed.</p>

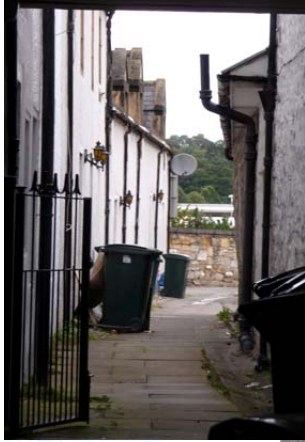
<p>Miller's Close Inhabited close of early 19th century rubble dwellings. Fine example of decrease in scale of houses in a close from the High Street. West side of the neighbouring close is lost leaving rubble elevation of Miller's Close buildings exposed. Close is paved with concrete slabs with some vestiges of cobbles at the verges.</p>

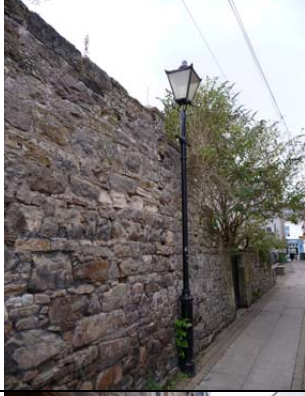
<p>Victoria Close Mostly 19th century rubble walled buildings, now painted, and many doors and windows boarded. It is not clear which of the buildings are in use. Mary Byatt states that as recently as 1978 the close was still cobbled. It has now been repaved with concrete slabs but retains perhaps the best surviving 'rigg' wall at the north end.</p>

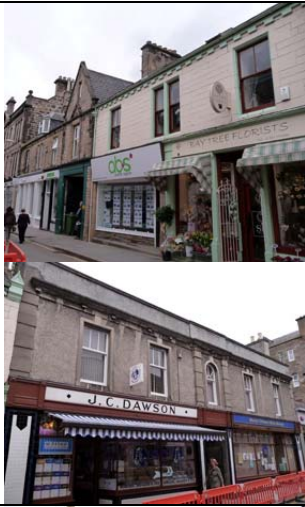
<p>12-32 Batchen Street later 19th century 2-storey commercial buildings (12-26 dated 1883). 24-26 painted facade. Good surviving shopfronts. No's 12 & 26 stone shopfronts. Variety of poor replacement windows above. No's 30-32: good interwar tiled shopfronts with stained glass and awning.</p>
