Moray Council

Inspection/Defect Report

Date Range:- From 01/02/2023 To 09/02/2024

Street :- 26352948 - U8E from Beaufighter Road in Nether Dallachy to C16E at Dryburn,

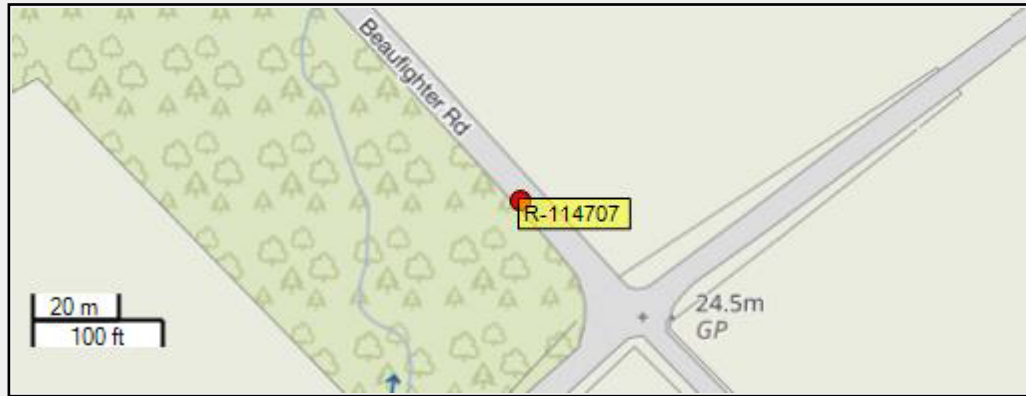
Instruction Reference: R-114707

Item Detail: Carriageway Defects

Defect Category: P3 - 30 working days

Location Description: approximately 40mts from junction

Description of Works: emulsion & chip to repair 3 defects

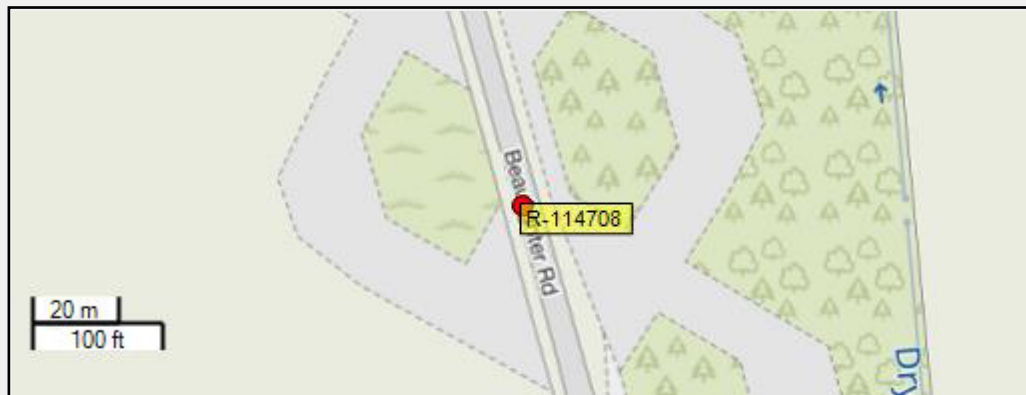
Instruction Reference: R-114708

Item Detail: Carriageway Defects

Defect Category: P3 - 30 working days

Location Description: on centreline of road

Description of Works: emulsion & chip to repair 1 defect

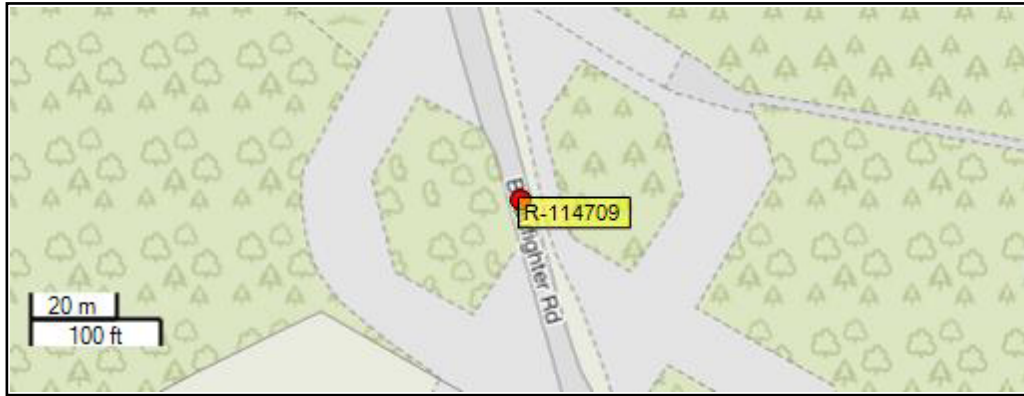
Instruction Reference: R-114709

Item Detail: Carriageway Defects

Defect Category: P3 - 30 working days

Location Description: on centreline of carriageway

Description of Works: emulsion & chip to repair 1 pothole

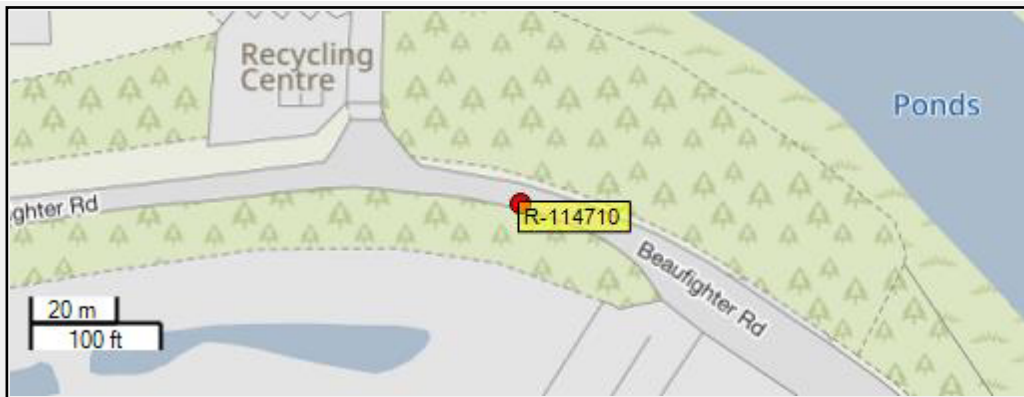
Instruction Reference: R-114710

Item Detail: Carriageway Defects

Defect Category: P3 - 30 working days

Location Description: edge defect inside corner

Description of Works: emulsion & chip to repair 2 sqm defect at inside corner on edge of road

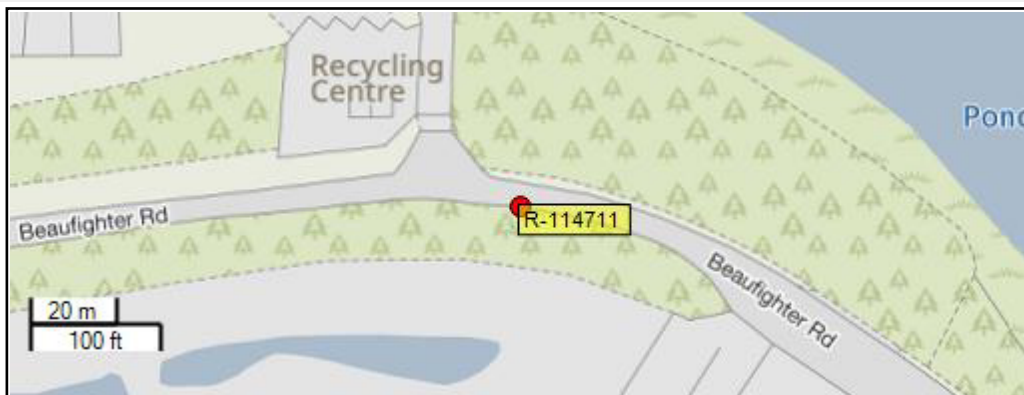
Instruction Reference: R-114711

Item Detail: Carriageway Defects

Defect Category: P3 - 30 working days

Location Description: at edge of carriageway inside corner

Description of Works: coldpac patch required and emulsion & chip to repair 1 edge pothole

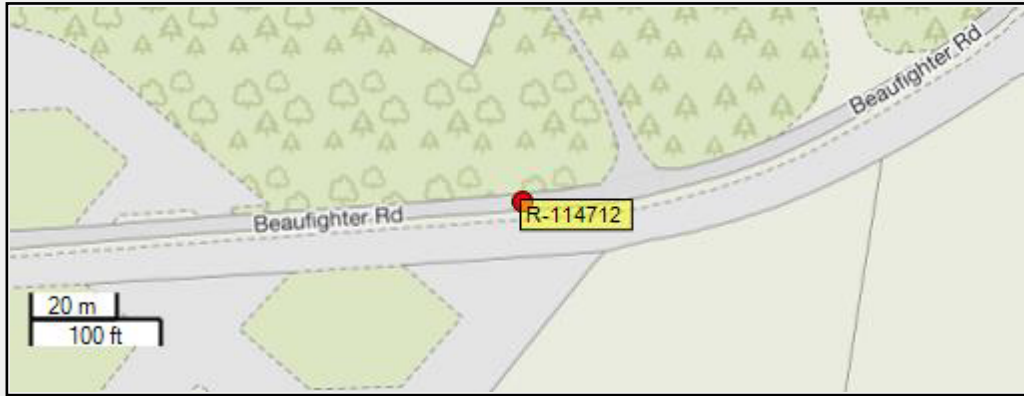
Instruction Reference: R-114712
Instruction Created: 08/02/2023 10:32:00
Instruction Status : *Works Complete*
Inspection: Safety Inspection Area E01 - 02 (Feb) on the 8th of February 2023
Item Type: Carriageway
Item Detail: Carriageway Defects
Defect Category: P3 - 30 working days
Issued Date: 08/02/2023 10:32
Target Date: 22/03/2023 10:32
Completion Date: 27/03/2023 14:49
Location Description: eastbound approx 40mtrs from wood entrance
Description of Works: emulsion & chip to repair defect

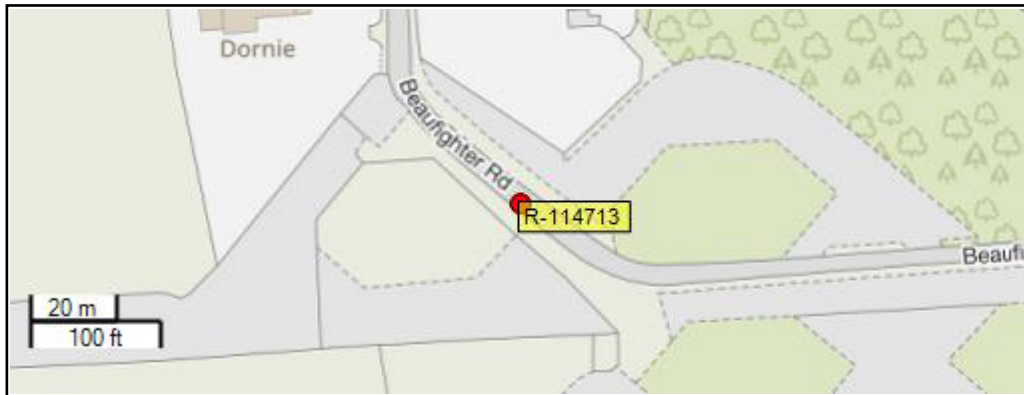
Instruction Reference: R-114713
Instruction Created: 08/02/2023 10:36:00
Instruction Status : *Works Complete*
Inspection: Safety Inspection Area E01 - 02 (Feb) on the 8th of February 2023
Item Type: Carriageway
Item Detail: Carriageway Defects
Defect Category: P3 - 30 working days
Issued Date: 08/02/2023 10:36
Target Date: 22/03/2023 10:36
Completion Date: 27/03/2023 14:50
Location Description: approx 45mtrs from corner eastbound
Description of Works: emulsion & chip to repair 1defect

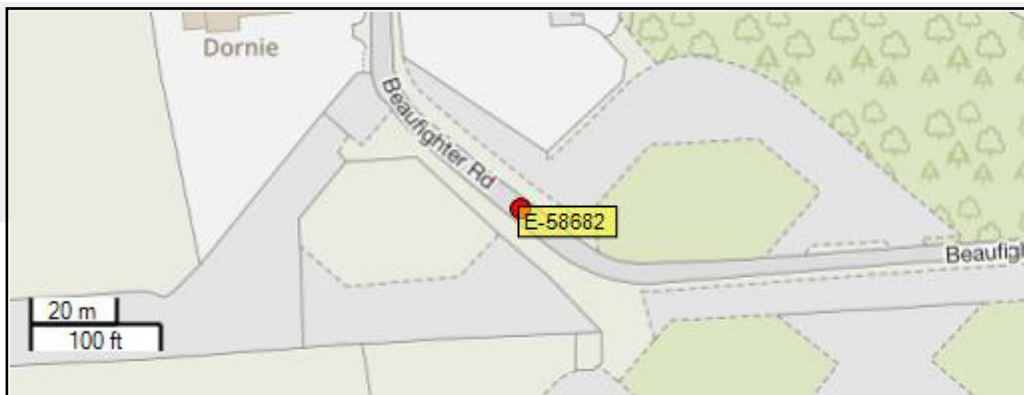
Enquiry Reference: E-58682
Enquiry Created: 24/04/2023 08:51:00
Enquiry Status : *Instruction Created*
Item Type: Carriageway
Item Detail: Carriageway Defects
Location Description: Beaufighter road, nether dallachy

Enquiry Comments: Numerous potholes along the stretch to the tip

Numerous smallish potholes along the stretch to the tip

Description of Works: E&C 6 small Potholes all approx 200mm x250mm x40mm

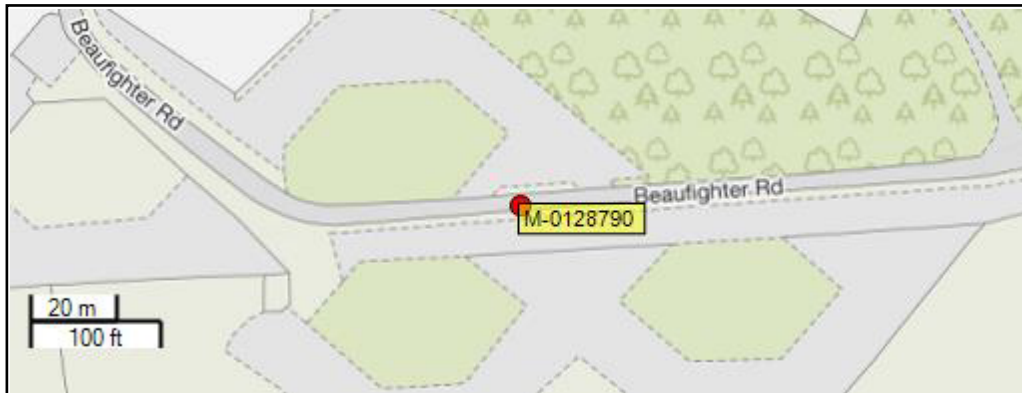
Instruction Reference: M-0128790

Item Detail: Pothole

Defect Category: P3 - 30 working days

Location Description: On carriageway heading west on nrside wheeltrack edge

Description of Works: E&C 1 Pothole Edge defect approx 2mtrs x 400mm x 45mm

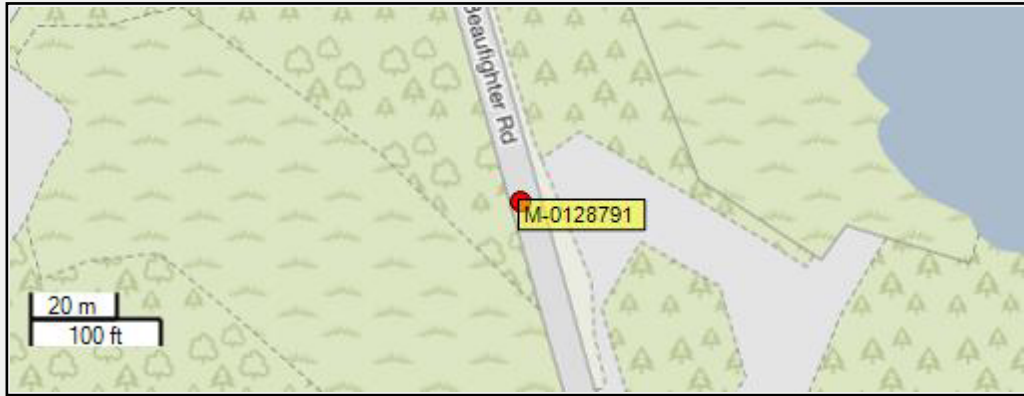
Instruction Reference: M-0128791

Item Detail: Pothole

Defect Category: P3 - 30 working days

Location Description: On carriageway heading north on nrside edge

Description of Works: E&C 2 Potholes both approx 300mm x 300mm x45mm

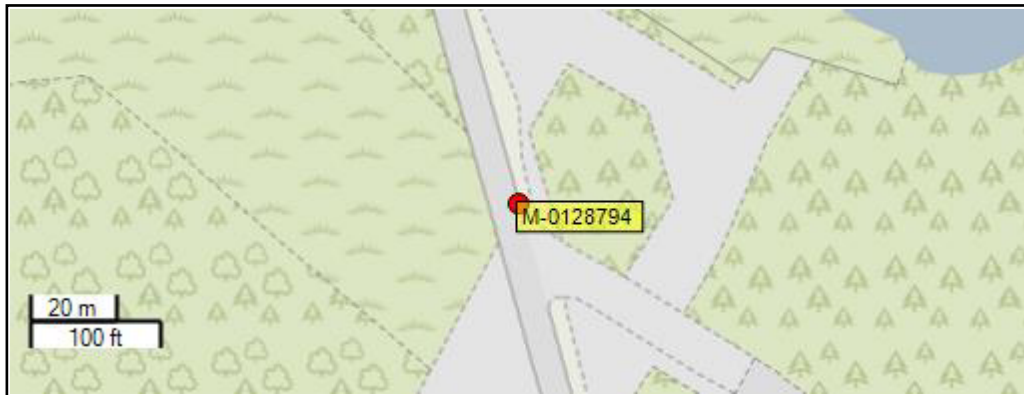
Instruction Reference: M-0128794

Item Detail: Pothole

Defect Category: P3 - 30 working days

Location Description: On carriageway heading south on road edge

Description of Works: E&C 2 Potholes both approx 1200mm x 500mm x 65mm

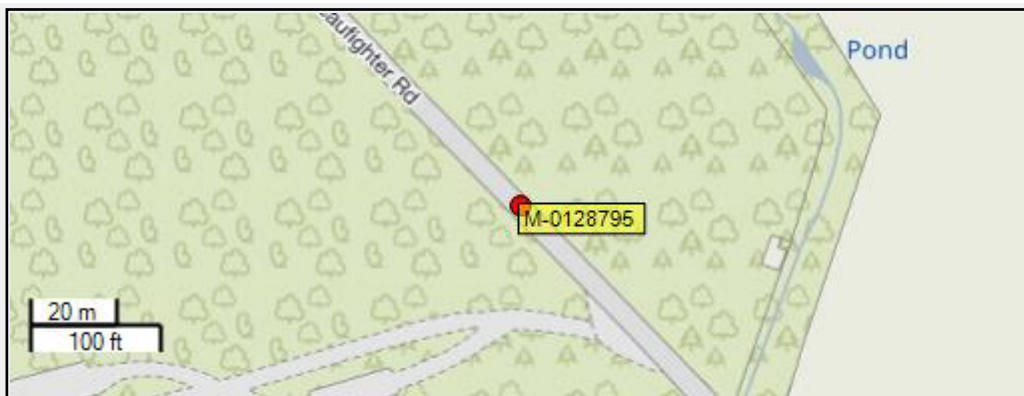
Instruction Reference: M-0128795

Item Detail: Pothole

Defect Category: P3 - 30 working days

Location Description: On carriageway on centreline

Description of Works: E&C 2 Potholes both approx 350mm x 200mm x45mm

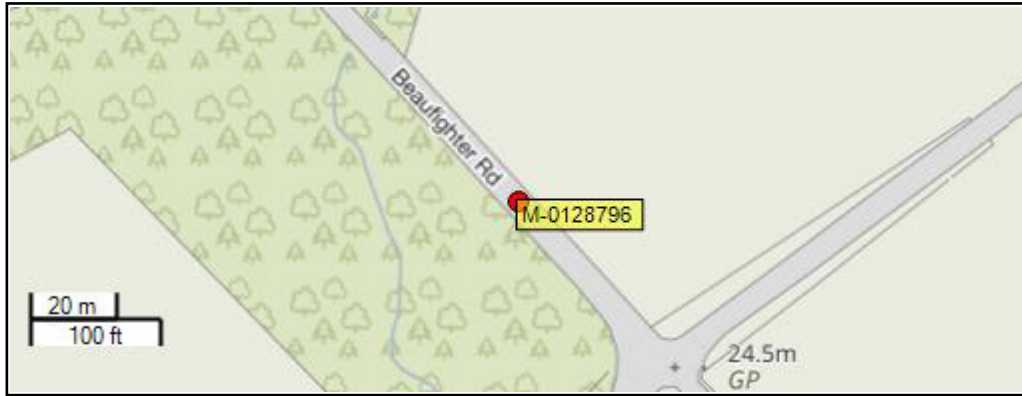
Instruction Reference: M-0128796

Item Detail: Pothole

Defect Category: P3 - 30 working days

Location Description: On carriageway on centreline

Description of Works: E&C 1 Pothole approx 300mm x 300mm x45mm

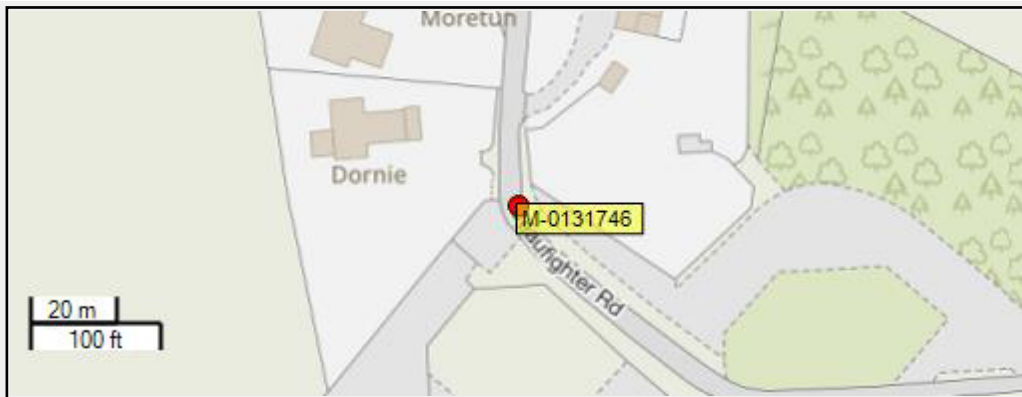
Instruction Reference: M-0131746

Item Detail: Pothole

Defect Category: P3 - 30 working days

Location Description: On carriageway on corner heading south

Description of Works: E&C 1 Pothole approx 250mm x 200mm x 45mm

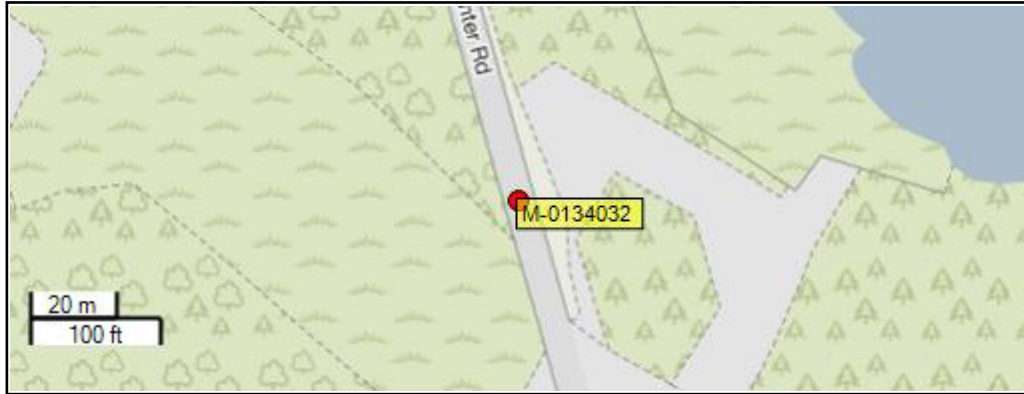
Instruction Reference: M-0134032

Extremely dangerous for cyclists or motorcyclists, potential for causing catastrophic accident or dismount. Is very high if struck unknowingly. Pothole has been obscured by rain water recently making even more dangerous.

Item Detail: Pothole

Defect Category: P3 - 30 working days

Location Description: On carriageway heading north on nrside wheeltrack

Description of Works: E&C 1Pothole approx

1x 700mm x 450mm x 50mm

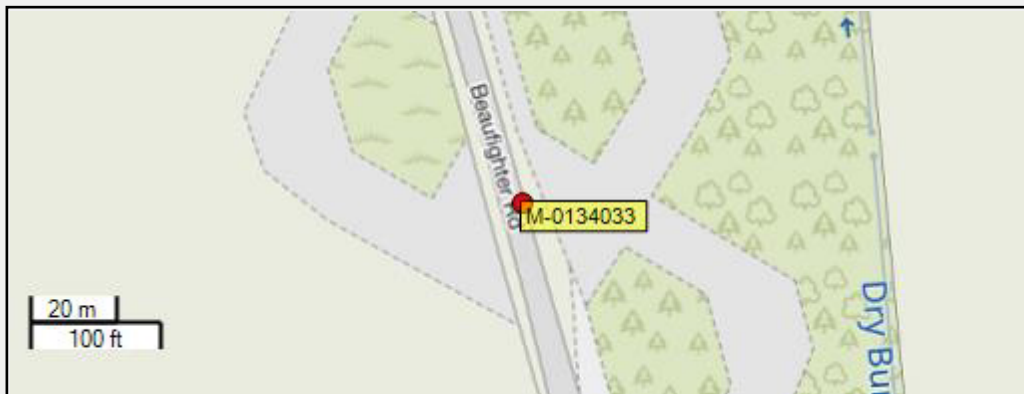
Instruction Reference: M-0134033

Item Type: Drainage

Item Detail: Blocked Offlets

Defect Category: P4 - 40 working days

Location Description: On both sides of carriageway from nether dallachy heading south to crossroads

Description of Works: Clean blocked offlets

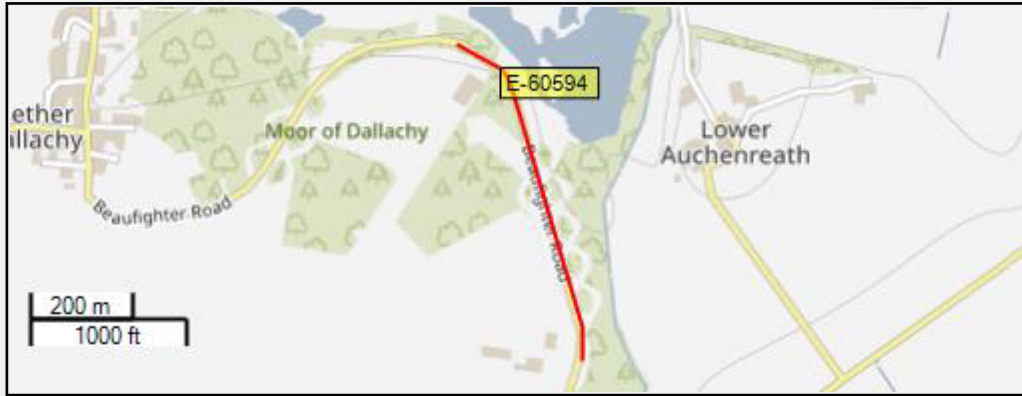
Enquiry Reference: E-60594

Location of fault: Pot holes all over various sizes & Depts all though Bogmoor. Then on Beaufighter Rd just round from the tip & gravel pits heading towards Grays there's massive deep hole. Then all the way up kerbside from 30 MPH sign to golf course entrance in Spey Bay previously repaired areas are all disintegrating , also opposite verge side holes appearing.

Further Fault Details: Well here I am again! Complaining about the B9104 road. If you were to repair it PROPERLY then miserable old farts like myself wouldn't need to bloody well MOAN. Do the job right 1st time & then it's done, saves time & money, but that's seems to be beyond your abilities.

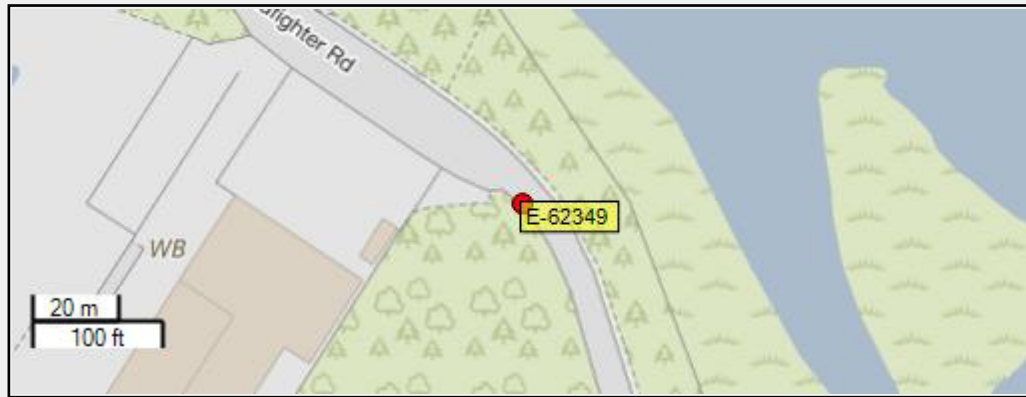
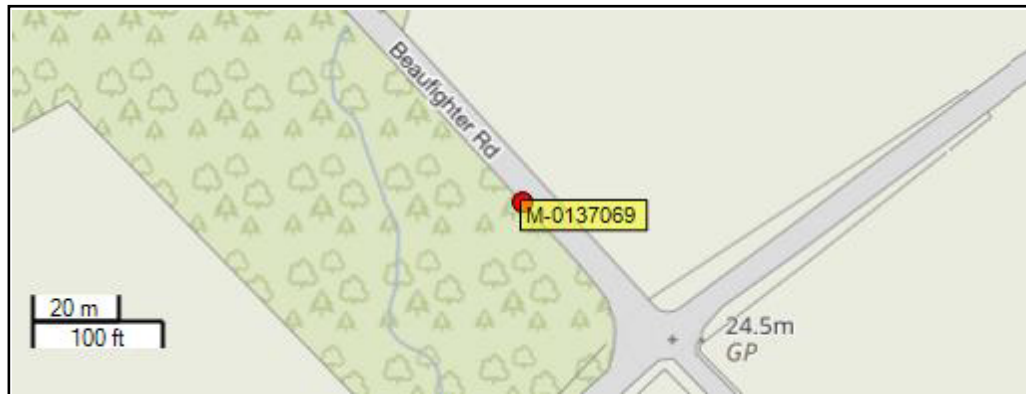
Location of fault: approximately 100 metres before the left hand bend between Grays Recycling and Pat Munro (Limehillock) Quarry on the left side of the road

Further Fault Details: I was on my way to Dallachy Recycling Centre yesterday 9th December at about 3pm when I hit a pothole on Beaufighter Road. The pothole was full of water and there was a van coming the other way, so I had no way of avoiding the flooded pothole. The location is just before the left hand bend (when travelling north) between Grays Recycling and Pat Munro (Limehillock) Quarry. What3Words location approximately is ///reheat.scarecrow.proof. My left, front tyre punctured immediately with a 60mm split in the sidewall (being a runflat I was able to limp home), there is also damage to the rim of my alloy wheel. The earliest appointment I could get to replace the tyre is Tuesday 12th December in Elgin. I'm not sure yet if I can drive the car there or have to use a breakdown recovery service.

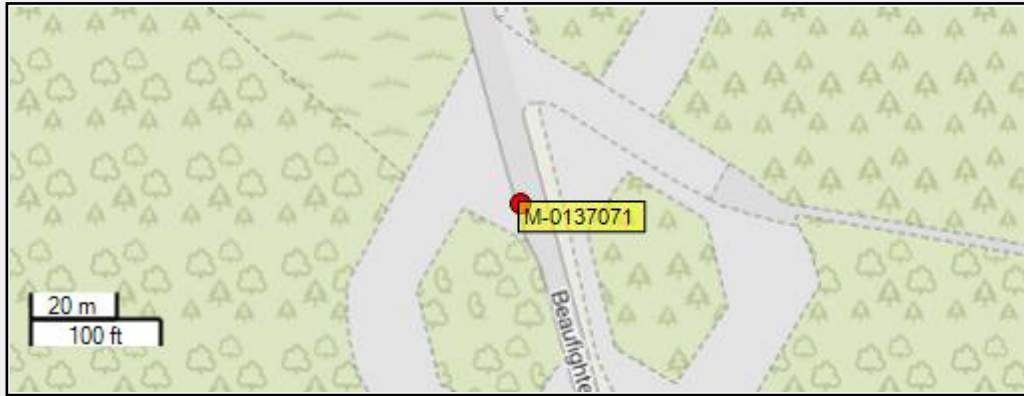
Instruction Reference: M-0137071
Instruction Created: 06/02/2024 10:19:00
Instruction Status : *Works Complete*
Inspection: Safety Inspection Area E01 - 02 (Feb) on the 6th of February 2024
Item Type: Carriageway
Item Detail: Pothole
Defect Category: P3 - 30 working days
Issued Date: 06/02/2024 10:19
Target Date: 19/03/2024 10:19
Completion Date: 22/03/2024 10:18
Location Description: On carriageway heading north on nrside wheeltrack
Description of Works: Cold Tar Pothole approx
1x 350mm x 350mm x50mm

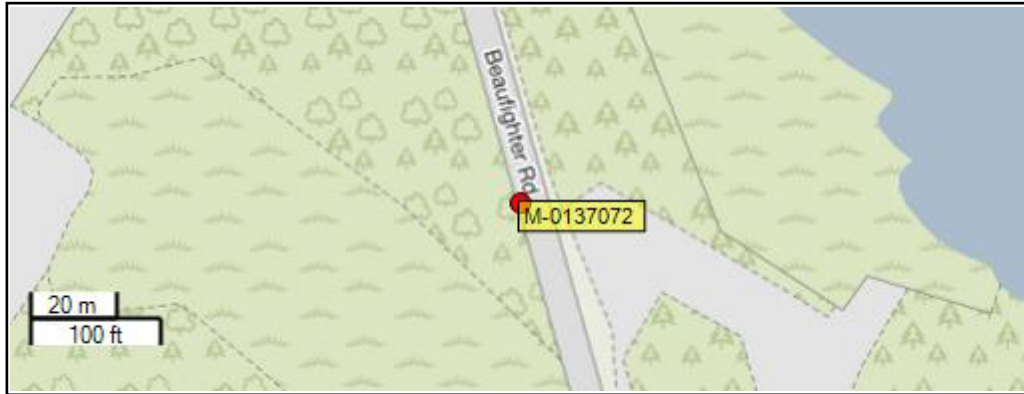
Instruction Reference: M-0137072
Instruction Created: 06/02/2024 10:22:00
Instruction Status : *Works Complete*
Inspection: Safety Inspection Area E01 - 02 (Feb) on the 6th of February 2024
Item Type: Carriageway
Item Detail: Pothole
Defect Category: P3 - 30 working days
Issued Date: 06/02/2024 10:22
Target Date: 19/03/2024 10:22
Completion Date: 22/03/2024 10:20
Location Description: On carriageway heading north on nrside wheeltrack
Description of Works: Cold Tar Pothole approx
1x 450mm x 450mm x 75mm

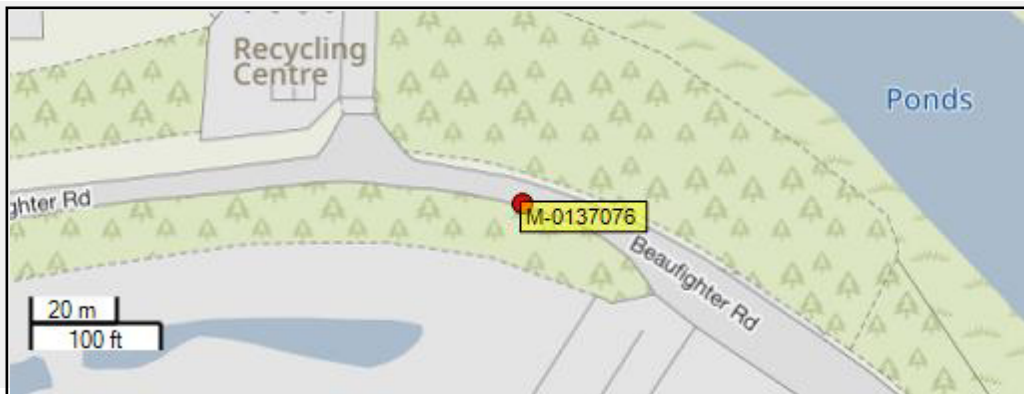
Instruction Reference: M-0137076
Instruction Created: 06/02/2024 10:29:00
Instruction Status : *Works Complete*
Inspection: Safety Inspection Area E01 - 02 (Feb) on the 6th of February 2024
Item Type: Carriageway
Item Detail: Pothole
Defect Category: P3 - 30 working days
Issued Date: 06/02/2024 10:29
Target Date: 19/03/2024 10:29
Completion Date: 27/02/2024 11:05
Location Description: On carriageway heading north on nrside edge

Description of Works: Hot tar Bowl fill 2 edge Potholes approx
1x 2.5mtrs x 500mm x 120mm
1x 1.75 mtrs x 500mm x 120mm

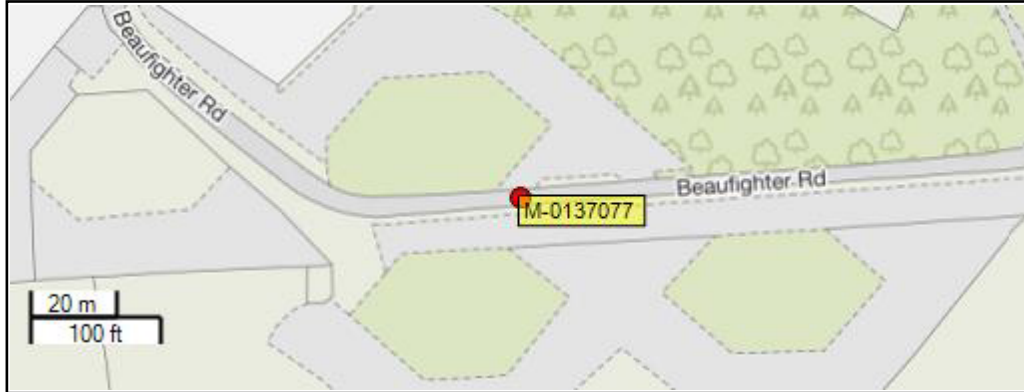
Instruction Reference: M-0137077

Item Detail: Pothole

Defect Category: P3 - 30 working days

Location Description: On carriageway heading north on offside side

Description of Works: Cold Tar Pothole approx
1x 300mm x 250mm x50mm
