# Moray Council

## Inspection/Defect Report

**Street :-** 26301306 - B9017 from Main Street in Newmill to A95 at Montgrew, Keith

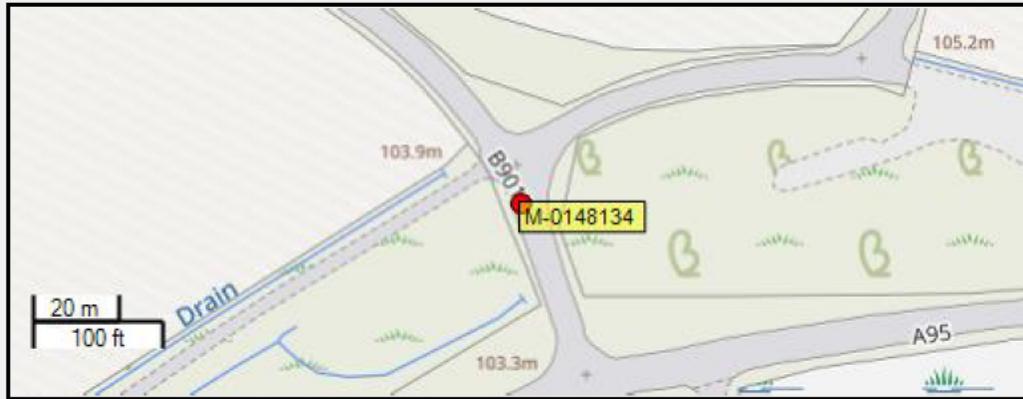
**Instruction Reference:** M-0148134

**Item Type:** Carriageway

**Item Detail:** Pothole

**Defect Category:** P3 - 30 working days

**Location Description:** On carriageway heading north on nrside wheeltrack

**Description of Works:** Cold Tar Pothole approx

1x 600mm x 300mm x 65mm ns wt

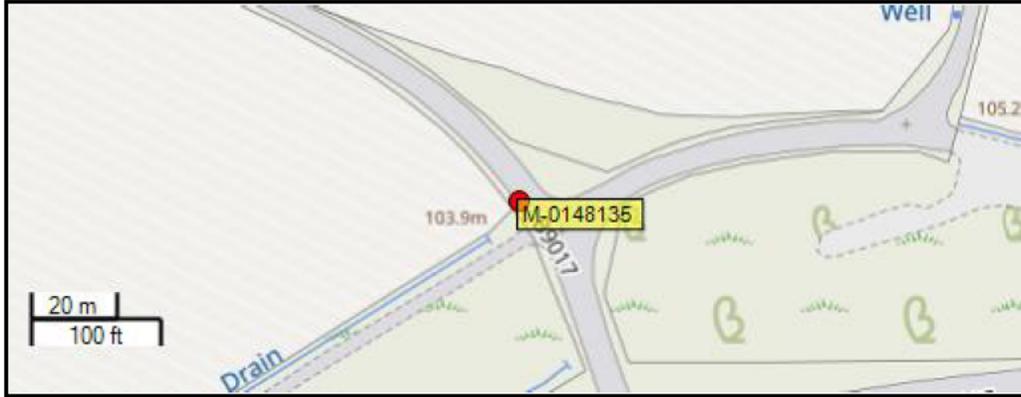
**Instruction Reference:** M-0148135  
**Instruction Created:** 10/12/2024 14:25:00  
**Instruction Status :** *Works Complete*  
**Inspection:** Safety Inspection Area E05 - 12 (Dec) on the 10th of December 2024  
**Item Type:** Carriageway  
**Item Detail:** Pothole  
**Defect Category:** P2 - 5 Working Days  
**Issued Date:** 10/12/2024 14:25  
**Target Date:** 17/12/2024 14:25  
**Completion Date:** 12/12/2024 11:52  
**Location Description:** On carriageway heading north west on nrside wheeltrack  
**Description of Works:** Cold Tar Pothole approx 1x 1mtr x 650mm x 70mm ns wt

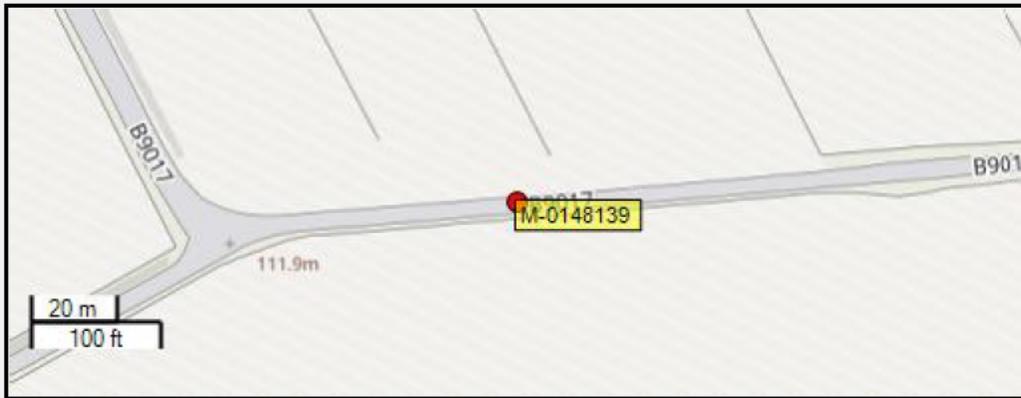
**Instruction Reference:** M-0148139  
**Instruction Created:** 10/12/2024 14:58:00  
**Instruction Status :** *Works Complete*  
**Inspection:** Safety Inspection Area E05 - 12 (Dec) on the 10th of December 2024  
**Item Type:** Carriageway  
**Item Detail:** Carriageway Defects  
**Defect Category:** P3 - 30 working days  
**Issued Date:** 10/12/2024 14:58  
**Target Date:** 28/01/2025 14:58  
**Completion Date:** 04/02/2025 13:28  
**Location Description:** On east bound carriageway edge as marked  
**Description of Works:** Hot tar Bowl fill approx 11mtrs x 500mm x 80mm+ ns edge

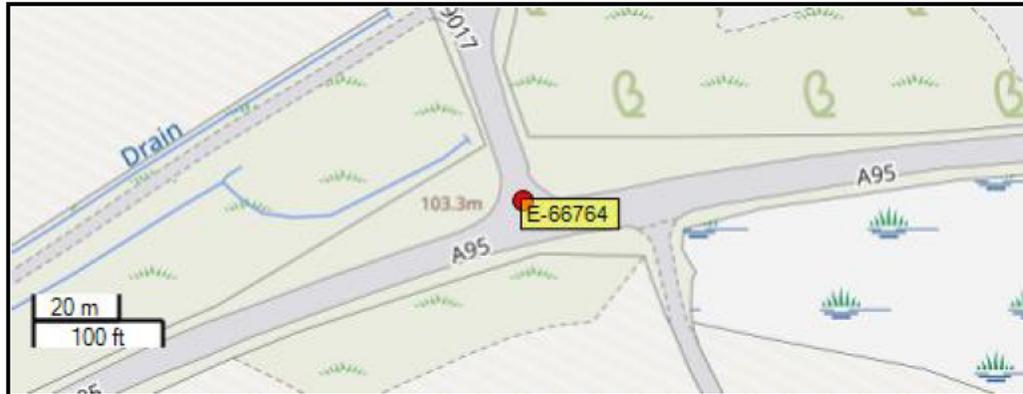
**Location Description:** Pothole at what3words address ///dolly.operation.hats

**Enquiry Comments:** Incident occurred 12/12/2024 at just after 12am. Hitting the pothole lead to damage to tyre and immediate loss of tyre pressure. I was subsequently stranded from midnight until 8am in freezing temperatures until RAC could recover the vehicle. Replacement tyre cost £84. I would I ke a claim form issued to [REDACTED] please.

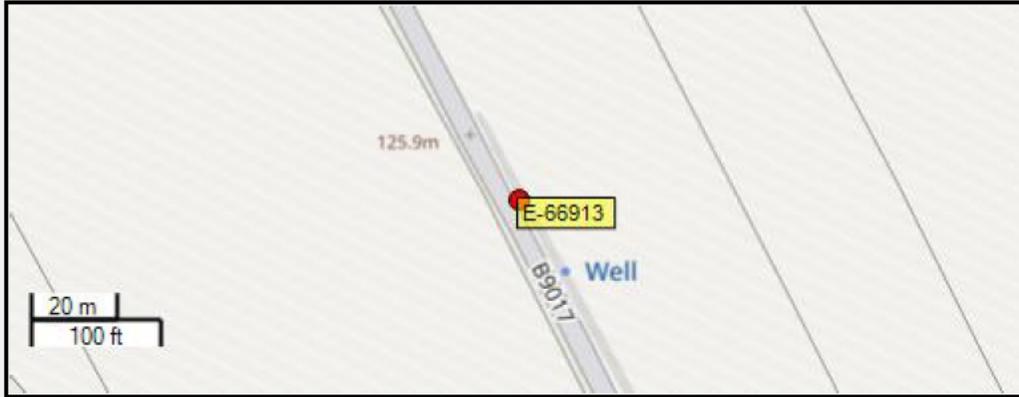
**Enquiry Reference:** E-66913

**Location Description:** customer called to report flooding on the road and also ditch damage on the 2 bends as you come into newmill from davoch side on the b9017

**Item Detail:** Blocked Ditch

**Description of Works:** Using digger clear short sections of blocked ditch going uphill from corner

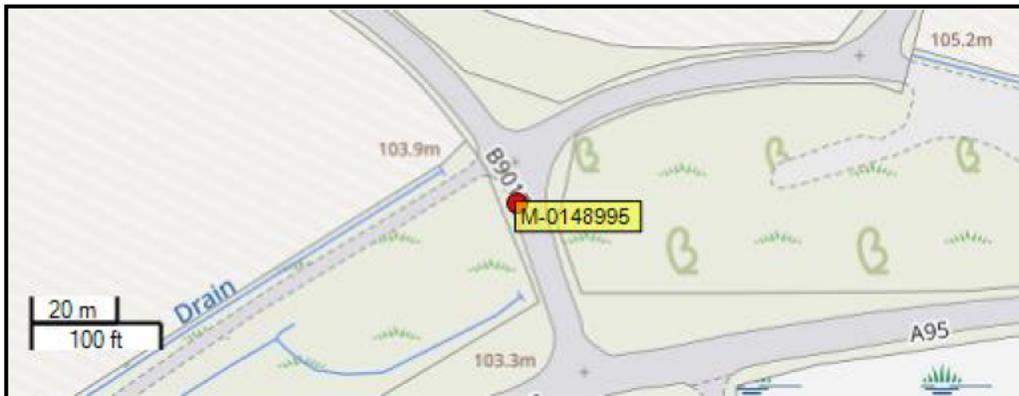
**Instruction Reference:** M-0148995

**Item Type:** Carriageway

**Item Detail:** Pothole

**Location Description:** On carriageway heading north on nrside wheeltrack

**Description of Works:** E&C Pothole approx  
1x 1mtr x 450mm x 45mm ns wt

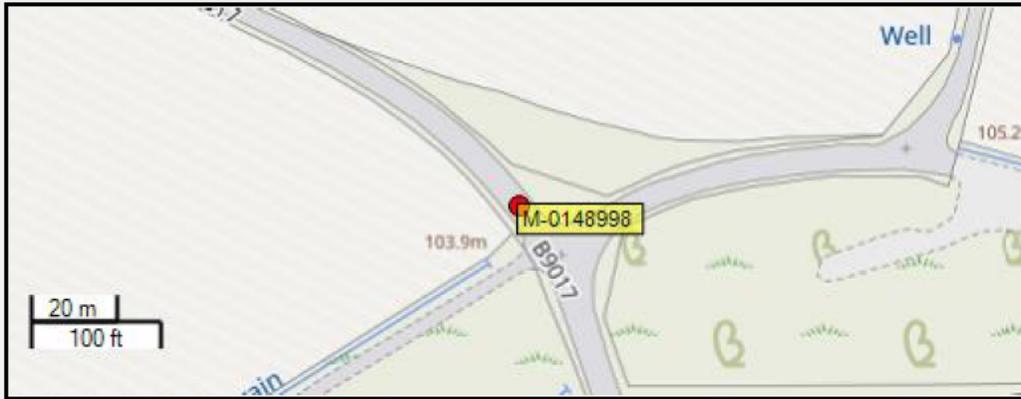
**Instruction Reference:** M-0148998

**Item Type:** Carriageway

**Item Detail:** Pothole

**Location Description:** On carriageway heading north westerly on offside wheeltrack

**Description of Works:** E&C 2 Potholes approx

1x 450mm x 350mm x 55mm os wt

1x 400mm x 350mm x 55mm ns wt

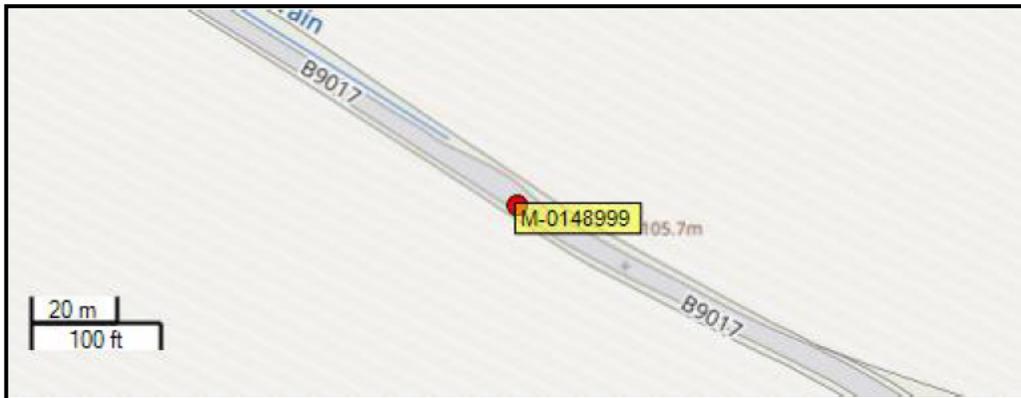
**Instruction Reference:** M-0148999

**Item Type:** Carriageway

**Item Detail:** Pothole

**Location Description:** On carriageway heading west on nrside wheeltrack

**Description of Works:** E&C 2 Potholes approx

1x 350mm x 300mm x 50mm ns wt

1x 300mm x300mm x 50mm ns wt

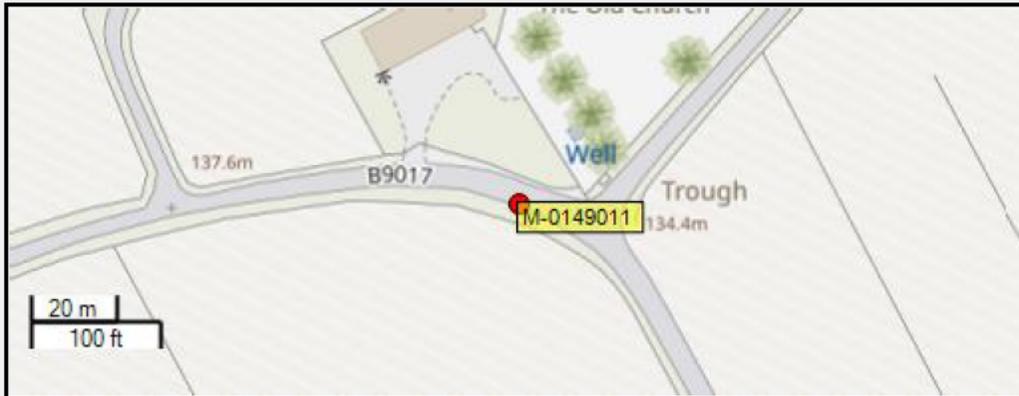
**Location Description:** From corner at top of hill heading up and round bend on south west side of carriageway

**Description of Works:** Replace section of washed out verge with recycled materials to protect road edge from further damage of erosion

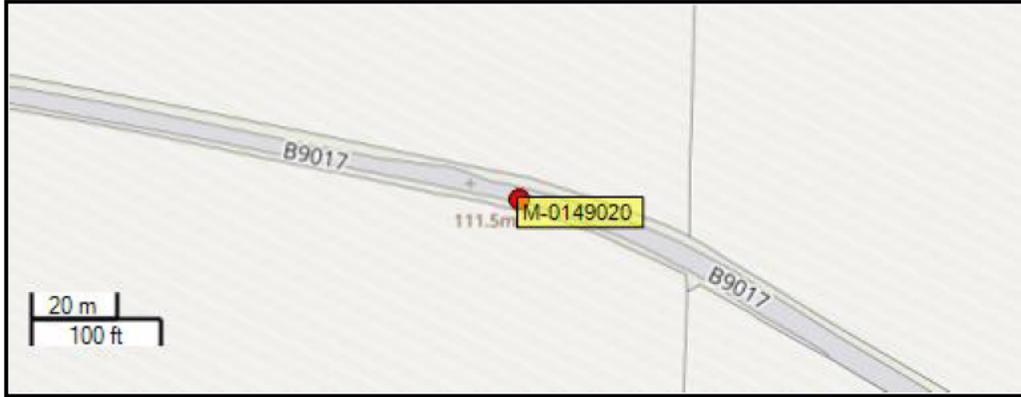
**Instruction Reference:** M-0149020

**Item Detail:** Over-run damage

**Location Description:** On south side of carriageway where veichle went off road opposite and beside passing place

**Description of Works:** Using digger pull back overrun verge to carriageway edge approx 100mtrs

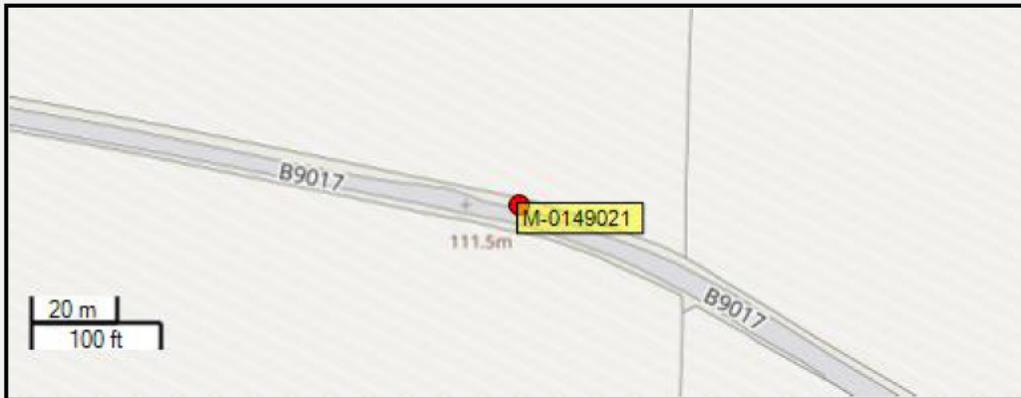
**Instruction Reference:** M-0149021

**Location Description:** On north side of carriageway next to passing place

**Description of Works:** Using digger clean and pull back overrun dich by veichle approx 80mtrs

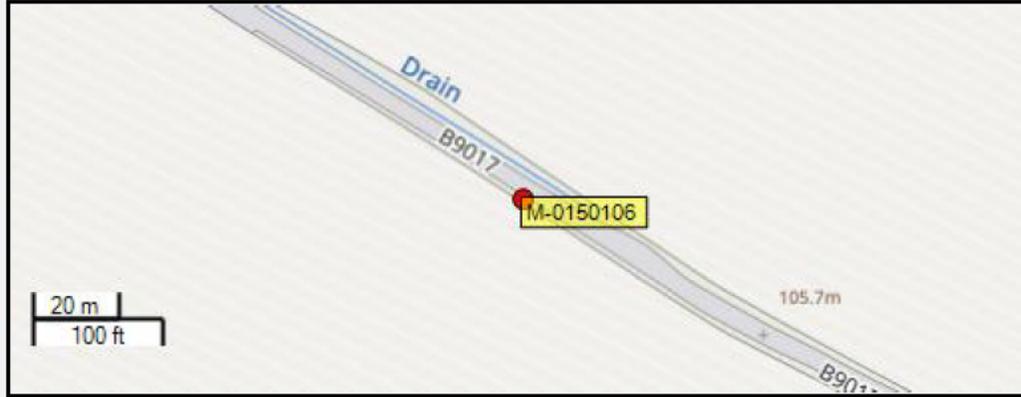
**Instruction Reference:** M-0150106

**Location Description:** On south side of carriageway

**Description of Works:** Clear silt from chamber and jet both entrance and exit pipes within chamber

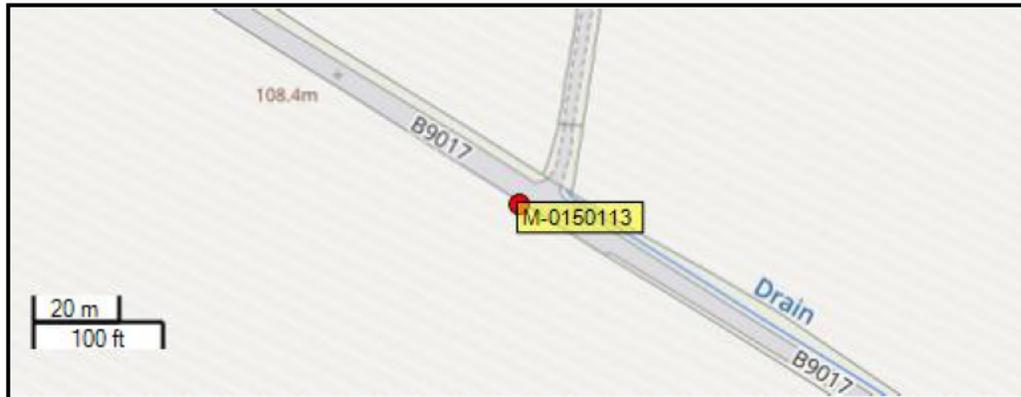
**Instruction Reference:** M-0150113

**Location Description:** On south side of carriageway nr gate of field

**Description of Works:** Using jetter clear any blockage from culvert pipe going into chamber

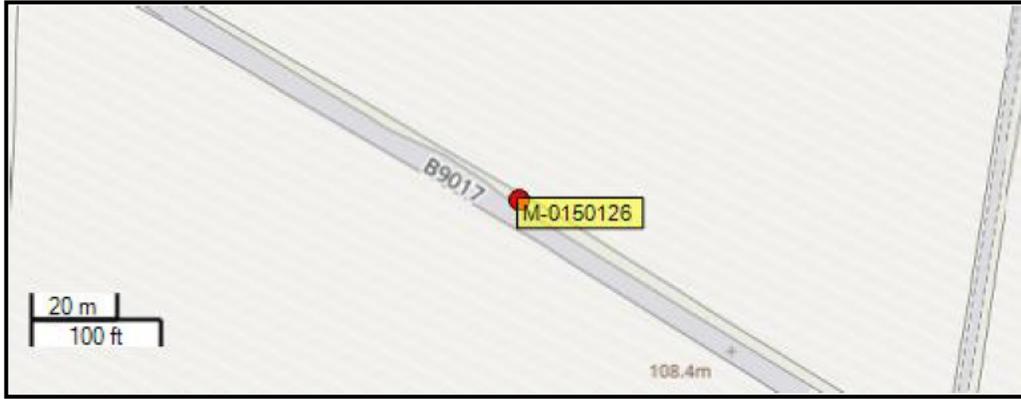
**Instruction Reference:** M-0150126

**Location Description:** On north side of carriageway below passing place

**Description of Works:** Clear blocked culvert underneath passing place

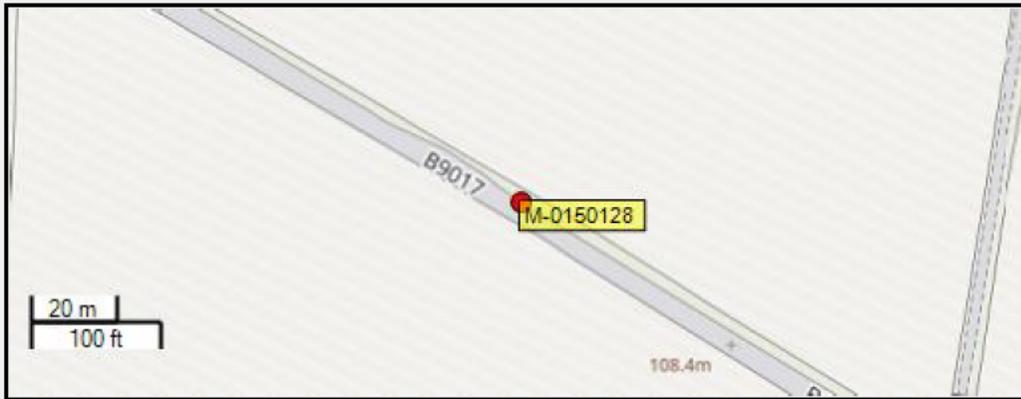
**Instruction Reference:** M-0150128

**Item Detail:** Drainage Defects/Problems

**Location Description:** On north side of carriageway at east end of passing place

**Description of Works:** Clean and pullback short section of badly overrun verge on east side of passing place approx 20mtrs

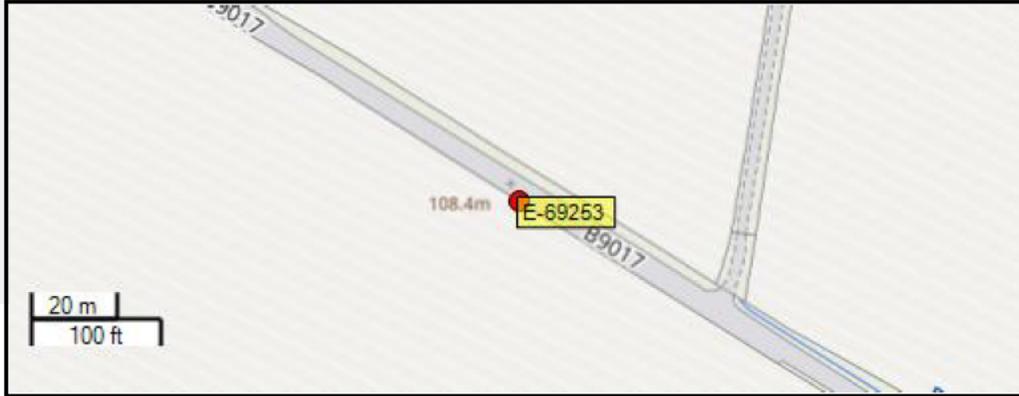
**Enquiry Reference:** E-69253

**Item Detail:** Over-run damage

**Location Description:** On south side of carriageway opposite passing places along with other short sections between crossburn and A95

**Enquiry Comments:** Overrun sections mainly on the south side of carriageway, some soil is on edge of carriageway, mainly been caused by larger vehicles.

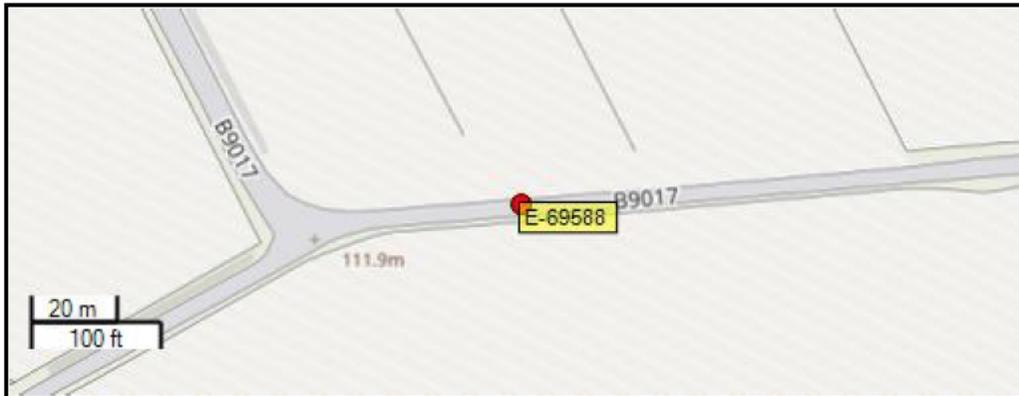
**Enquiry Reference:** E-69588

**Item Detail:** Over-run damage

**Location Description:** On north side of carriageway heading east

**Enquiry Comments:** Overrun damage to verge which in turn has been pushed into ditch approx 35mtrs in length,  
Add to previous enquiry related to B9017

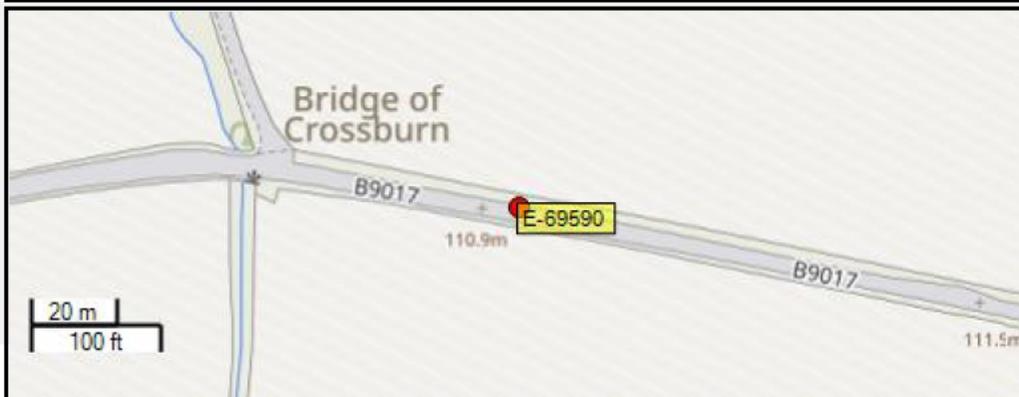
**Enquiry Reference:** E-69590

**Item Detail:** Over-run damage

**Enquiry Comments:** Extensive overrun damage has been caused to verge causing ditch side to be pushed in approx 60mtrs in length  
Add to previous enquiry for B9017

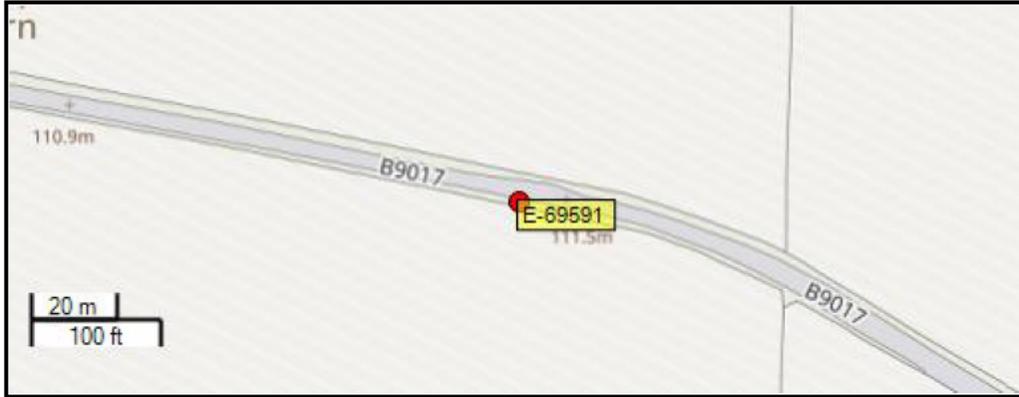
**Enquiry Reference:** E-69591

**Item Detail:** Over-run damage

**Enquiry Comments:** Overrun damage has been caused to verge approx 50mtrs in length

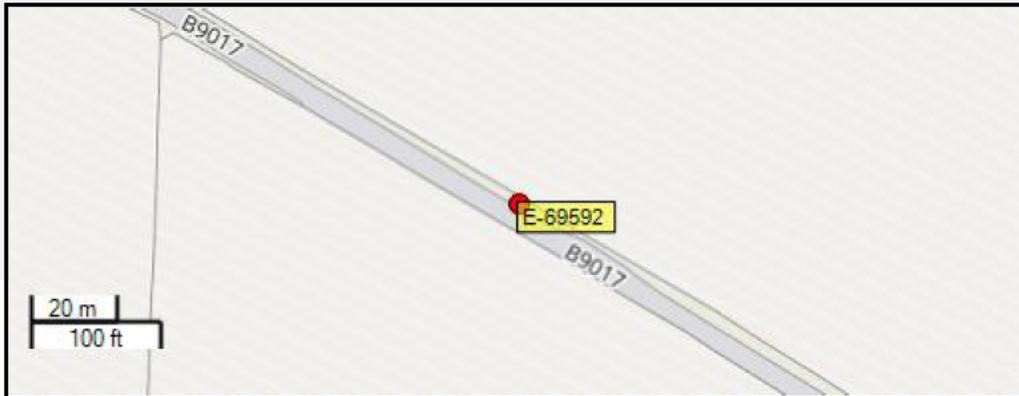
**Enquiry Reference:** E-69592

**Enquiry Comments:** Vehicle has entered and exited ditch partially blocking culvert

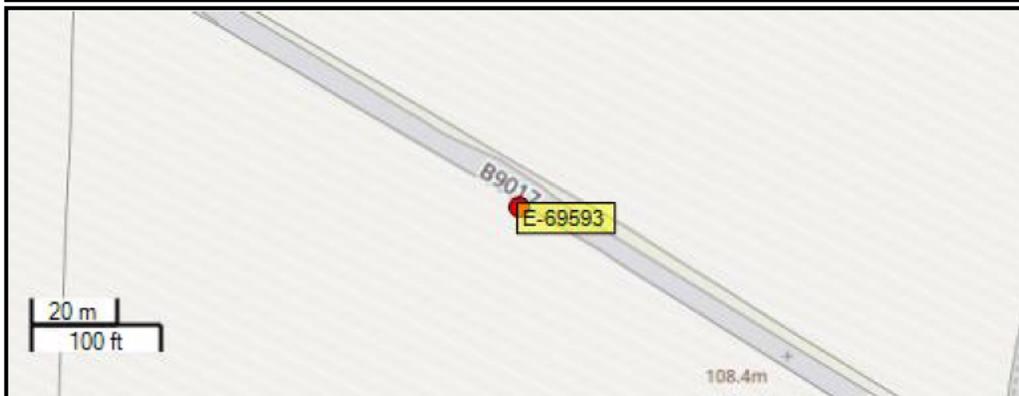
**Enquiry Reference:** E-69593

**Item Detail:** Over-run damage

**Enquiry Comments:** Overrun damage caused to verge opposite passing place approx 60mtrs in length

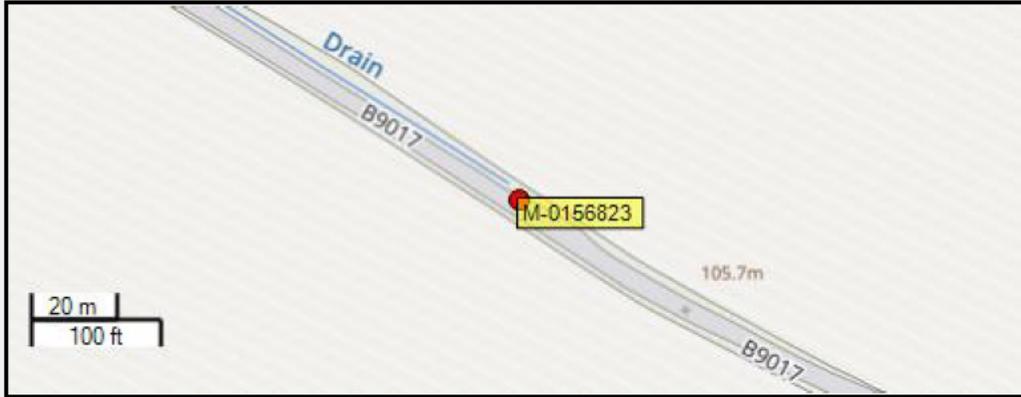
**Instruction Reference:** M-0156823

**Location Description:** On carriageway heading east on ns edge/wt at entry to passing place

**Description of Works:** E&C Pothole approx  
1x 400mm x 350mm x 60mm ns wt/edge

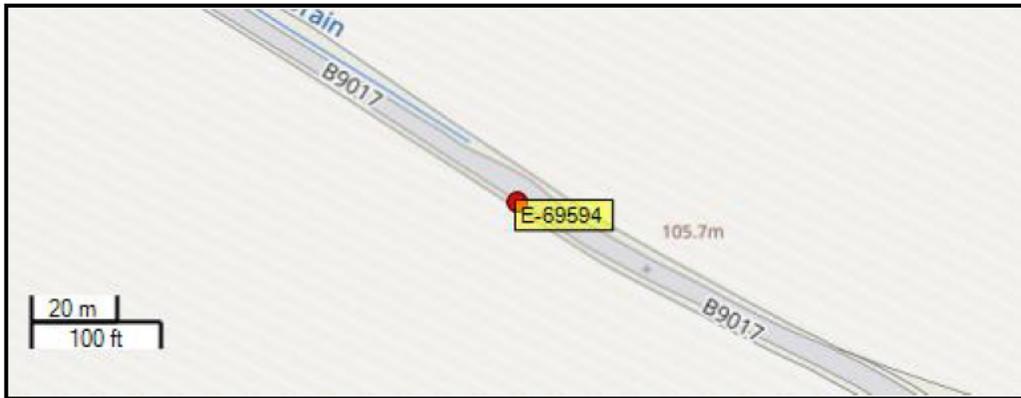
**Enquiry Reference:** E-69594

**Item Detail:** Over-run damage

**Location Description:** On south side of carriageway

**Enquiry Comments:** Verge has excessive overrun from corner east of passing place heading west to west side of passing place  
Approx 150mtrs  
Add to previous enquiry for B 9017

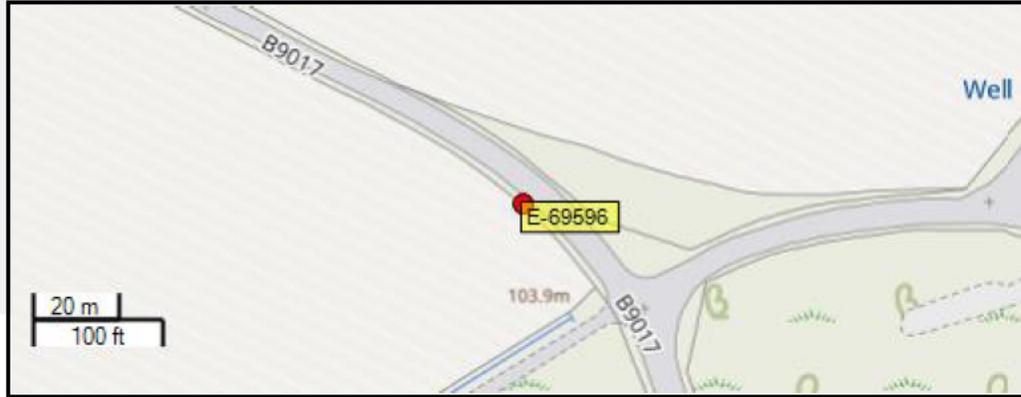
**Enquiry Reference:** E-69596

**Item Detail:** Over-run damage

**Enquiry Comments:** Overrun damage to verge at corner approx 150mtrs in length

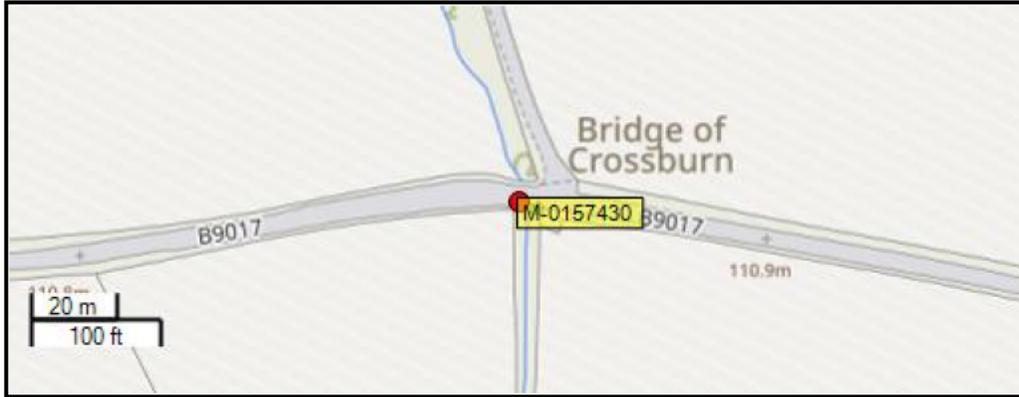
**Instruction Reference:** M-0157430

**Location Description:** On carriageway heading west on ns wt

**Description of Works:** E&C Pothole a  
1x 300mm x 300mm x 45mm ns wt

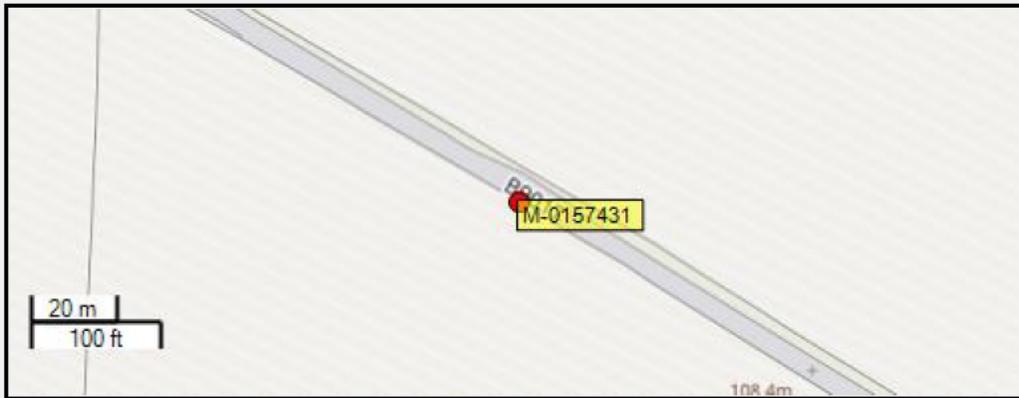
**Instruction Reference:** M-0157431

**Defect Category:** P2 - 5 Working Days

**Location Description:** On carriageway heading west on ns edge /wt oppositeside to passing place

**Description of Works:** Compamac ph approx  
1x 600mm x 400mm x 70mm ns edge
