## **BRIEFING NOTE**

### **RCC 322 Access Road to Tesco Store**

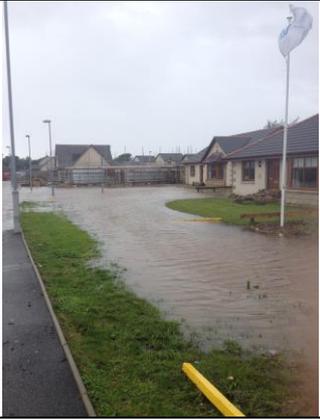
Summary Notes (photographs and extracts from communications)	
Date	Note
12/08/14	<p>Find attached photographs of flooding at Tesco, Buckie yesterday.</p> <p>As agreement has been reached with all relevant parties can you confirm if a programme has been implemented for the new drainage arrangement.</p>
11/08/14

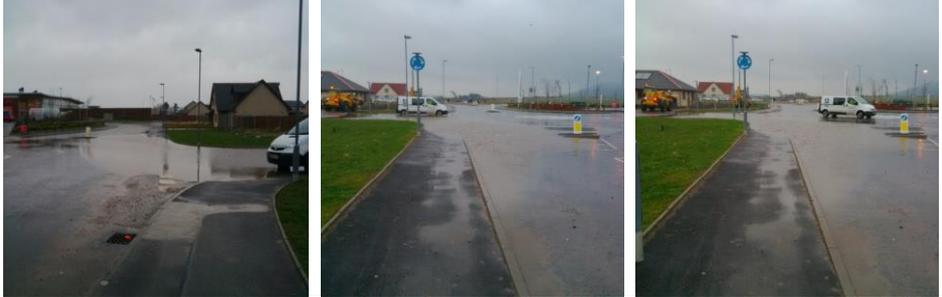
Summary Notes (photographs and extracts from communications)	
Date	Note
29/01/14

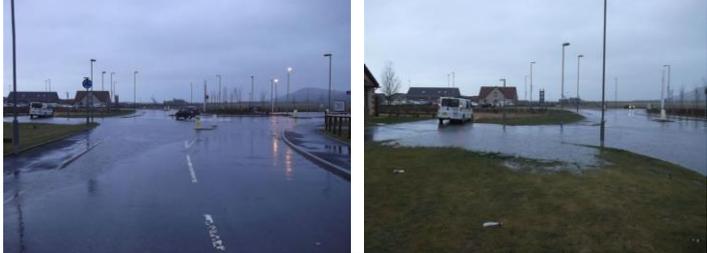
<b>Date</b>	<b>Note</b>
24/12/12	<p>URGENT: RCC 322 Tesco Buckie Access Road</p> <p>The attached photograph taken on Sunday 23 December 2012 shows the situation on the access road.</p> <p>I am advised by colleagues that the SUDS system is not coping with the levels of surface water and there is also an indication of problems with the foul sewer in the area (possibly from surface water entering that system).</p> <p>We require your urgent attention to investigate the situation, consider options for improvement to the drainage system and discuss proposals with us at the earliest possible opportunity.</p>
23/12/2012
